# Inspection Report

## National Property Inspections

### 11 Month Warranty Inspection

123 Any Street  
Any City TX

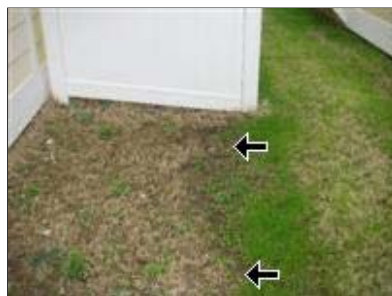
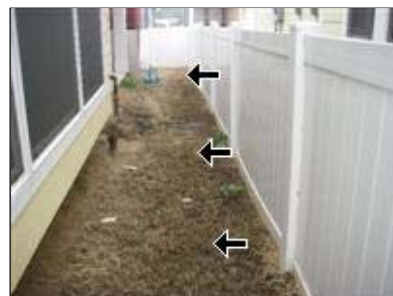
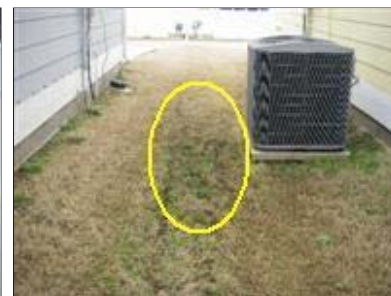
Poor drainage noted on both sides of the structure near the property and/or fence line with standing water observed. Today's standards require that surface drainage be diverted to a storm sewer conveyance or other approved point of collection so as to not create a hazard. A surface drain or other approved landscaping solution may be necessary to channel water away to the storm drains. Recommend further evaluation and repair by a qualified landscaping contractor. Note: This standard is required independent of a roof gutter system.

B. Picture 1 Right side

B. Picture 2 Right side

B. Picture 3 Left side

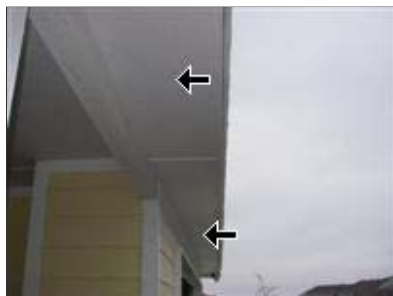
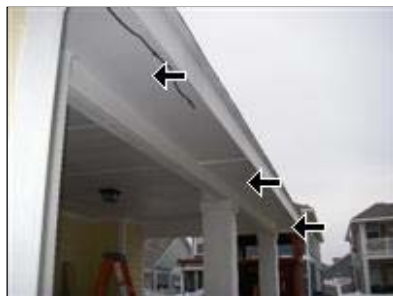
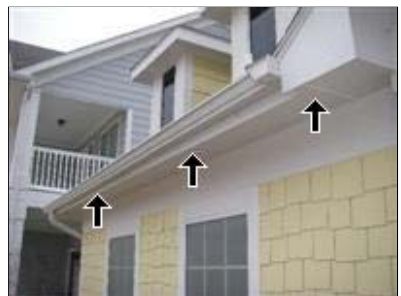
(2) Structure does not appear to have adequately placed attic ventilation along the soffits. For proper attic ventilation, it is recommended that one cubic foot of venting be obtained for every 300 feet of attic space. Half of this ventilation from the soffits (intake) and half at the roof line (exhaust). Although there may have been enough soffit vents installed to meet this standard, the placement was not equally spaced along the rear, right rear nor the front to provide adequate airflow for these areas. Also, only five passive vents found on the roof. This is improper. Considering that the attic is approximately 2100 square feet (garage and porch attic included), a total of nine vents should be present as this is a minimum standard.

D. Picture 1 Rear

D. Picture 2 Right rear

D. Picture 3 Front

Recommend further evaluation by a qualified roofing contractor and/or ventilation specialist. Please see the attachment page for more information regarding ventilation.

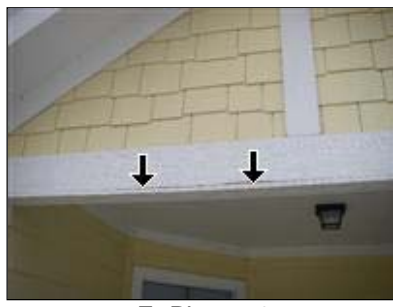
E. Picture 1

(1) Noted sealant separation along the beam at the front porch area. Recommend new sealant be applied.

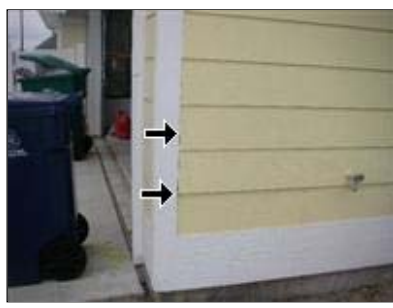
E. Picture 2

(2) The lap siding was not fully secured at the left rear corner with misapplied sealant observed. Recommend repair by a qualified contractor.

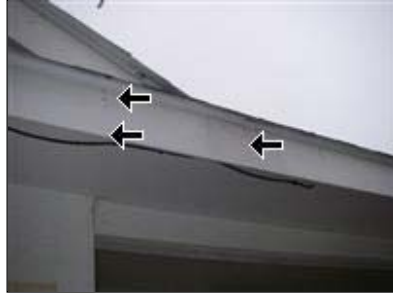
E. Picture 3

(3) There were several holes in the right side fascia. This appears to be due to previous mounting of antenna equipment.

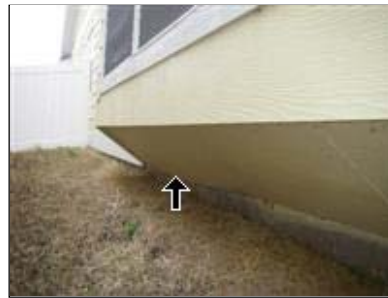
E. Picture 4

(4) The cement board at a lower portion of a right side window was no longer secured to the structure. Recommend securing.

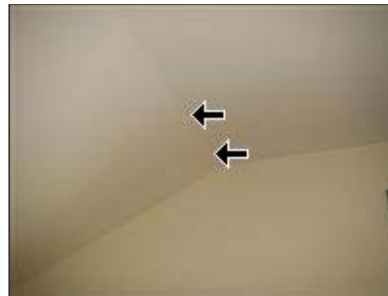
F. Picture 1

Noted a hairline drywall ceiling crack in the living room. This did not appear to be structural but cosmetic. Recommend repair by a qualified contractor.

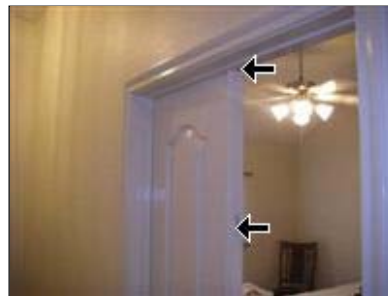
G. Picture 1

The left master bedroom door was difficult to latch. Recommend repair/adjustment.

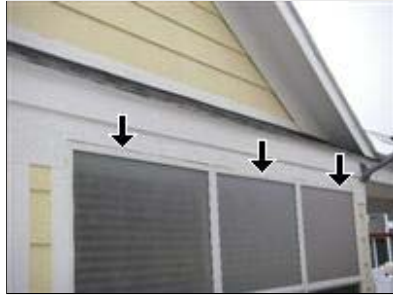
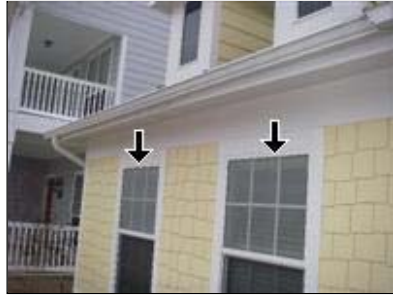
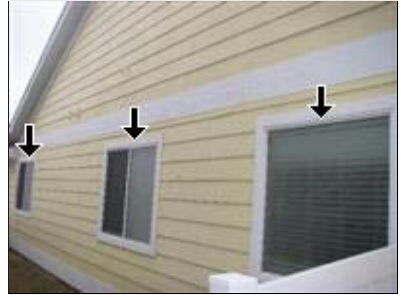
(2) Improper flashing detail noted along the top of several windows. There was no drip cap/head flashing present like several other windows throughout the structure. Flashing is necessary for long term performance as these areas are potential entry points for moisture. Recommend repair by a qualified contractor. Note: The eave at the front does not have the proper dimensions (depth) to eliminate the flashings for this area.

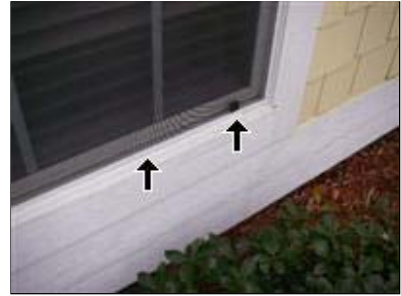
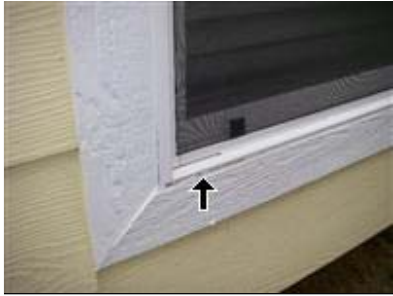
(3) Missing and/or misapplied sealant was observed at several windows around the structure. These are potential entry points for moisture. Recommend new sealant be applied.

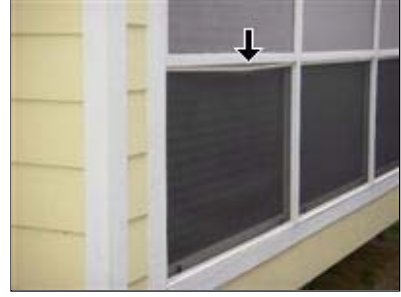
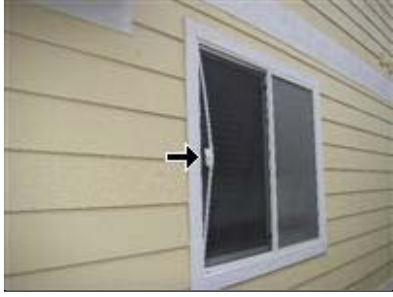
(4) One or more screens were damaged or missing. Recommend replacement.

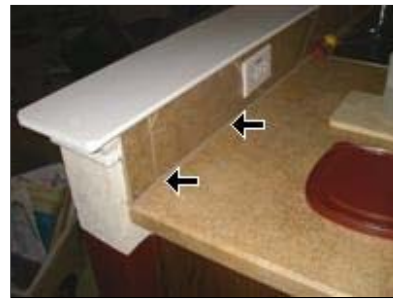
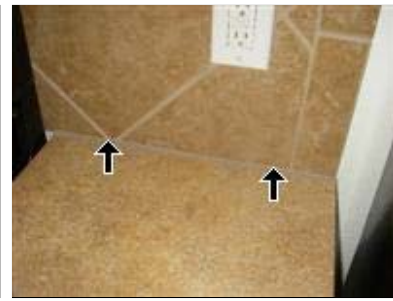
(1) The kitchen had cracked grout/sealant along the countertop/backsplash transition. Recommend repair by a qualified contractor.

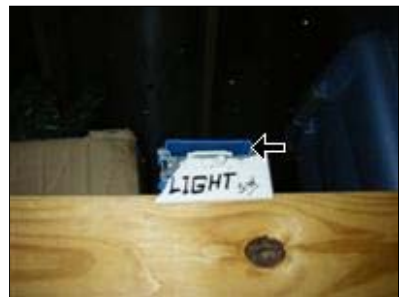
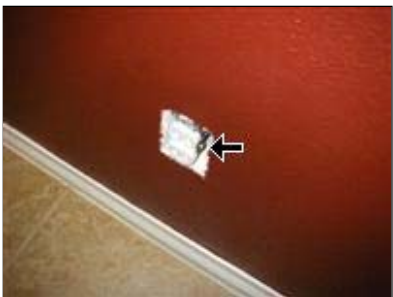
- (1) A representative number of lighting fixtures and receptacles/outlets tested were performing as intended.
- (2) The cover for the attic light was broken. Also, several receptacles were missing covers. Recommend new covers be installed.

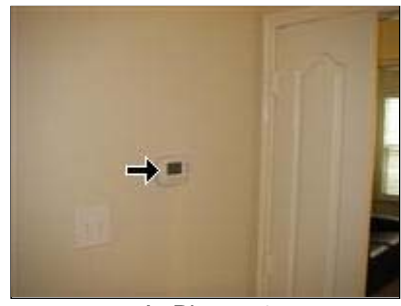
A. Picture 1

- (1) Heating equipment appears to be operating as intended at time of inspection.
- (2) Thermostat located in master bedroom. This was not installed in an appropriate location. To properly monitor temperature, thermostats should be located in common areas on an inside wall not adjacent to the exterior. Ex. (hallway), or at a room that has a return vent. Recommend further evaluation and repair by a qualified heating and air conditioning contractor.

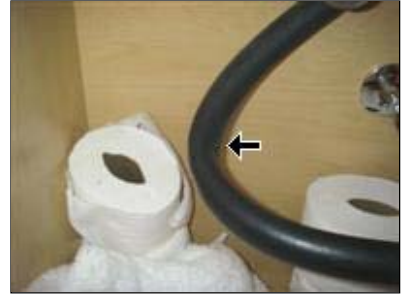
B. Picture 1

- (1) Cooling equipment was visually inspected but not tested for proper operation due to the outside air temperature being 60 degrees or less. For proper condenser lubrication, the air temperature should be above 60 degrees for several hours. If not, damage could result.
- (2) The hose in the guest bathroom used for the cooling equipment condensate line was narrowed due to a kink in the hose. A kink in the hose can contribute to a backup of condensate over time. Recommend repair by a qualified contractor.

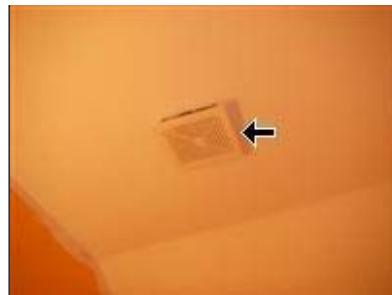
G. Picture 1

The cover for the exhaust vent in the guest bathroom was no longer positioned flush to the ceiling. Recommend securing.

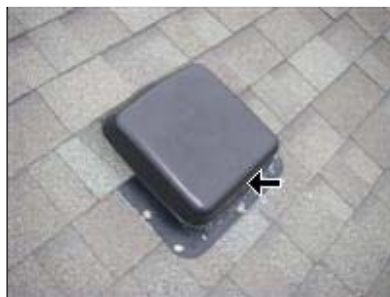
J. Picture 1

There was no damper present at the dryer vent termination. Today's standards require that dryer vent terminations have a backdraft damper. Recommend repair by a qualified contractor.
