Property Condition Assessment

Rochester NH

Property Condition Report

Report Date: February 15 2007

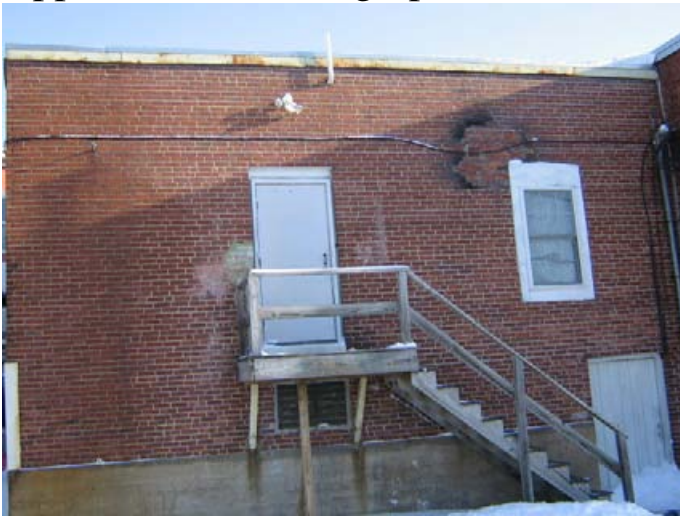
The exterior brick masonry is in poor to fair condition. There are weep holes in the bricks above the windows and above the grade. There various cracks and deterioration in mortar and prior repairs noted in rear. The vinyl siding and stucco appears in good condition.

Damage to brick work

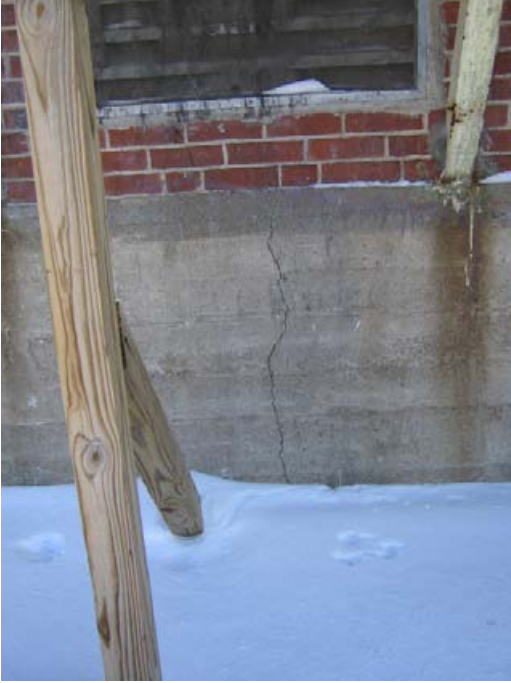
The foundation system is stone and mortar in the south “café” area and poured footings and bearing walls on the rest of the building, with reinforced concrete slab on grade for the basement floor. Some minor settlement cracks observed on the exterior of the foundation, typical for the age of the structure.

Crack in foundation

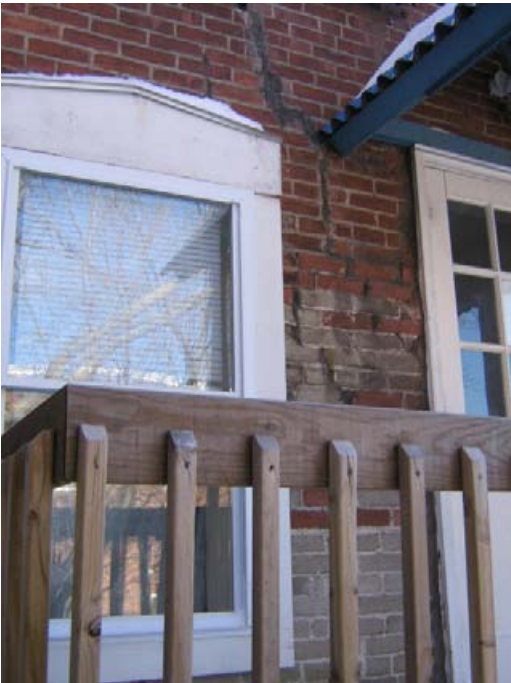
Crack in brick work

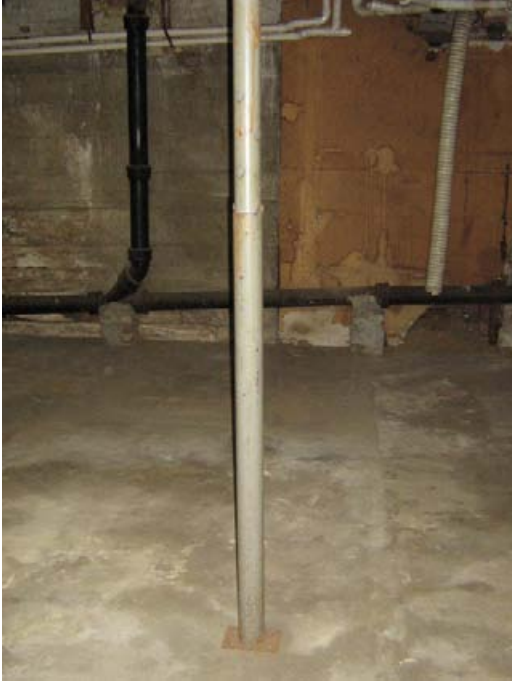
~~inspection and maintenance by a licensed pest control company. One lolly column under a wooden beam does not appear to have a poured footing present. The south café foundation has prior repairs and added metal columns, Should be monitored for any further shifting or settling.~~

Column in café no footing

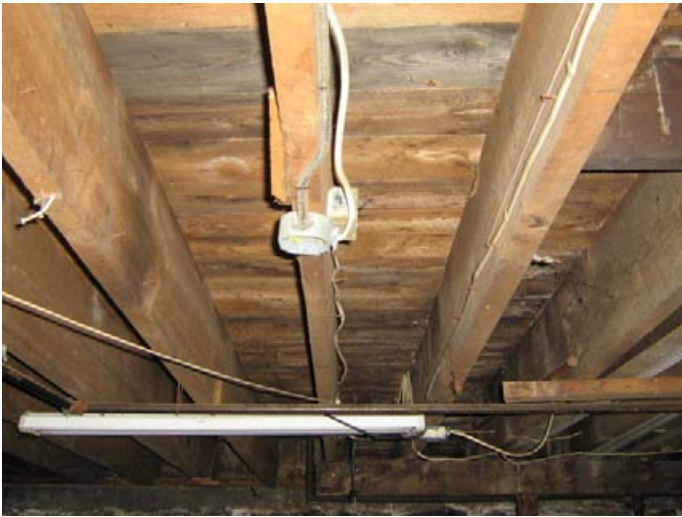
Open junction box

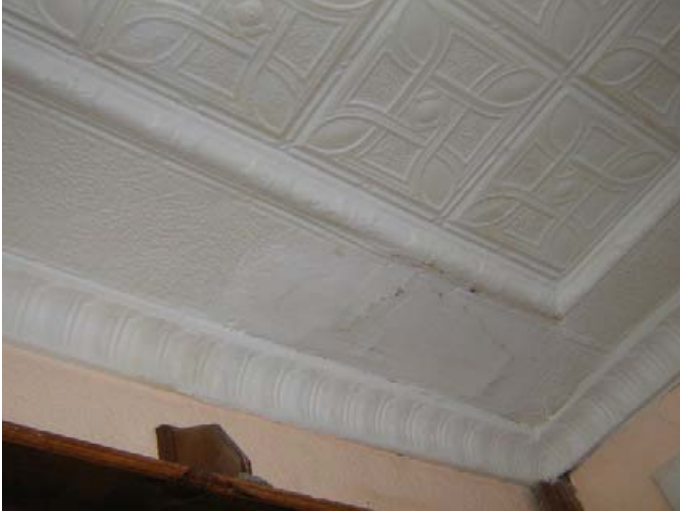
Prior repair in café from roof leak. Roof drain moved and leak repaired per broker.

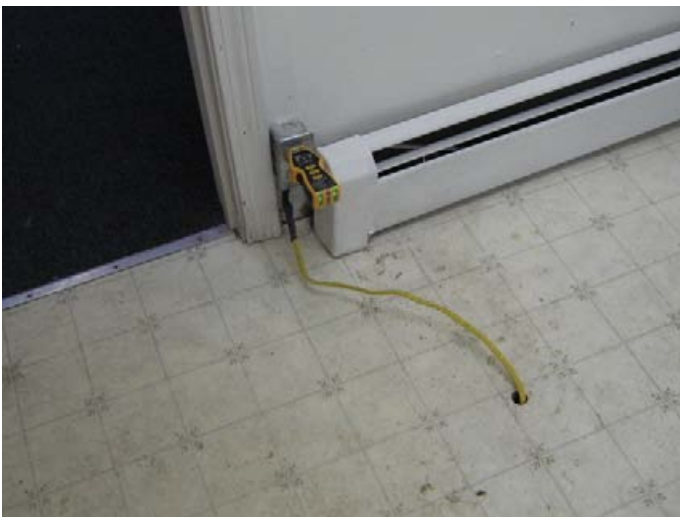
Improper exposed wiring.

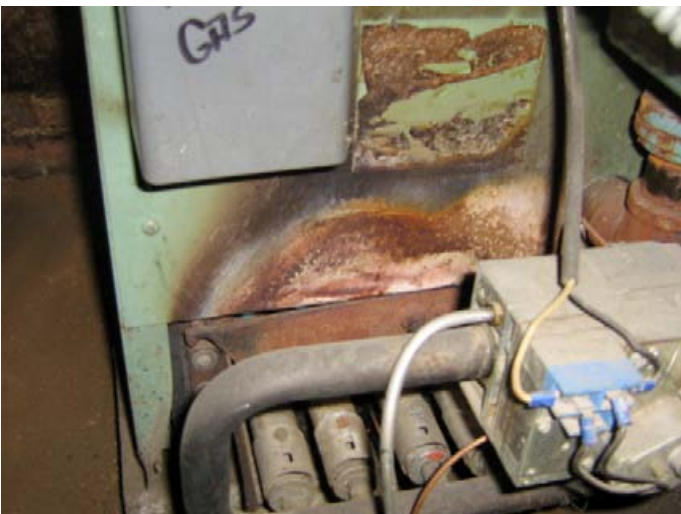
Two of the units burners showed excessive corrosion and dirt. Recommend budgeting funds for a preventative maintenance and possible repairs. One oil boiler requires annual maintenance. No record of service found.

Corrosion on furnace burner.

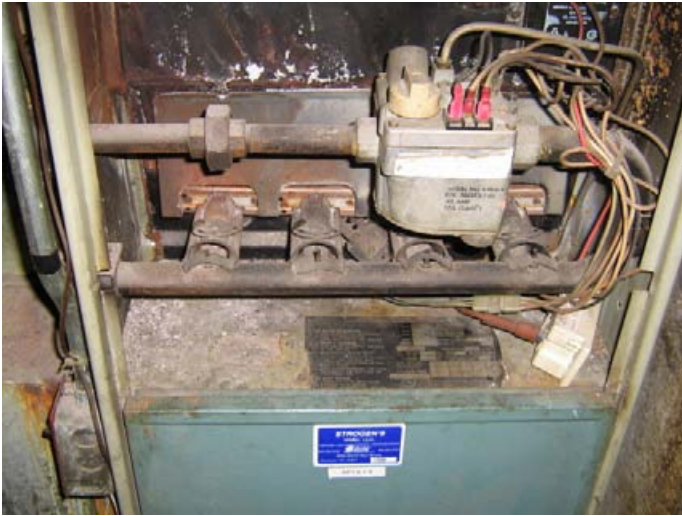
More corrosion on burners.

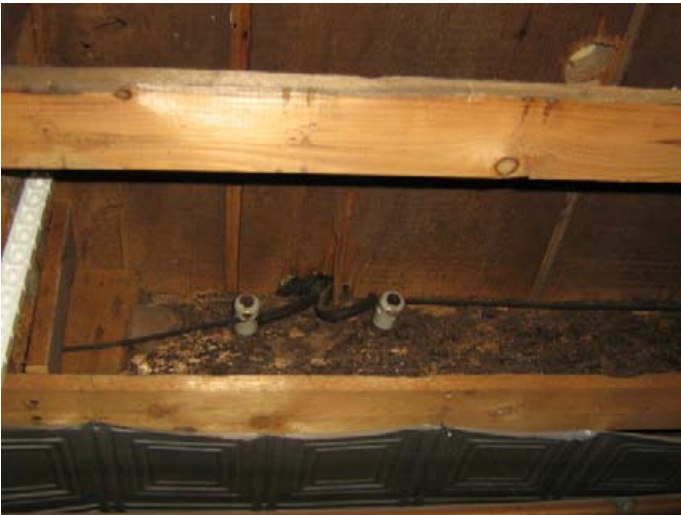
Exposed knob and tube wiring presumed terminated.

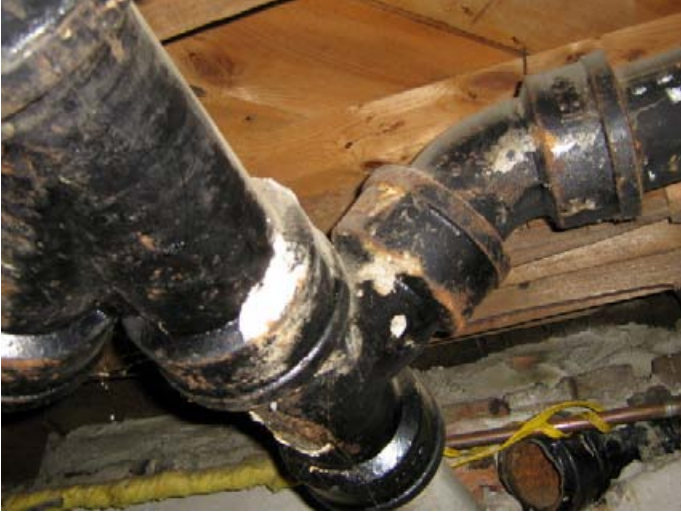
Many terminated plumbing and unusual amount of lines from many remodels over the years. Unable to observe entire plumbing system. Cast iron drain lines have corrosion evident. No current leaks noted.

Cast iron septic main line with corrosion.

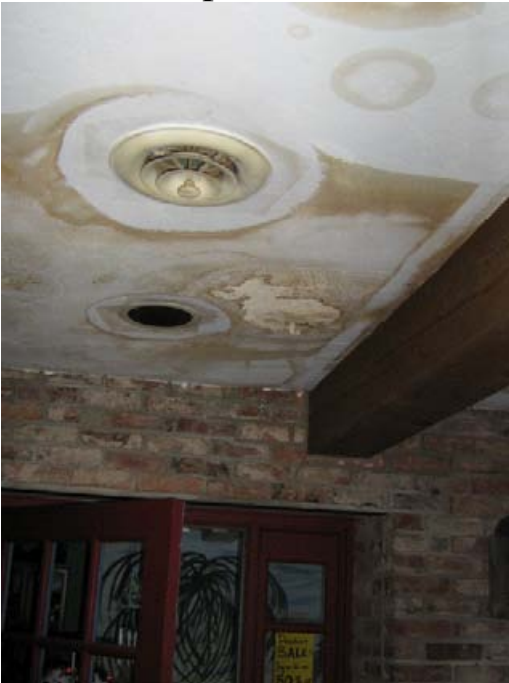
Water stains on ceiling in common hall to tavern and salon.

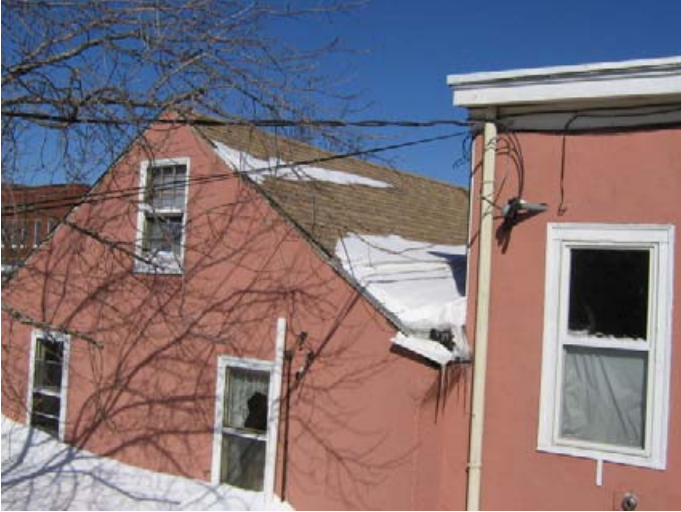
Roof valley needs to be monitored. Ice and snow damming.

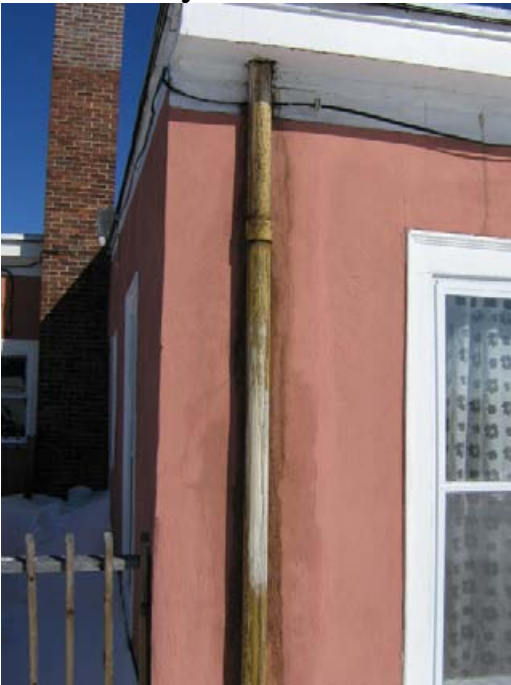
Roof drain staining wall should be cleaned and checked.

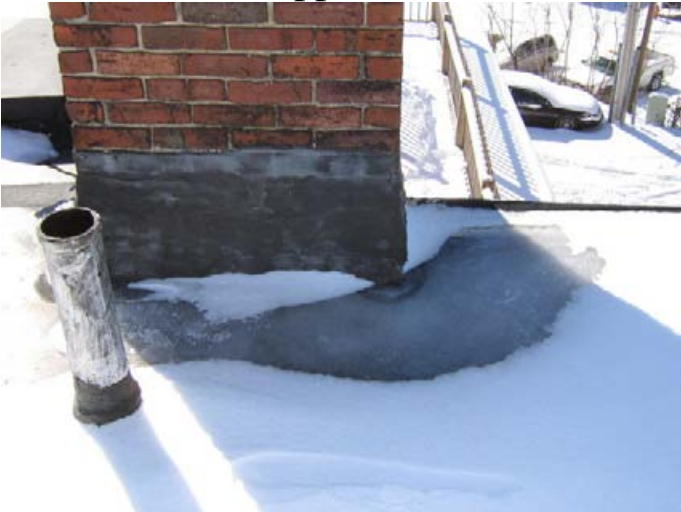
Ice damming around chimney. Area should be monitored.

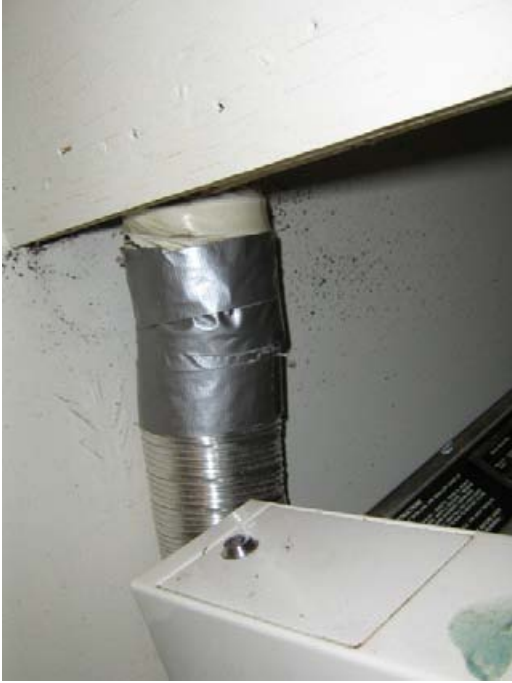
Dryer vent in common hall needs repair.

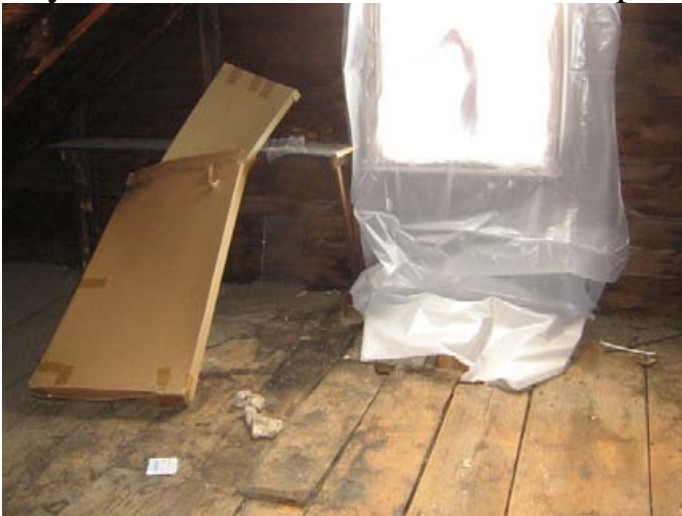
Window in attic with plastic sheeting above apartment # 1.

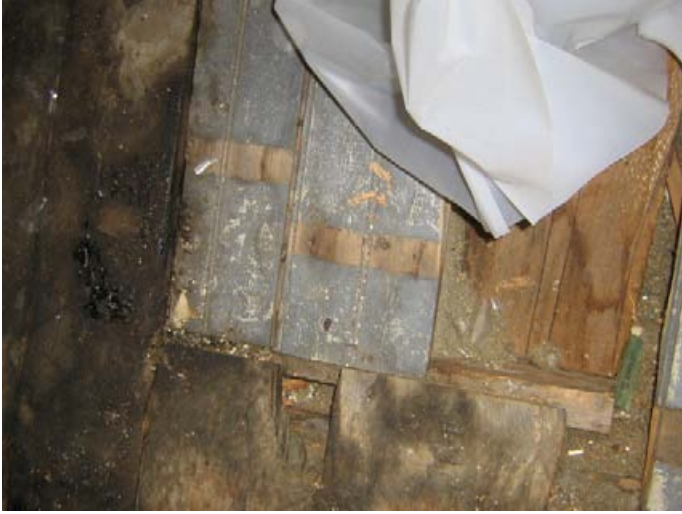
Broken floor boards in attic.
