PROPERTY INSPECTION REPORT

National Property Inspections**6310 Millwood Court****Arlington, TX 76016****Office 817-492-0161****Fax 817-451-0233****Mobile 469-964-4414****www.npidfw.com****service@npidfw.com****Inspected By: Eric Evans TREC #7077****Inspection Date: 4/25/2006****Client**

111 Your Home

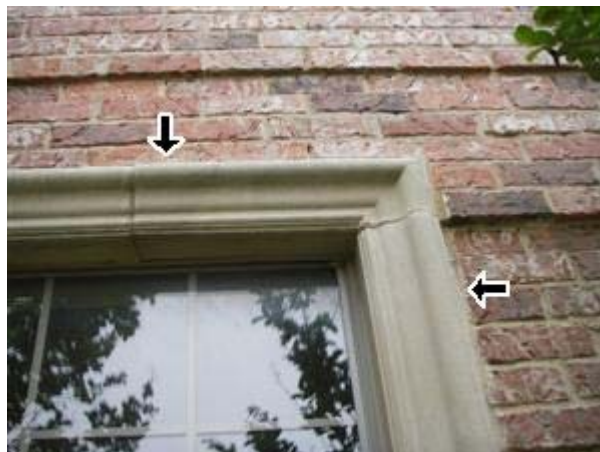
A. Picture 1

Comments: Foundation appears to be functioning as designed at time of inspection. Noted a few small brick veneer step cracks, however these do not appear to be significant or structural in nature at time of inspection. Noted representative number of doors and windows operated without dragging or other issues. Recommend following suggestions noted in grading and drainage section below to manage water around foundation perimeter. Recommend future monitoring for further developments.

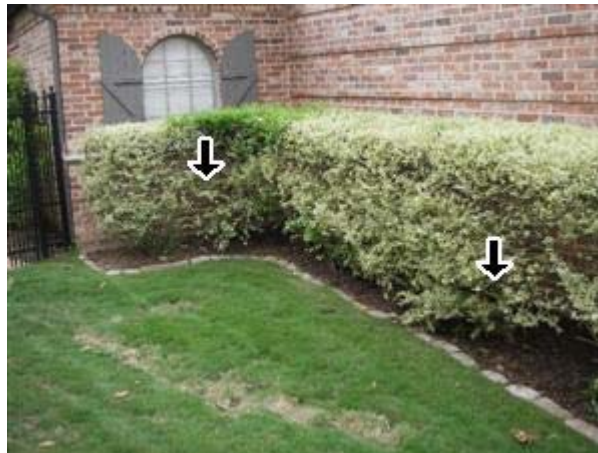
B. Picture 1

Comments: Overall grading appears to be performing as designed at time of inspection. Noted some minor negative sloping towards structure and low spots on property where water will stand after rain. These areas do not appear to properly drain water from property and need landscaping and drainage corrected. Recommend qualified contractor evaluate and repair.

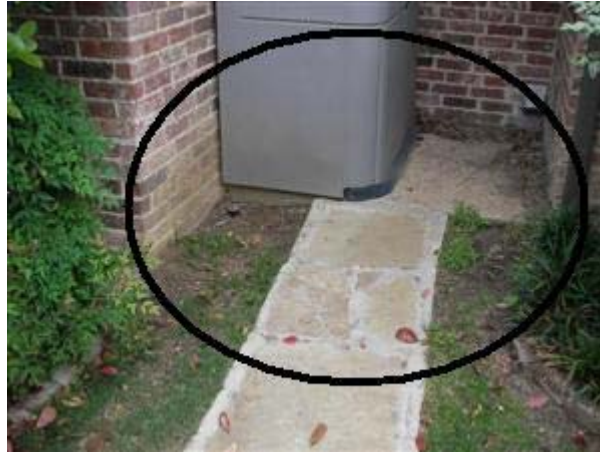
B. Picture 5

Noted soil too high at points around structure. Recommend maintaining a minimum of 4 to 6 inches of exposed foundation wall around structures perimeter. This is a moisture retention issue and WDI (wood destroying insect-termite) issue. Recommend qualified contractor evaluate and repair.

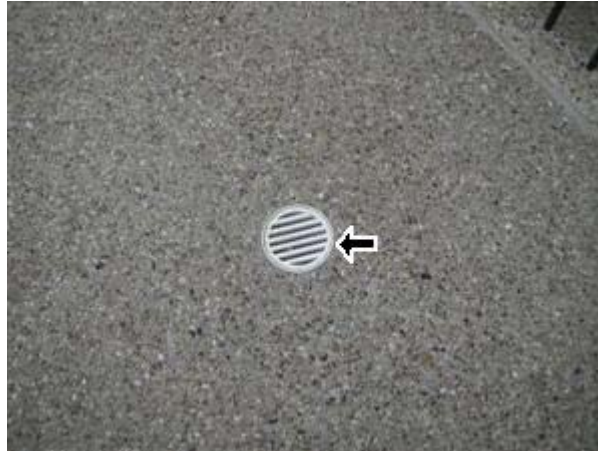
B. Picture 8

Noted gutter and drainage system in need of minor repairs and cleaning at various points around structure. Recommend qualified contractor evaluate and repair.

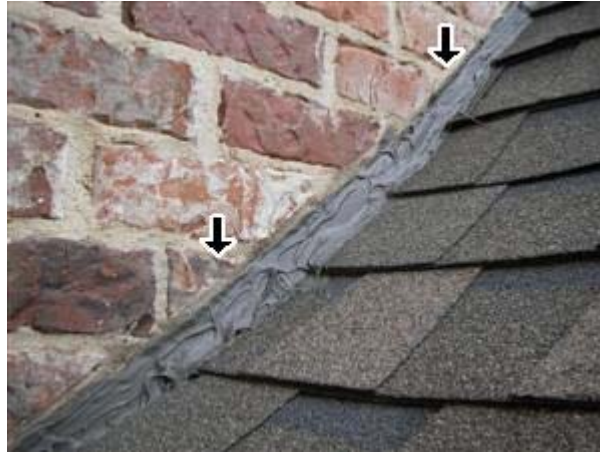
C. Picture 1

Comments: Roofing materials appear to be performing as expected and show normal wear and tear.

Noted a few points where flashing-counter flashing in need of additional sealing. Recommend qualified contractor evaluate and repair.

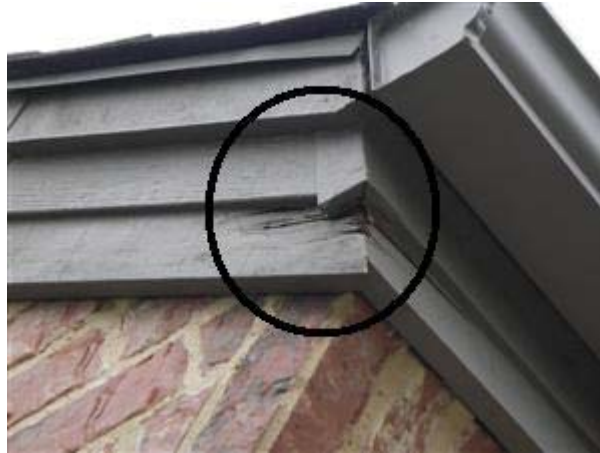
E. Picture 1

Comments: Noted siding and trim materials are failing at a few points (less than 2%) around structure. Water absorption present. Blisters and deterioration observed. Recommend qualified contractor evaluate and repair.

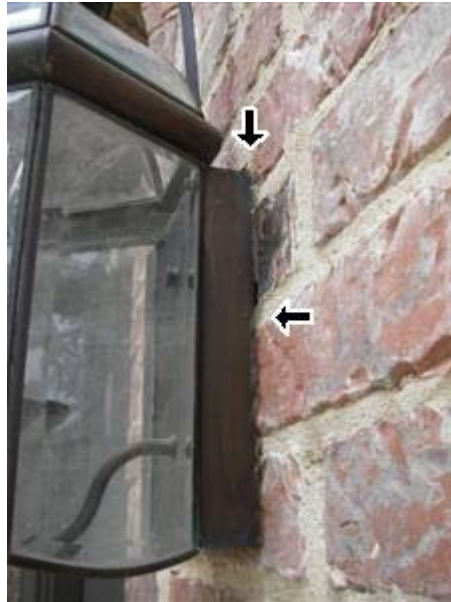
E. Picture 3

Noted caulk deteriorated or missing at points around structure. These are moisture retention issues. Today's standard building practices do not mandate the caulking of some of the noted points, however maintaining caulk and paint in these areas will realize prolonged life expectancy of building materials. Recommend qualified contractor evaluate and repair.

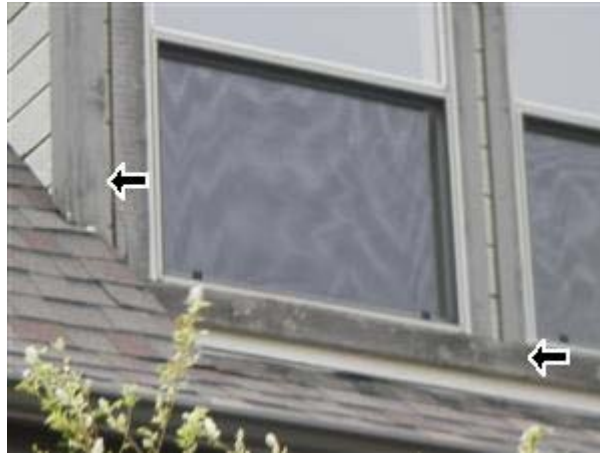
E. Picture 18

Recommend keeping all debris, fences, decks and vegetation from contacting structure. These are moisture retention and pest concerns. Recommend qualified contractor evaluate and repair.

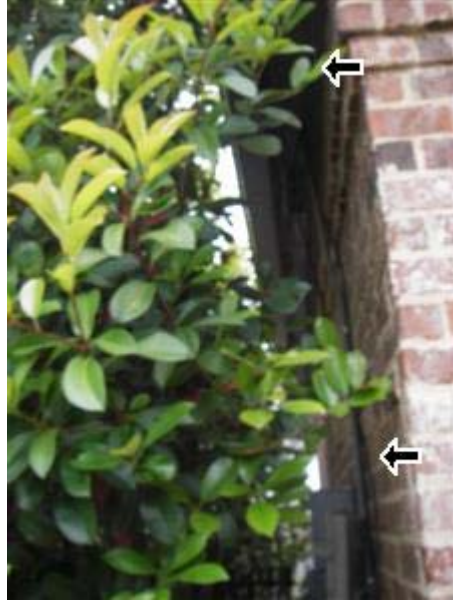
E. Picture 19

Noted hole in siding needs closing off with sealant or liquid foam where compressor lines enter structure. Recommend qualified contractor evaluate and repair.

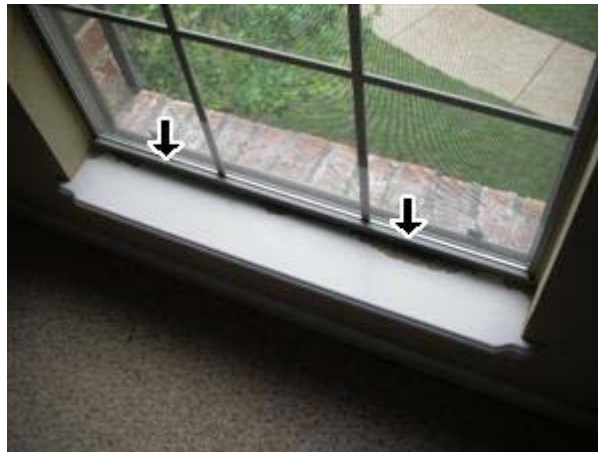
G. Picture 1

Noted evidence of prior leaks noted on some upstairs window sills. Recommend future monitoring for leaks at windows. Recommend qualified contractor evaluate and repair leaks and cosmetic damage.

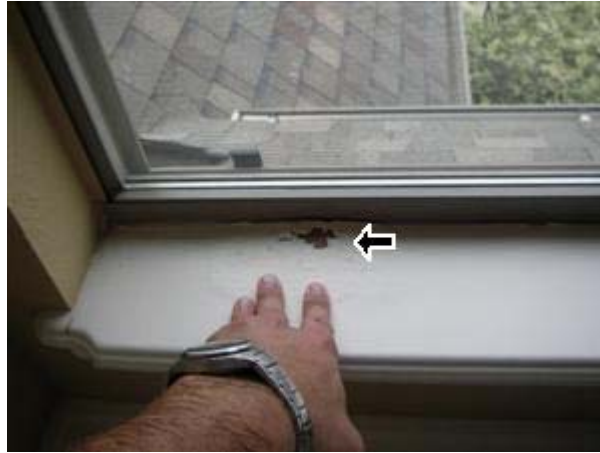
G. Picture 2

Noted some window caulking at or near end of life expectancy or missing. Recommend qualified contractor evaluate and repair.

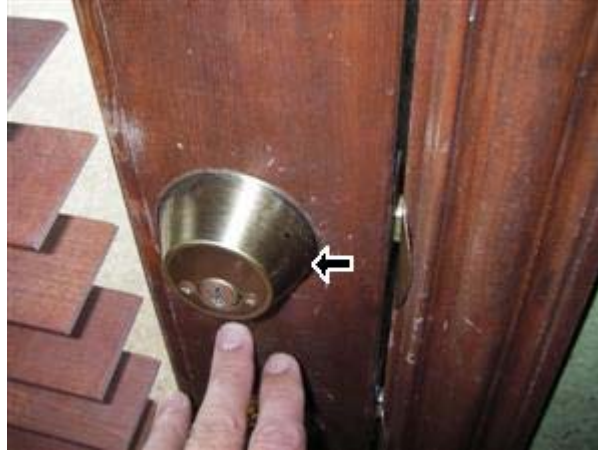
H. Picture 1

Noted some exterior doors are keyed on inside of home. This is a safety concern in the event of fire and the need for prompt exit. Recommend qualified contractor evaluate and repair.

Comments: Noted some exterior doors are keyed on inside of home. This is a safety concern in the event of fire and the need for prompt exit. Recommend qualified contractor evaluate and repair.

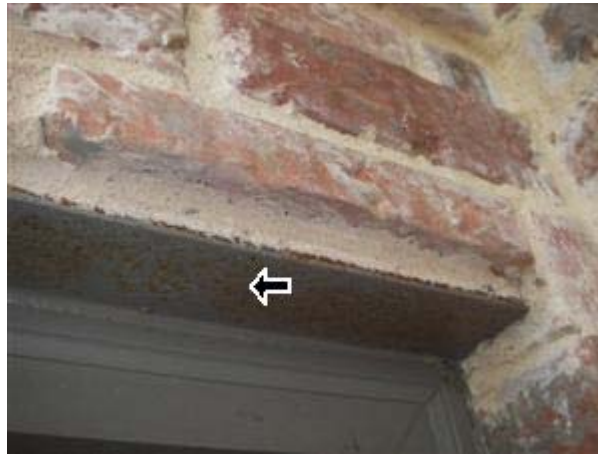
H. Picture 2

Recommend priming and painting of all steel lintels with rust prohibitive enamel paint instead of latex. Recommend qualified contractor evaluate and repair.

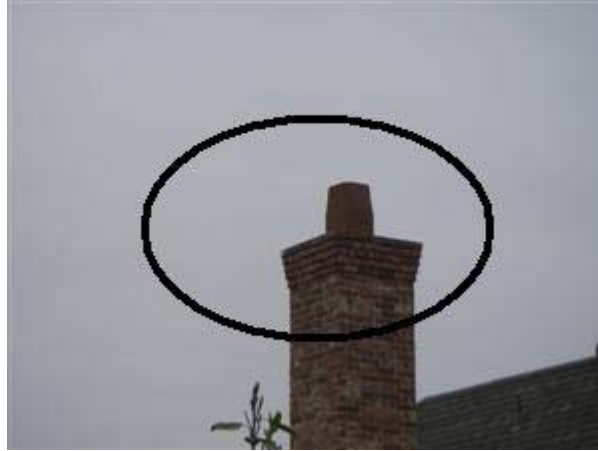
J. Picture 1

Noted lack of chimney rain cap. Recommend qualified contractor evaluate and repair.

Comments: Noted lack of chimney rain cap. Recommend qualified contractor evaluate and repair.

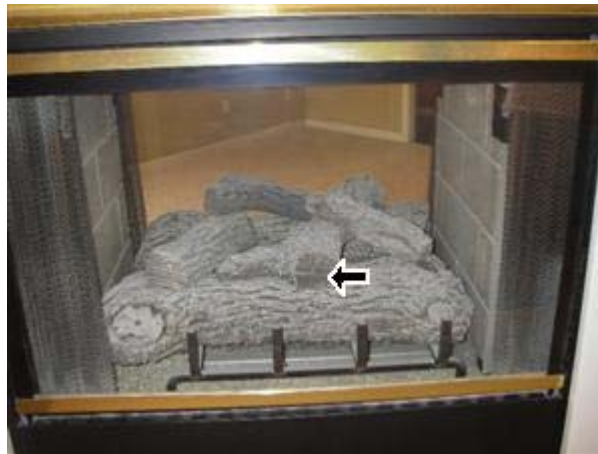
J. Picture 2

Noted lack of damper block to keep damper from completely shutting. Damper block should be present where gas appliances are present to allow for gas leaks to effectively be drafted from living space of home. Recommend a licensed chimney sweep inspect and repair.

We could not get the master bedroom fireplace to ignite at time of inspection. Recommend qualified contractor evaluate and repair.

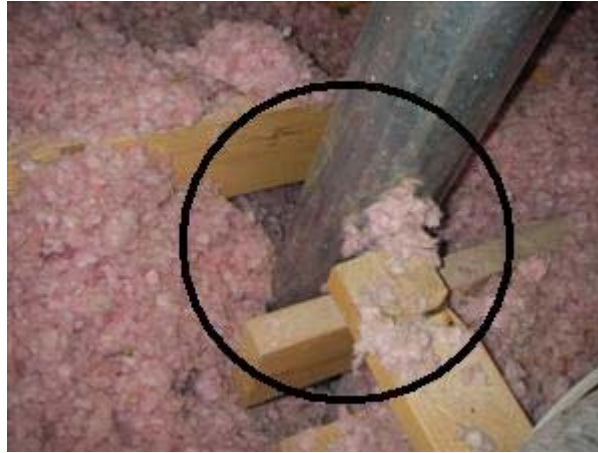
J. Picture 3

Recommend separation of building materials from master bedroom fireplace flue in attic area. Recommend qualified contractor evaluate and repair.

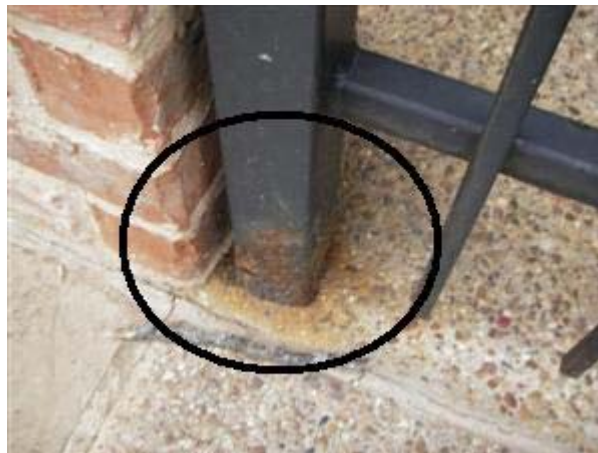
L. Picture 1

Comments: Noted a few iron fence posts excessively rusted at time of inspection. Recommend qualified contractor evaluate and repair.

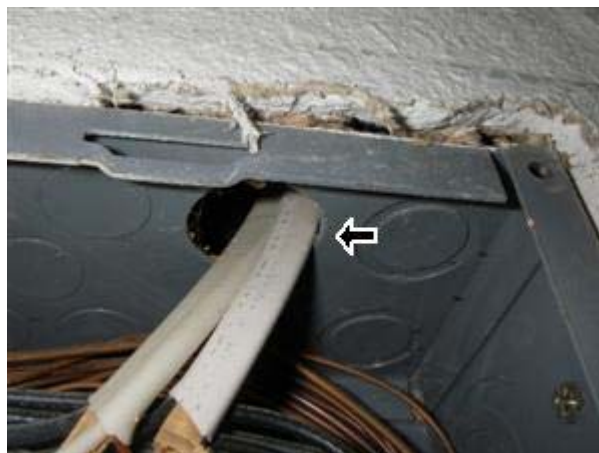
A. Picture 2

Noted lack of wire protection at some panel entry points. Recommend licensed electrician evaluate and repair.

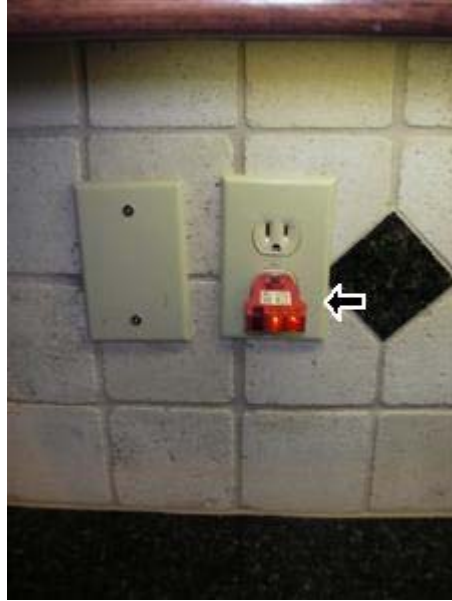
B. Picture 1

Noted some outlets over kitchen countertops not GFCI protected or would not operate when tested. All outlets over kitchen countertops should be GFCI protected. This is a safety issue by today's standards. Recommend licensed electrician evaluate and repair.

Comments: Noted some outlets over kitchen countertops not GFCI protected or would not operate when tested. All outlets over kitchen countertops should be GFCI protected. This is a safety issue by today's standards. Recommend licensed electrician evaluate and repair.

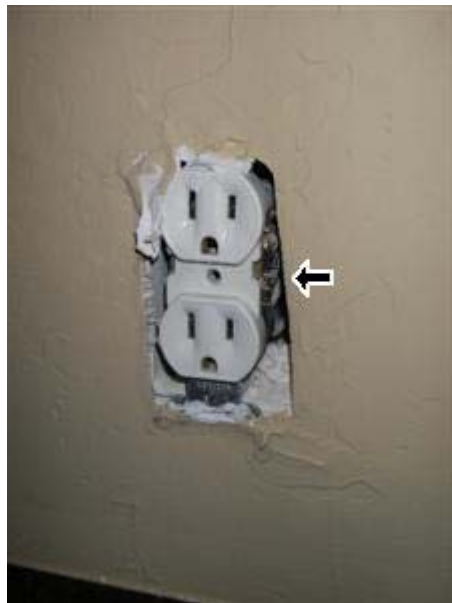
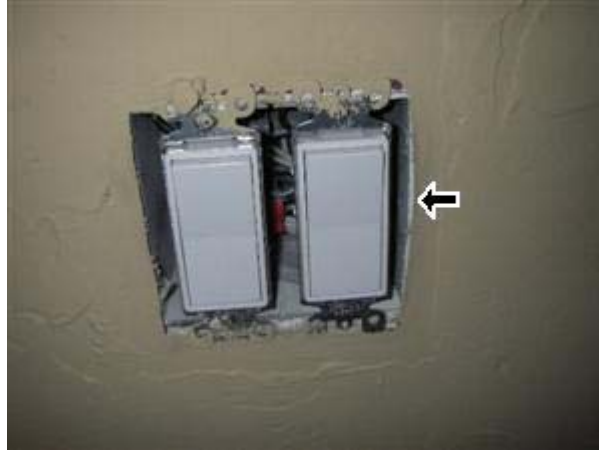
Exposed wiring noted in structure (faceplates removed for painting purposes). These are safety issues. Recommend licensed electrician evaluate and repair.

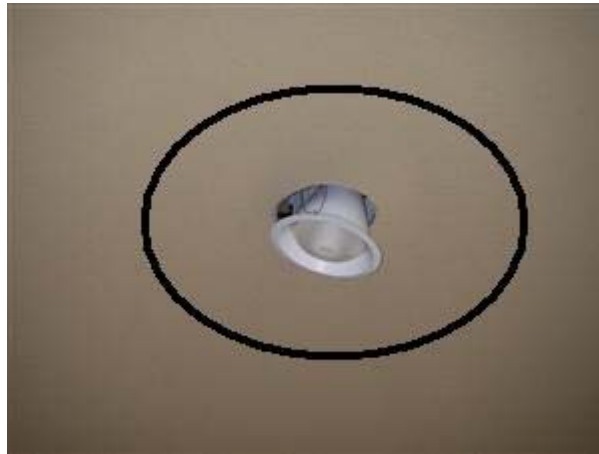
B. Picture 4

Noted recessed lighting fixtures in need of securing at master bedroom area. Recommend licensed electrician evaluate and repair.

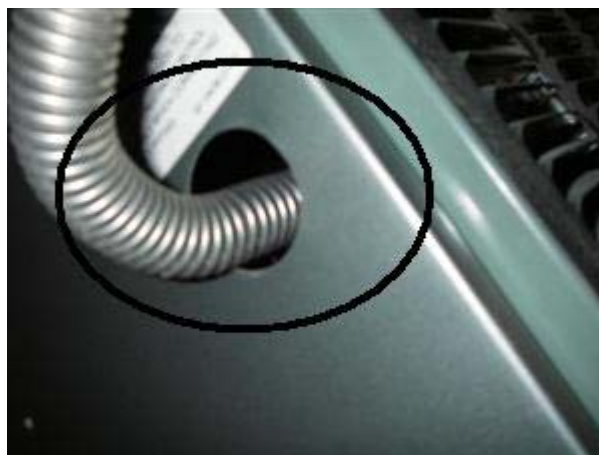
A. Picture 1

Noted flexible gas supply line is not terminated outside of the furnace housings. Vibration from the HVAC unit is known to rub through flexible lines causing gas leaks. Need solid extension and connections to flexible lines made outside of furnace housing. Recommend qualified HVAC technician evaluate and repair.

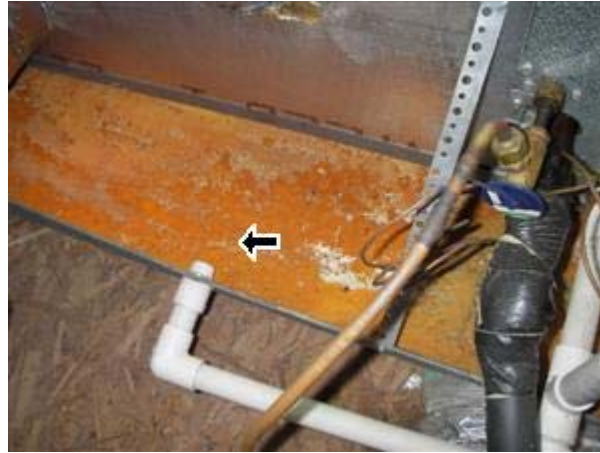
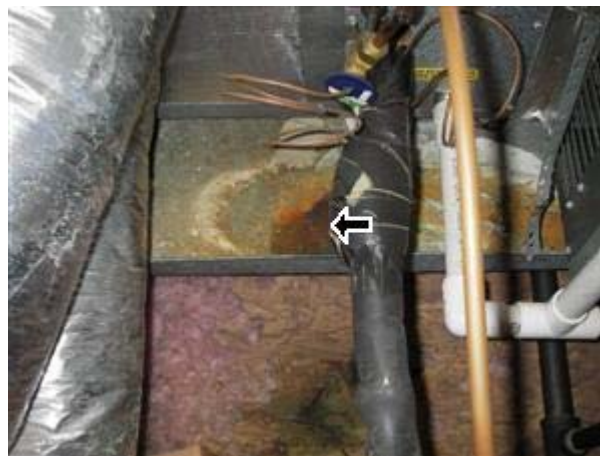
Noted excessive rust at the secondary condensation pan under the two upstairs attic mounted units. This could indicate the units are in need of servicing and cleaning. Recommend qualified HVAC technician evaluate and repair.

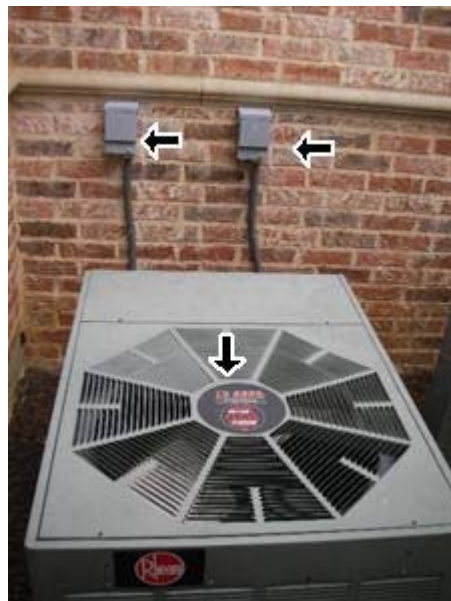
B. Picture 3

Noted exterior AC compressor cut-off placed directly behind unit. This is a concern in the event of emergency with unit and the need to operate cut-off from a safe location. Recommend qualified HVAC technician evaluate and repair.

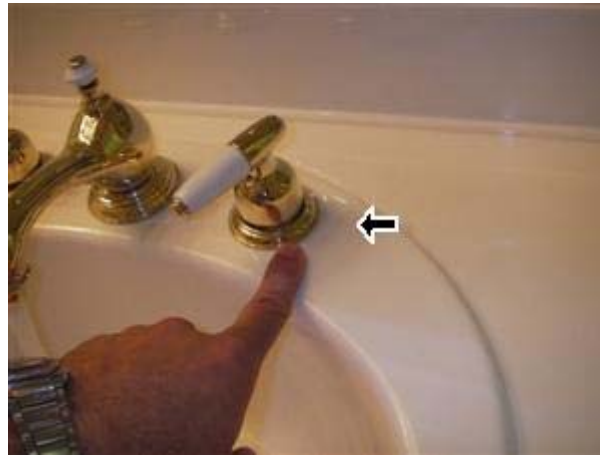
A. Picture 1

Comments: Fixtures handles leak at base on faucet when turned on and off at master bathroom sink fixture. Recommend licensed plumber evaluate and repair.

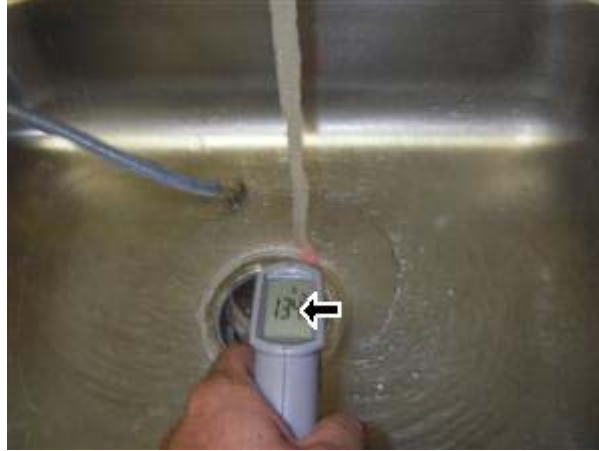
C. Picture 1

C. WATER HEATER EQUIPMENT
Comments: Noted water heater temperatures set to high (139 degrees). This is a safety issue. Recommend setting between 115 and 120 degrees.

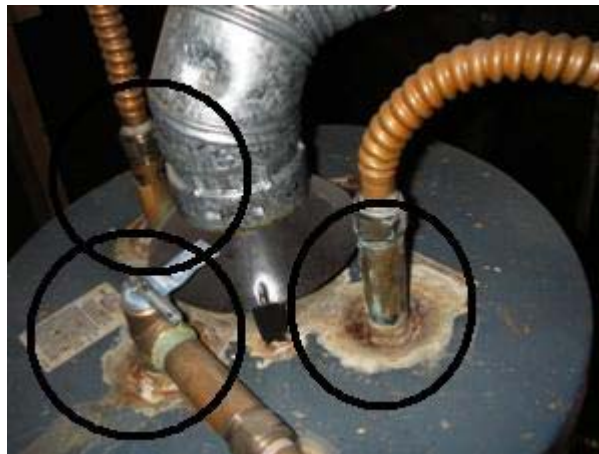
C. Picture 2

Noted dissimilar metal corrosion at TPR, hot and cold pipe connections of two of the three water heaters. Active plumbing noted at one of the upstairs attic mounted water heaters due to this issue. Recommend licensed plumber evaluate and repair.

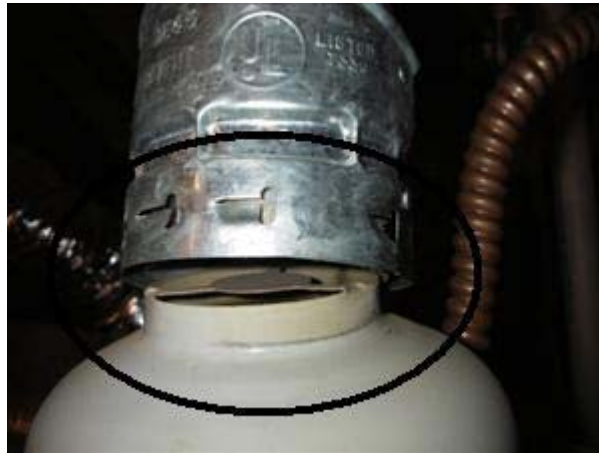
C. Picture 5

Noted vent stack at attic mounted water heater is mis-positioned and not adequately venting gases out of attic area. Recommend licensed plumber evaluate and repair.

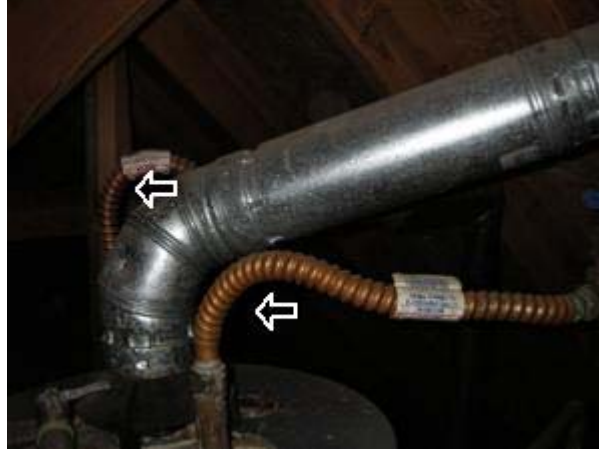
**C. Picture 7**

Noted lack of insulation installed on water pipes within five feet of water heater unit. This is a concern by today's standards. Recommend licensed plumber evaluate and repair.

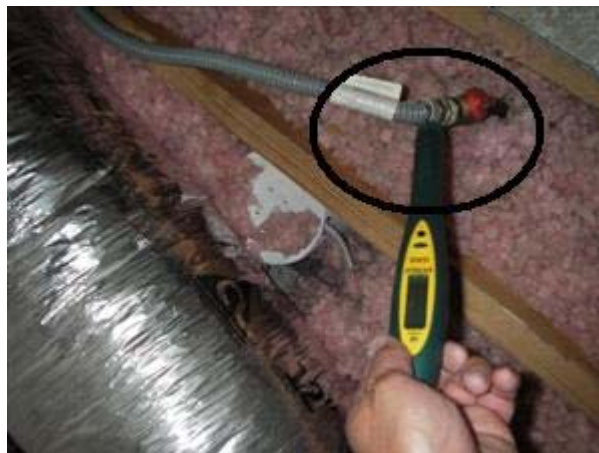
E. Picture 1

Comments: Noted small gas leak at master bedroom attic area water heater supply fitting. Recommend qualified contractor evaluate and repair.

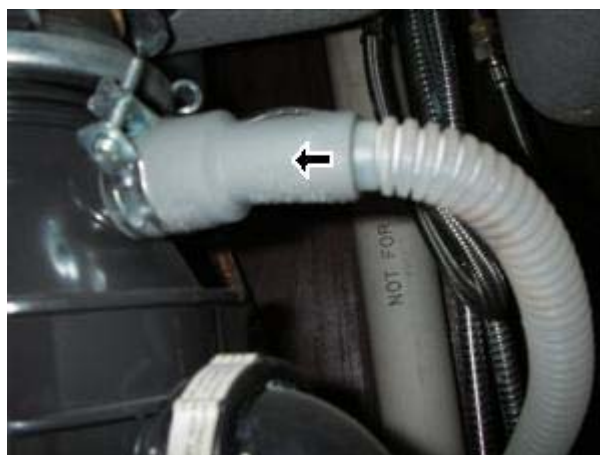
A. Picture 1

Comments: Noted lack of visible anti back-flow device. This is a concern by today's standards. Recommend qualified service technician evaluate and repair.

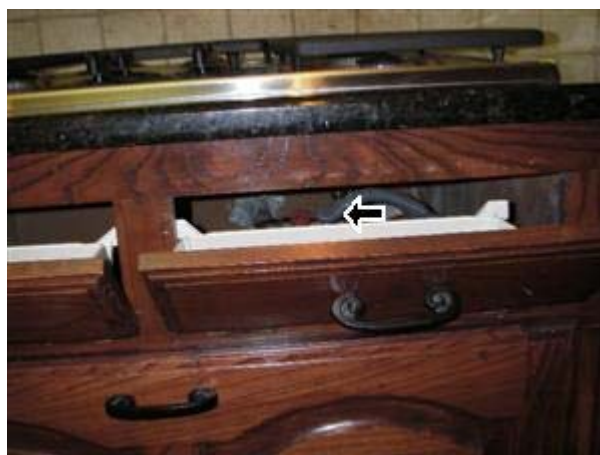
D. Picture 1

Comments: Gas shut-off valve difficult to get to. This is a concern in the event of an emergency and the need for quick access to turn off supply. Recommend qualified service technician evaluate and repair.

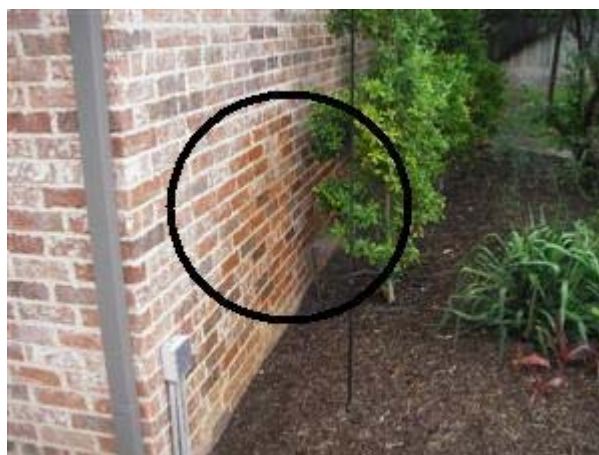
A. Picture 1

Comments: Noted a few heads as either clogged or misfiring. Recommend qualified contractor evaluate and repair.

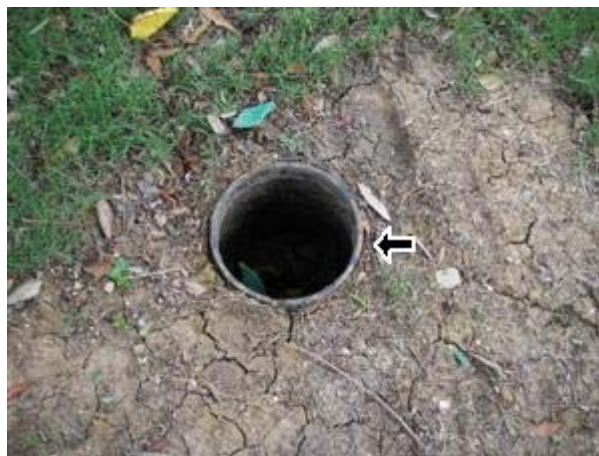
A. Picture 2

Noted a few sprinkler valve box covers missing at a few various points around property. Recommend qualified contractor evaluate and repair.

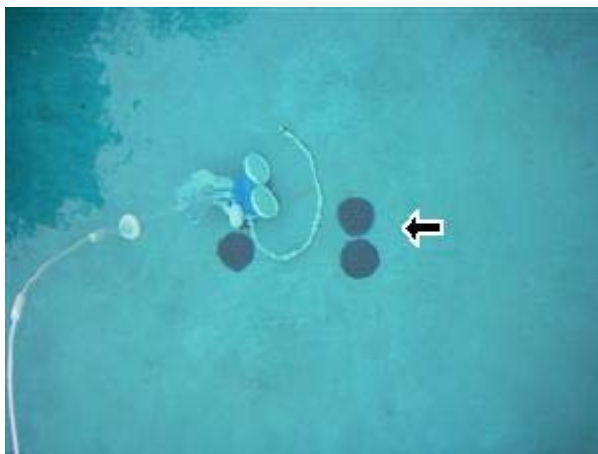
A. Picture 1

Comments: Noted lack of anti-vortex drain covers (dual drain design only) present at time of inspection to prevent possibility of suction entrapment. This is a concern by today's standards. Recommend qualified contractor evaluate and repair.

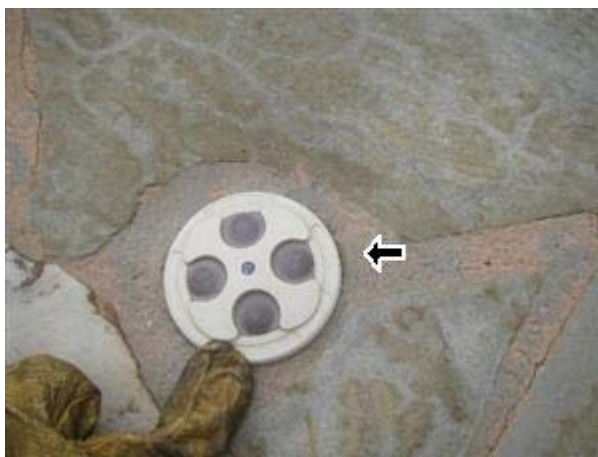
B. Picture 1

Comments: Noted some of spa side controls did not appear to operate at time of inspection. Recommend qualified contractor evaluate and repair.

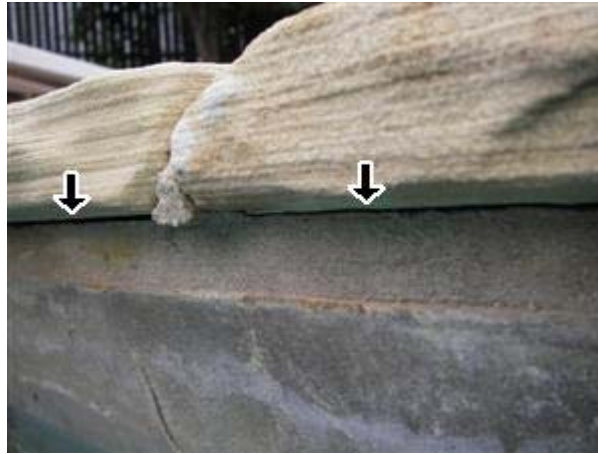
C. Picture 1

Comments: Noted small separation crack between pool wall and coping surround

at diving board end of pool. Recommend qualified contractor evaluate and repair.

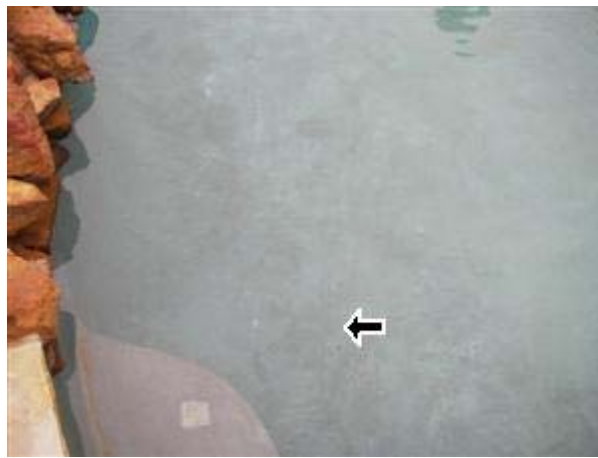
C. Picture 2

Noted pool plaster appears to be approaching life expectancy. Recommend qualified contractor evaluate and repair.

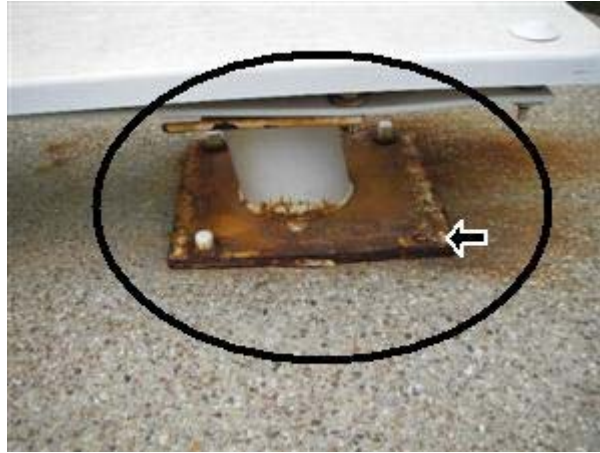
D. Picture 1

Comments: Noted one anchor bolt missing and excessive rust present at diving board base. Recommend qualified contractor evaluate and repair.

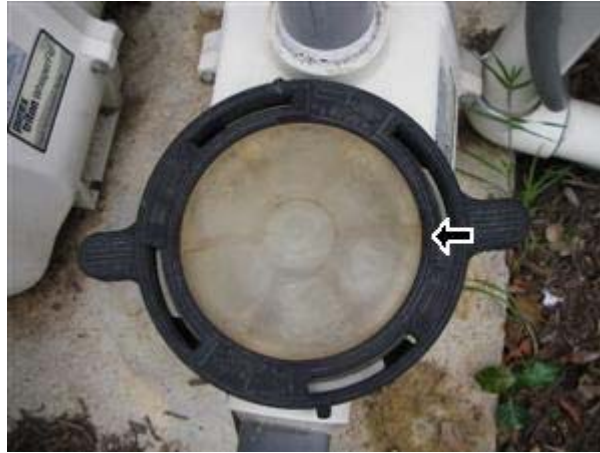
E. Picture 2

Noted air bubbles at jets which indicate a possible plumbing leak. Recommend qualified contractor evaluate and repair.

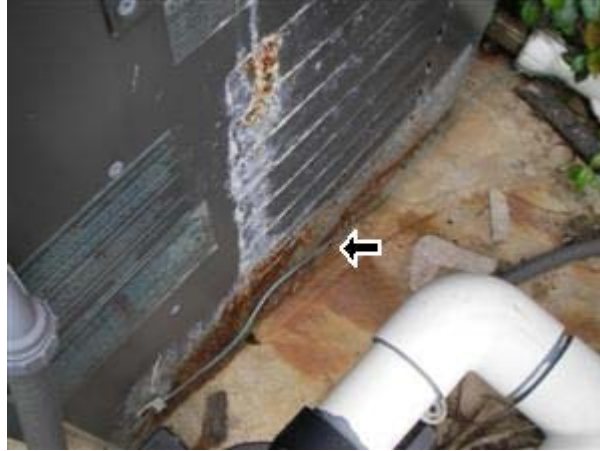
H. Picture 1

Comments: Noted excessive rust at base of heater housing. Recommend qualified contractor evaluate and repair.

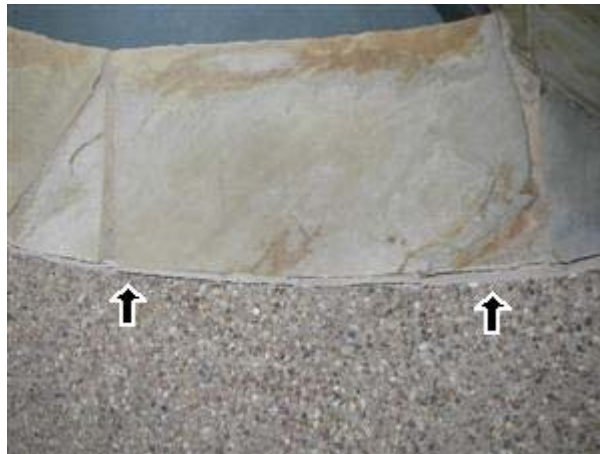
I. Picture 1

Comments: Noted mastic seal is at or near life expectancy at points. Recommend qualified contractor evaluate and repair.

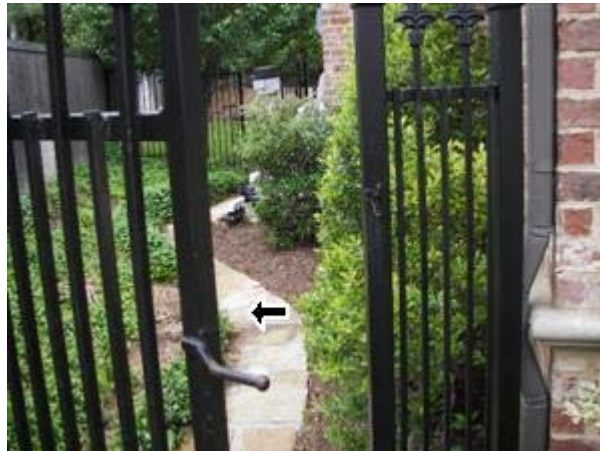
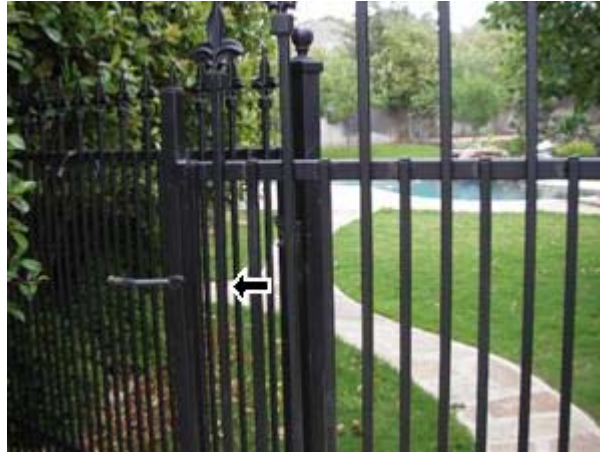
Comments: Noted lack of working (dragging and springs would not close) fence gates at pool entrance area. Fence gates around pools should be self closing and latching. Recommend qualified contractor evaluate and repair.

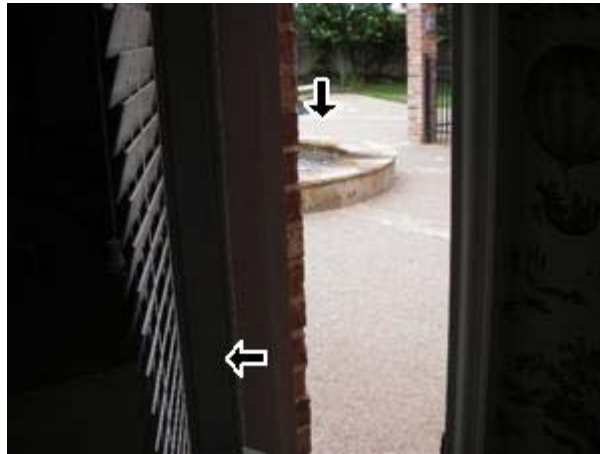
J. Picture 3

Noted lack of self closing doors to pool area from structure. Recommend qualified contractor evaluate and repair.
