NATIONAL PROPERTY INSPECTIONS

----- INSPECTION REPORT -----

Inspection Date: 3/23/2007

Location of Property Inspected: **1313 Mockingbird La.**
Suntoohot FL. 23456

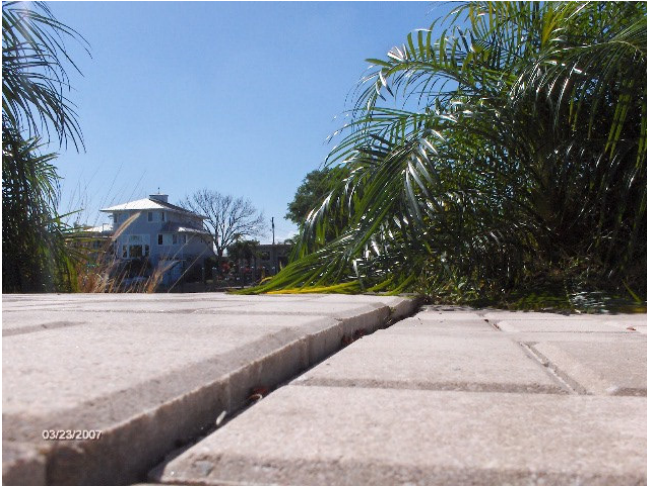
The rear retaining walls appear in generally good condition. There appear to be several issues, probably related to one another, with the seawall/walkway above seawall and the pool patio on the south side and s/w corner of pool. The seawall appears to have bowed outwards. This appears to have caused the walkway (pavers) to sink and misalign. This is evident at the area below the pool. The seawall has no less than 30 cracks and broken sections across span of entire wall. Recommend further evaluations and repairs by a licensed seawall contractor. (See "Pool" section of report for pool patio comments).

Sunken and separated area of pavers at s/w corner of pool patio.

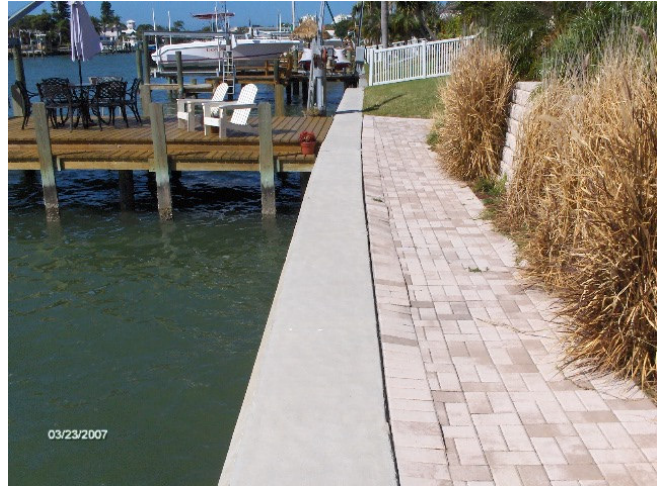
"Bowed" seawall at area below pool.

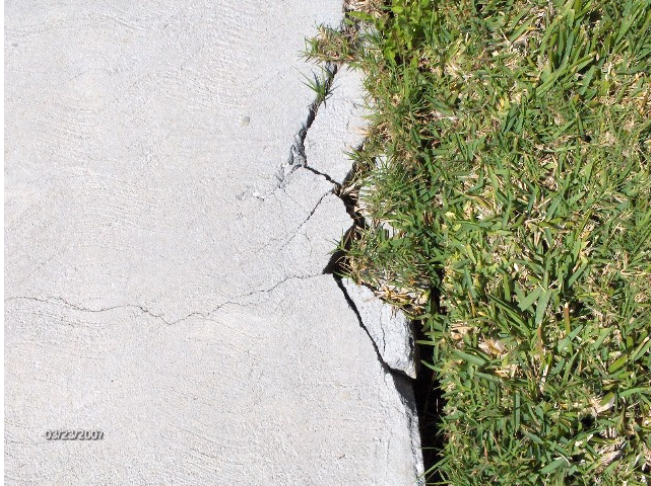
Broken sections of seawall.

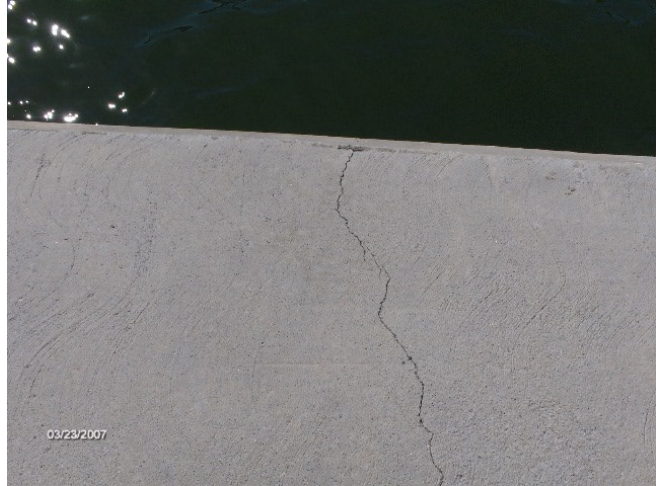
Cracks in seawall.

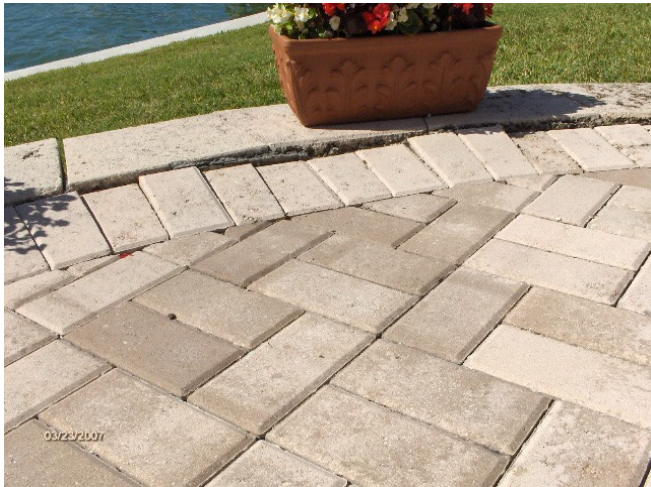
Sunken area of pavers on patio at s/w corner.

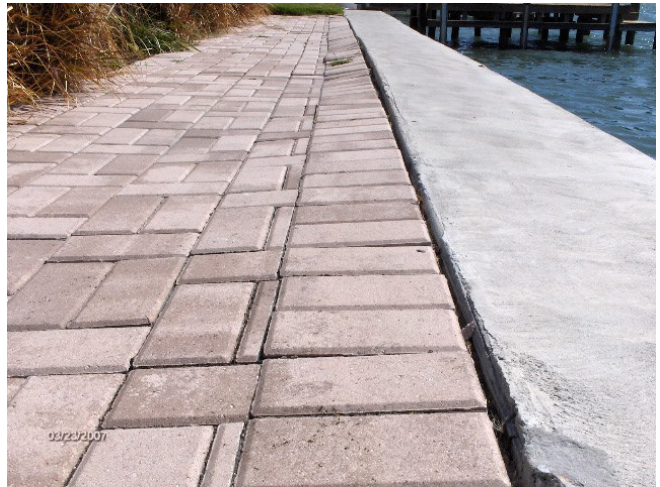
Sunken area of paver walkway above seawall/below pool.

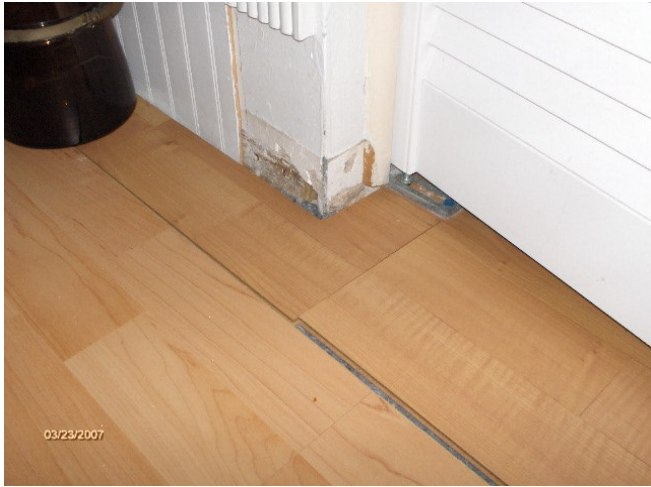
Incomplete molding at several areas of interior.

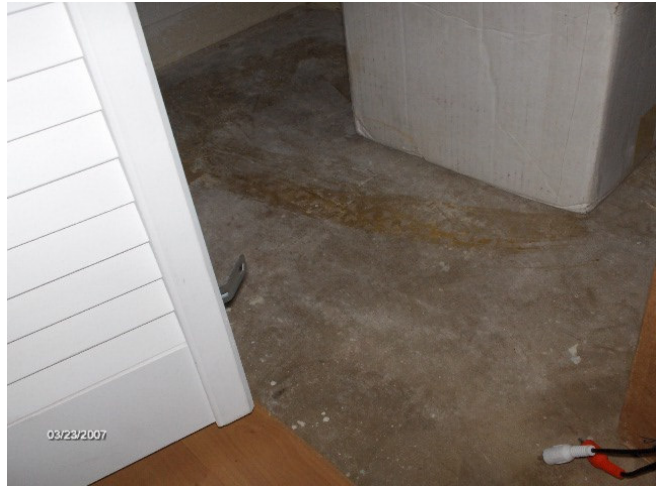
Comments: **Molding incomplete around interior of closet floor.
Left side closet bi-fold door does not close properly.
Ceiling fan(s) operational at time of inspection.
*May not be a defect, however, closet(s) have older style incandesant bulb fixture, potential for fire hazard. Recommend changing to a protected fixture with a floresent bulb for safety.**

Floor not complete inside closet of west side bedroom.

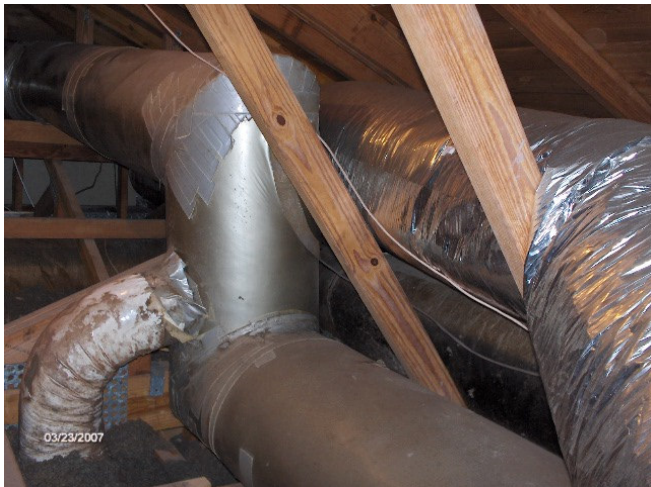
Combination of older and newer ductwork in attic. No defects to ductwork noted. Monitor over time.

View of ductwork in attic.

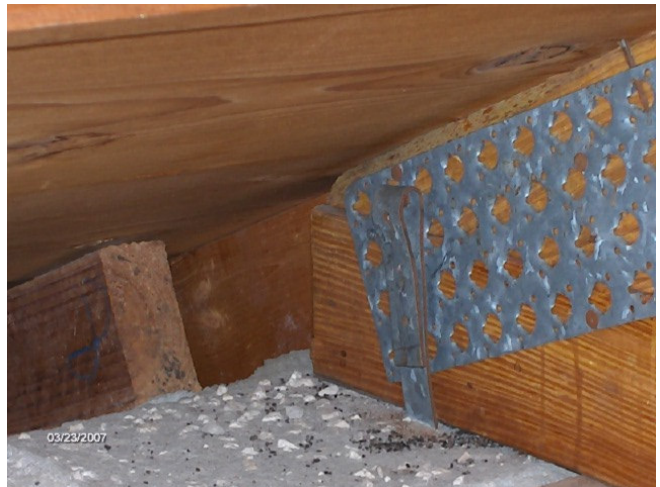
Hurricane strap system present at roof structure.

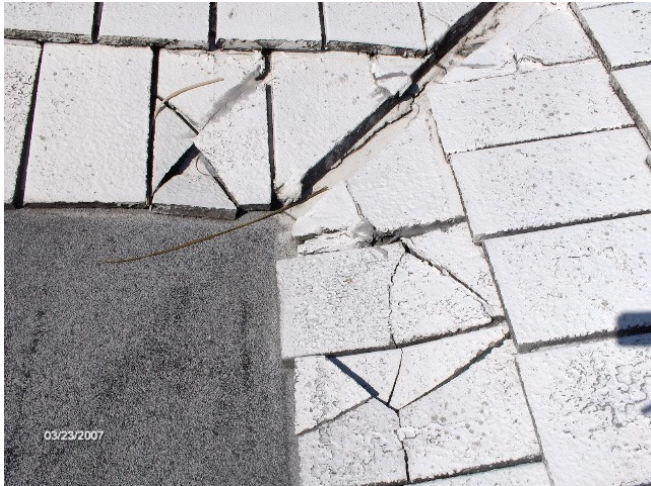
Roof is cement tiles fastened with mortar. Main roof not walked, view of the roof was from a ladder at the eaves and from rear flat roof. Age of roof unknown; appears original. Clay/concrete/tile roof design life is 30-50 years, depending greatly on when the tiles were installed, as many improvements have been made in recent years. Flat roof is rolled asphalt roofing material. Estimated age 2-4 years. Good condition; no defects noted. Main tile roof shows several defects. There are several areas with previous repairs. There are several broken or cracked tiles present. North side 10-15 defective tiles. West side 2 defective tiles. South side 6-8 defective tiles. East side no defective tiles. The tiles around perimeter of home were tight, but many of the tiles on the roof top were loose. Also, most peak tiles show cracking, detached and loose tilework. All above are not only a concern of leaking, but are safety hazards in the event of high winds. Recommend additional evaluation and professional repairs as required by a licensed roofing contractor.

Several broken/cracked/detached roof tiles at most areas of the main roof.

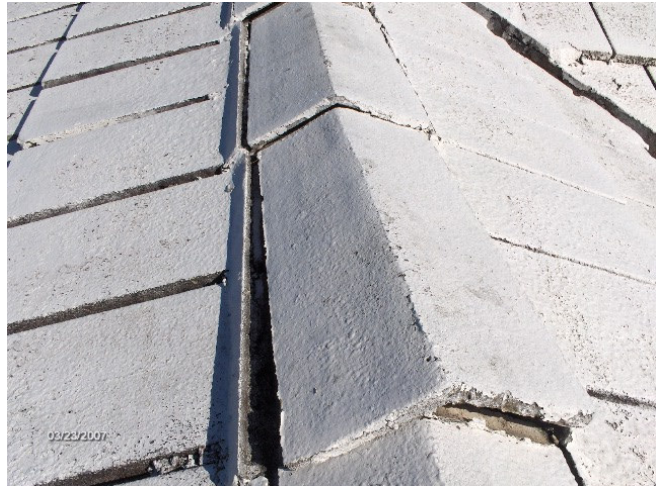
Detached and broken roof tiles at peaks.

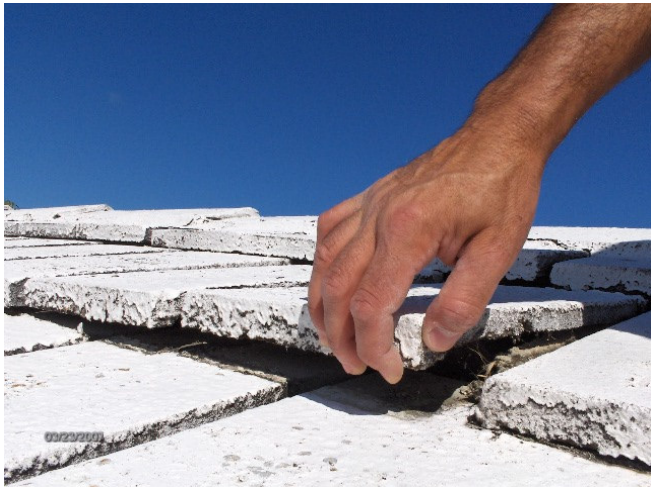
Loose roof tiles present.

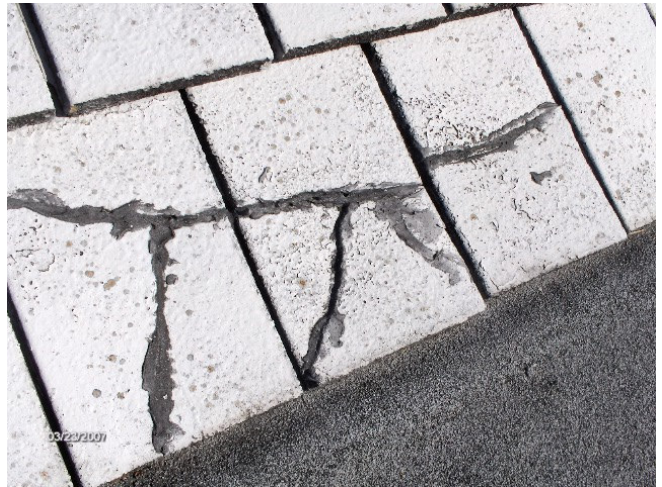
Previous repairs to roof tiles.

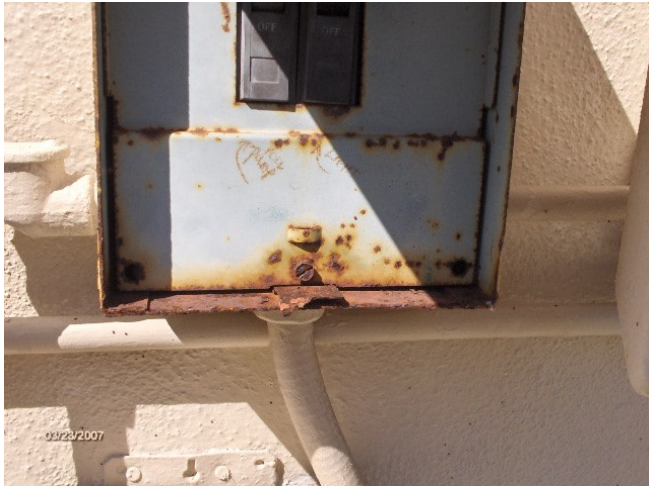
Pool electrical panels rusted and damaged.

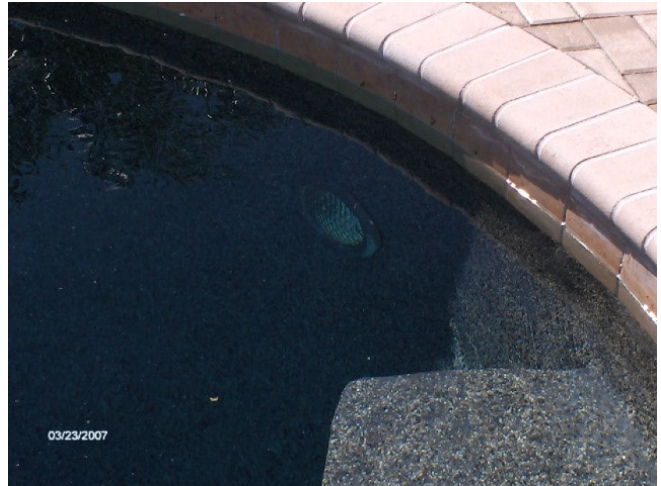
Pool light inoperable.

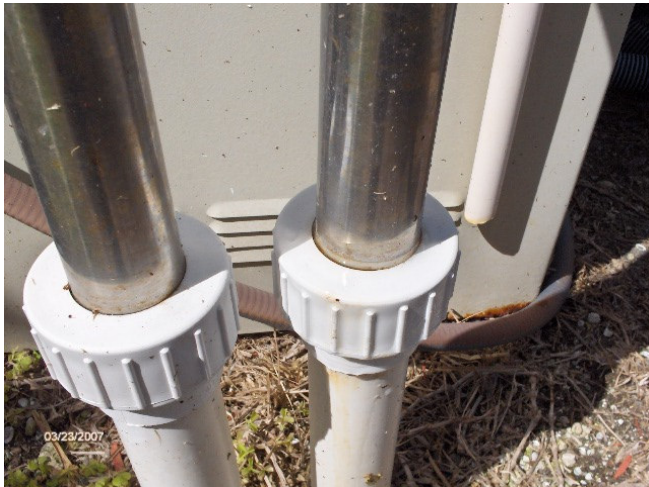
Leak at output line of pool heater.

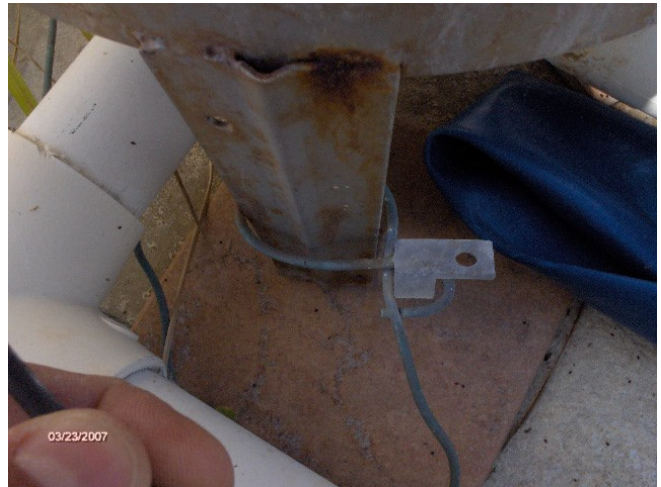
Improper ground at pool filter casing.

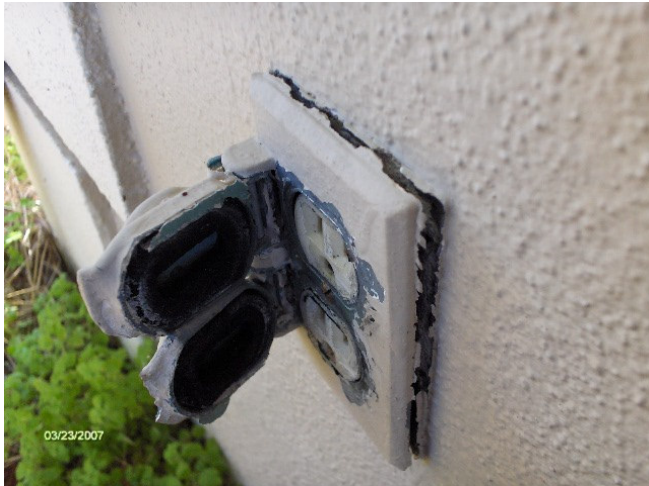
Outlet at n/e corner is loose from wall.

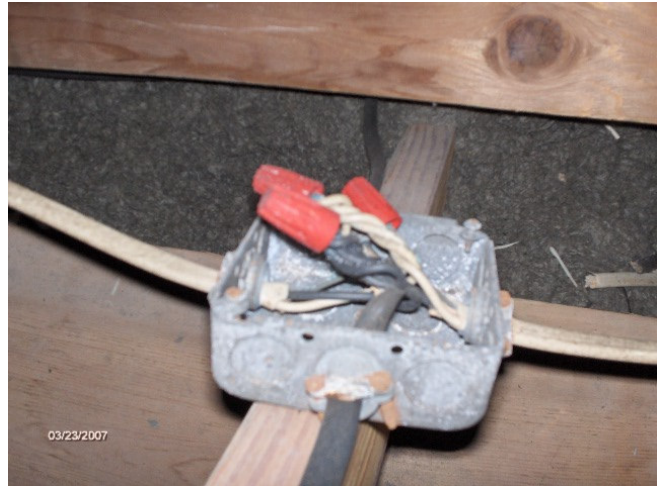
Open electrical junction box near kitchen access; safety hazard. Recommend repairs by licensed electrician.

Open junction box in attic access above kitchen pantry.

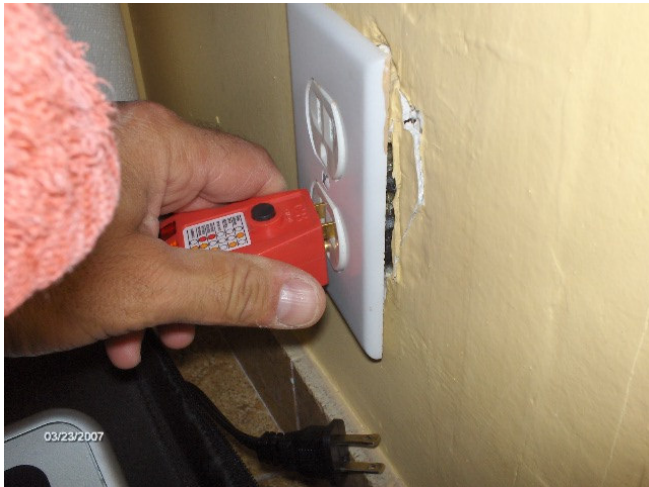
Outlet in master bedroom bathroom is very loose from wall.

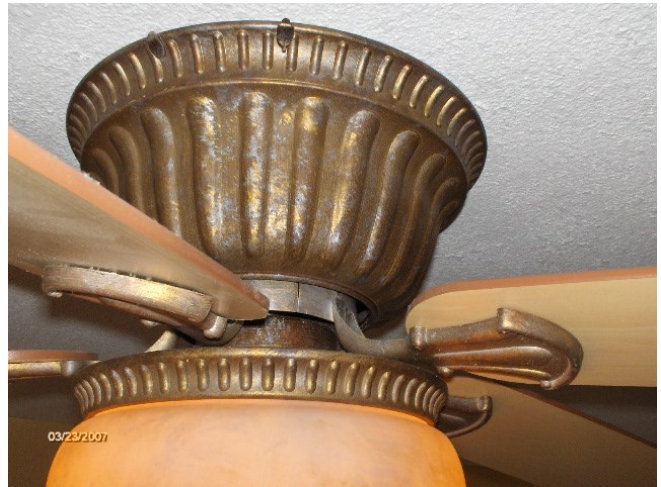
Fan in east bedroom did not operate properly.

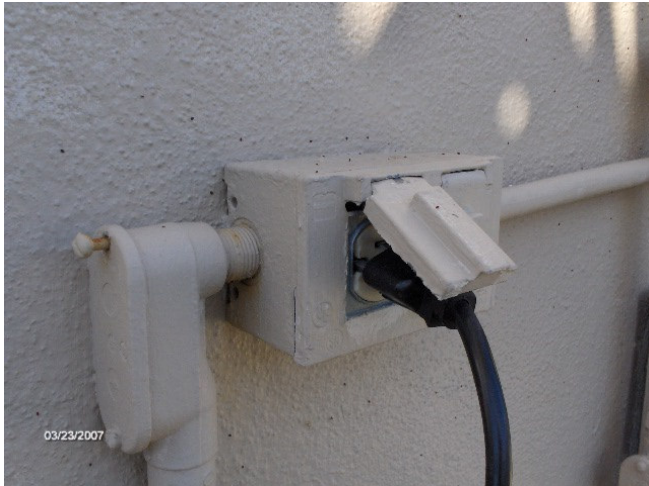
Exterior outlets should have weather resistant covers; most do not.

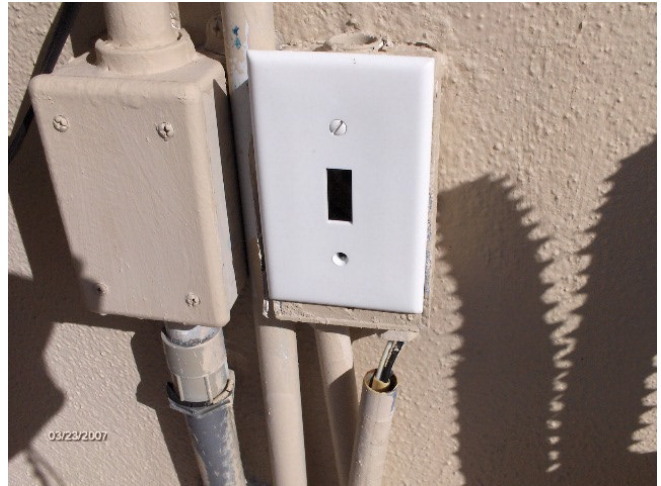
Open junction box with detached conduit to left of patio.

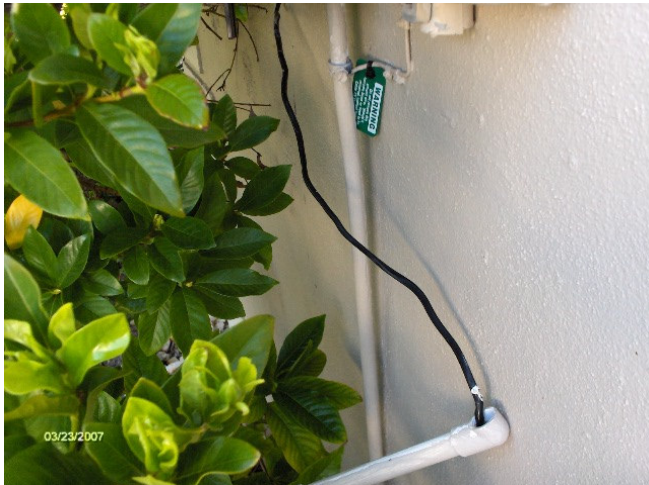
Main electrical panel is located in the garage.
 The clamp on the bond at water main is loose from the grounding bar; safety hazard.
 The conduit enclosing the wires from the sprinkler control is detached from n/w corner wall.
 The conduit at the junction box to left of patio is disconnected and the cover is improper.
 (Light switch cover with hole). Recommend professional repairs by licensed electrician.
 (Pool equipment--see Pool section of report for details).
 Smoke detectors were tested with a canned smoke. Operated properly.

Detached conduit at sprinkler system control panel wiring.

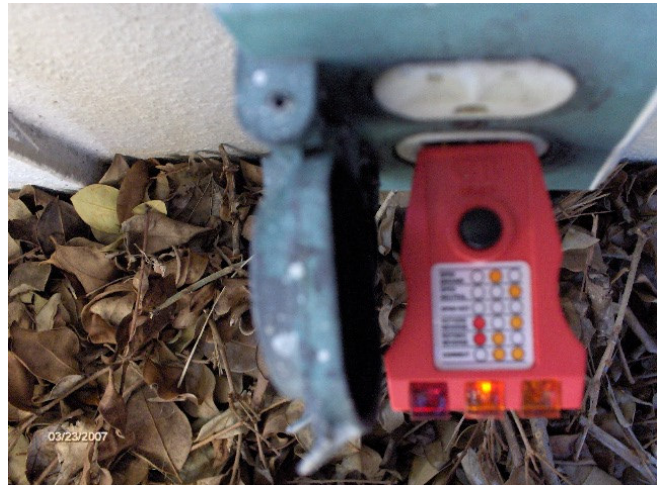
Open/grounded outlet to left of garage overhead door.

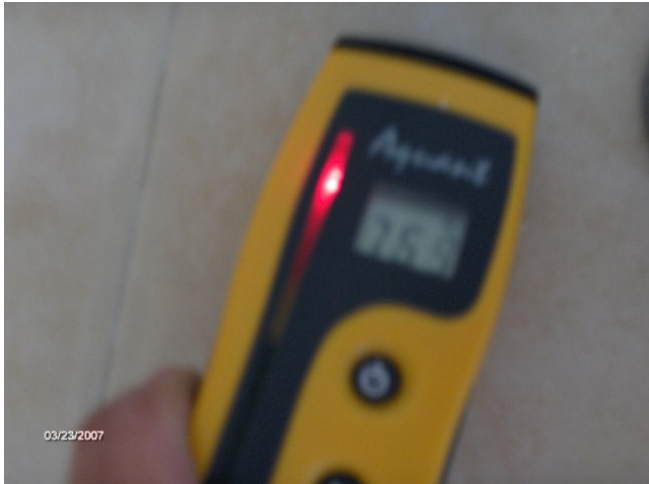
FYI-No exhaust fan present. Recommend opening window during use to allow moisture to escape.
 Recommend installing GFCI outlet(s) for safety.
 Very high moisture content reading with moisture meter on tilework near faucets of bathroom shower/tub.
 There is a severe water leak inside of access panel at tub/shower lines, opposite of wall noted in above comment.
 Toilet bowl is not properly secured to the floor, loose; toilet should be removed to inspect the flange which will require a new wax seal.
 Sink stopper does not work properly; detached.
 Faucet shut-offs under sink missing their handles. Recommend replacing.
 Recommend repairs by a licensed plumber for all above concerns.

Very high moisture content reading with moisture meter on tilework near faucets of main bathroom shower/tub. See pics below.

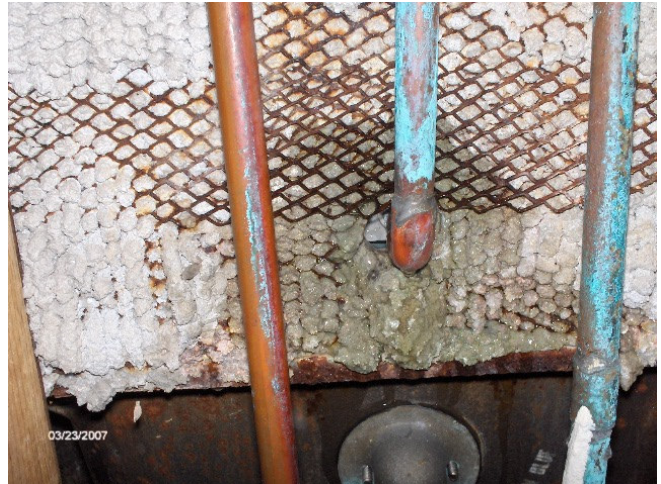
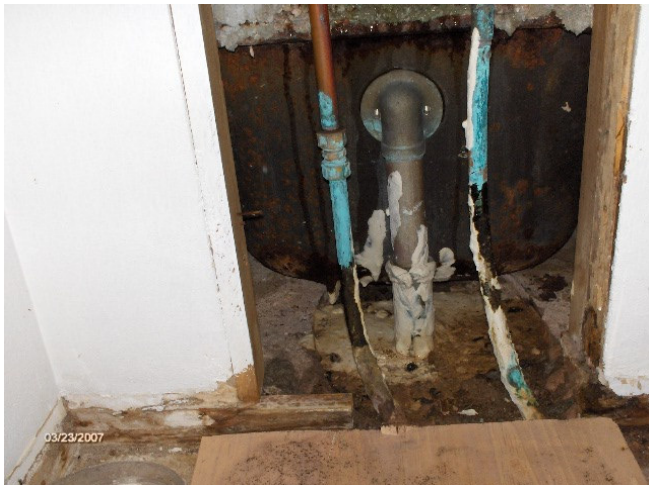
Severe water leak at main bathroom shower access panel.

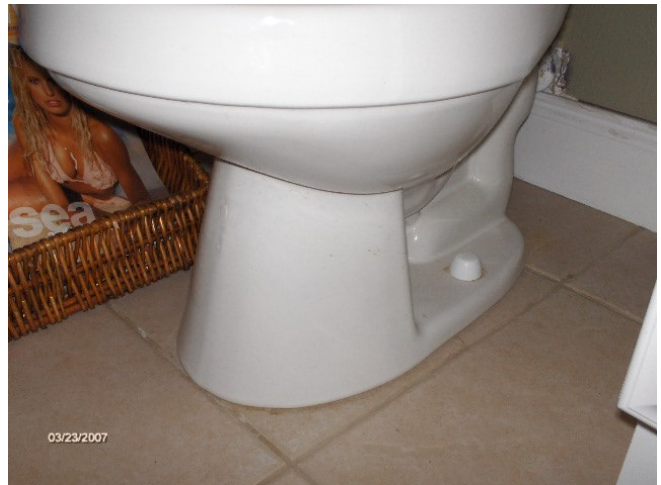
Recommend installing GFCI outlet(s) for safety.
Toilet bowl is not properly secured to the floor, loose; toilet should be removed to inspect the flange which will require a new wax seal.
Faucet shut-offs under sink missing their handles. Recommend replacing.
Recommend repairs by a licensed plumber.
Outlet very loose from wall; safety hazard.
Recommend repairs by a licensed electrician.
No bathtub/shower access panel present.
Shower pan filled with water, no leaks detected.

Both toilets in home are very loose from the floors.

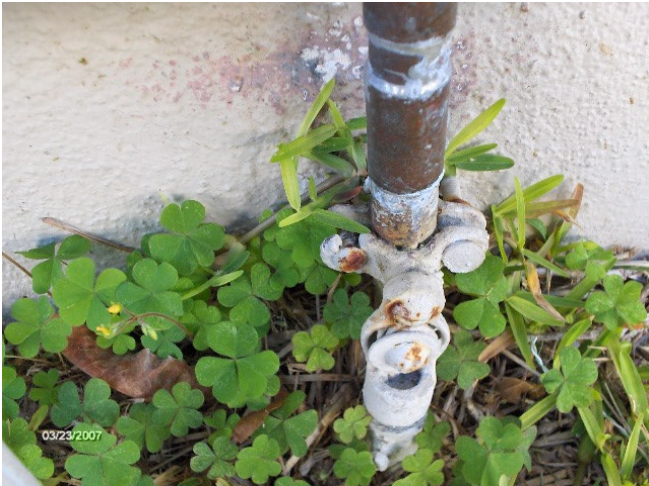
Bond clamp loose at water main.

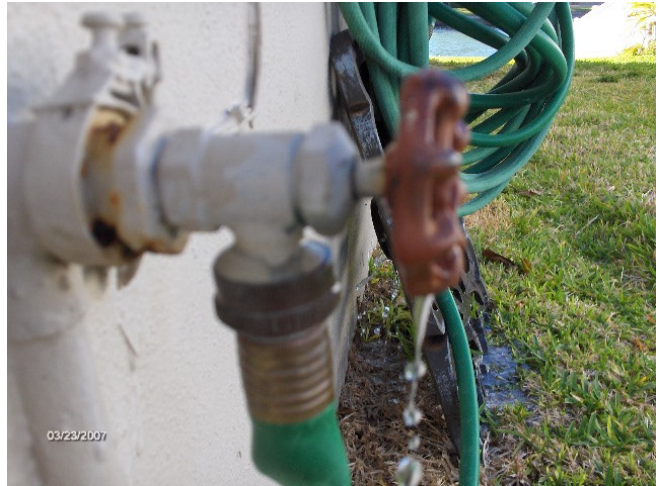
Comments: **Body of the house is stucco over block with wood fascia and soffits.
 Hairline stucco cracks present at section of west wall between garage utility door and rear corner. Appear cosmetic. Recommend sealing and monitoring over time.
 Fascia and soffit boards are in good, solid condition. Always keep freshly painted to prolong the life of the wood.
 Electrical outlet to left of garage overhead door shows an open/ground connection; safety hazard.
 Electrical outlet at n/e corner is very loose from wall; probable water intrusion.
 Exterior outlets should be protected by weather resistant covers. Most are not.
 Recommend repairs as needed by a licensed electrician.
 Faucet at west wall leaks at handle.
 Recommend repairs by a licensed plumber.**

Leak at faucet handle on west wall.

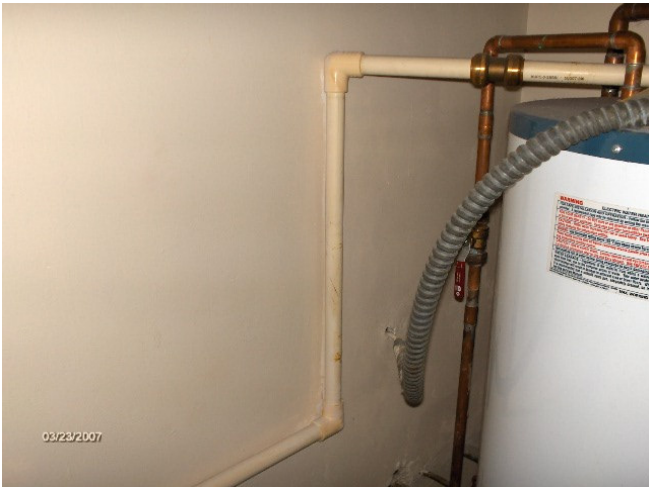
Water heater is located in the utility room.
 Water heater operational at the time of the inspection.
 Water heater temperature set at 120 degrees.
 Temperature pressure relief valve tube must exit within 6" of floor. Improper installation.
 There are 3 elbows present in pipe and TPR would most likely not serve its intended purpose if tank was to release pressure. Recommend professional repairs as required by a licensed

Improper TPR valve extension pipe on water heater.

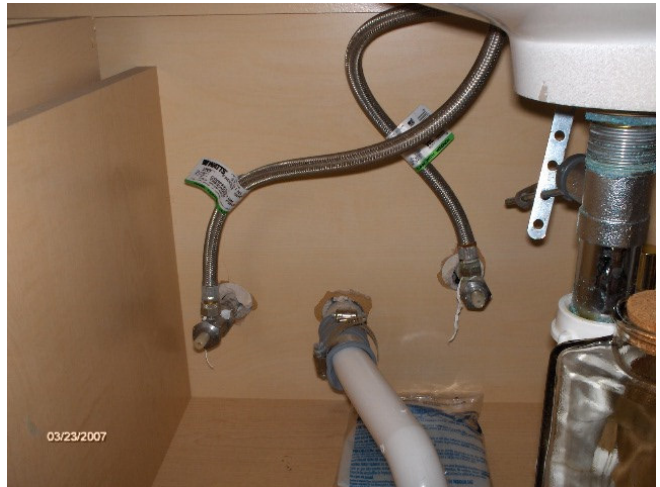
Bathroom sink faucet shut-offs missing their handles.

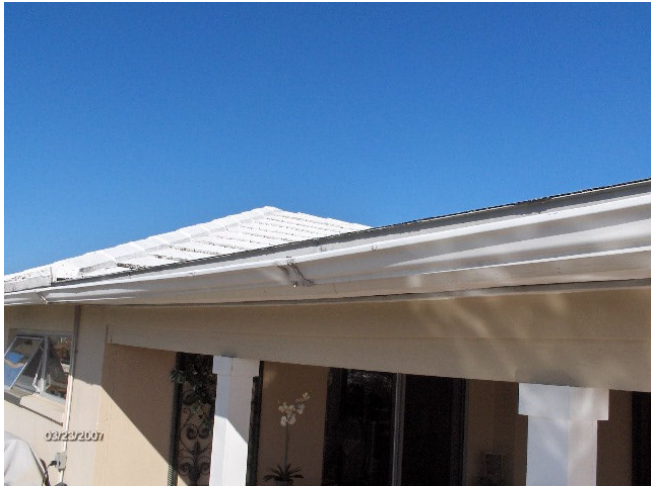
Comments: **Gutter at rear patio roof is misaligned and not shedding water properly. (Decayed, lower areas obvious).
 Gutter at s/w corner of home is missing its down spout and extension.
 Gutter at n/e corner of home has a detached bracket.
 Recommend professional repairs as required by a licensed contractor.
 *Recommend adding splash plates at downspouts to divert water away from the foundation.
 Gutters are filled with debris. Recommend cleaning to prevent future damage.**

Gutters are misaligned, detached and are missing downspouts and extensions.

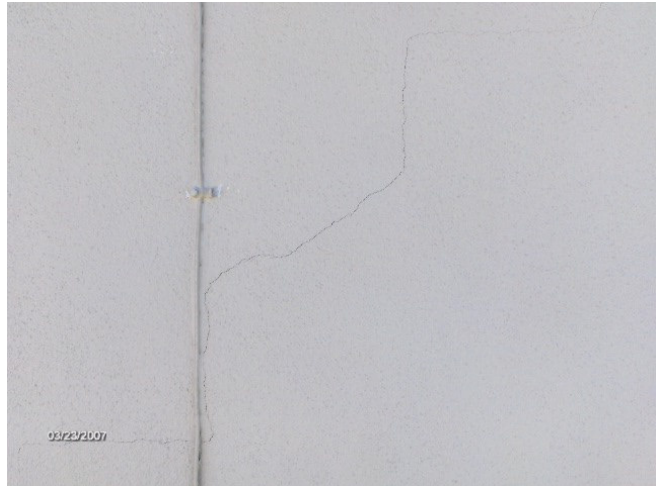
Hairline "step" cracks at s/w corner of stucco wall.

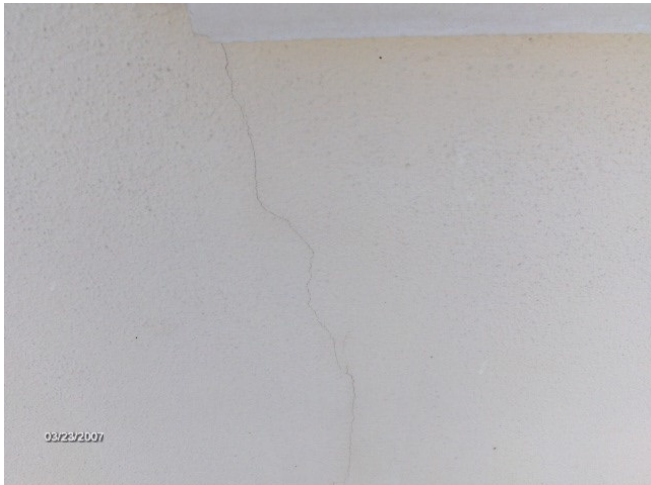
Vertical cracks at s/w corner of stucco wall.

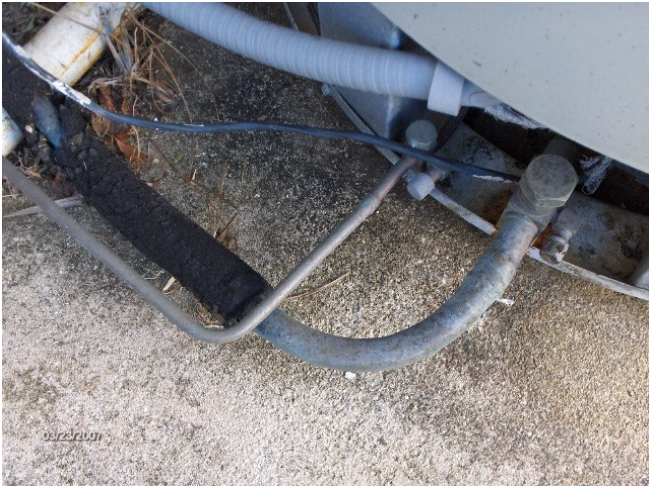
Insulation on exterior freon line is damaged/missing and needs replacing to allow unit to run at optimum efficiency.
 Fins on exterior of unit are damaged/bent/rusted.
 Recommend normal maintainence and cleaning by a licensed HVAC contractor.
 *FYI-Close proximity to salt water will usually cause mechanical units and their components to rust and age faster than normal. System is operational at the time of the inspection, temperature splits are within the design limits.

AC freon line missing sections of insulation.

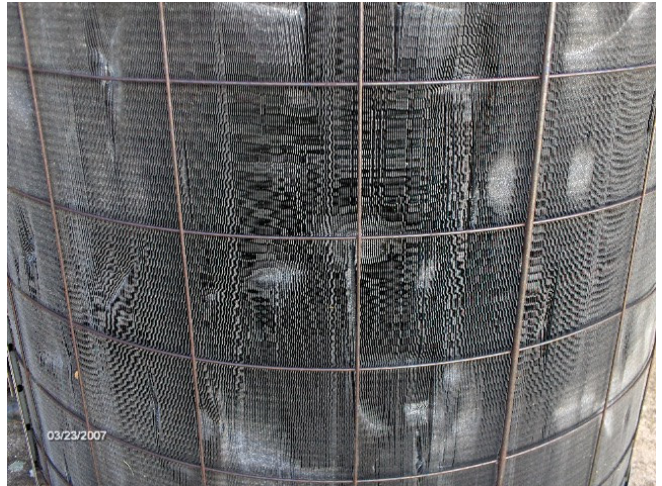
Damage to ac condensor fins.

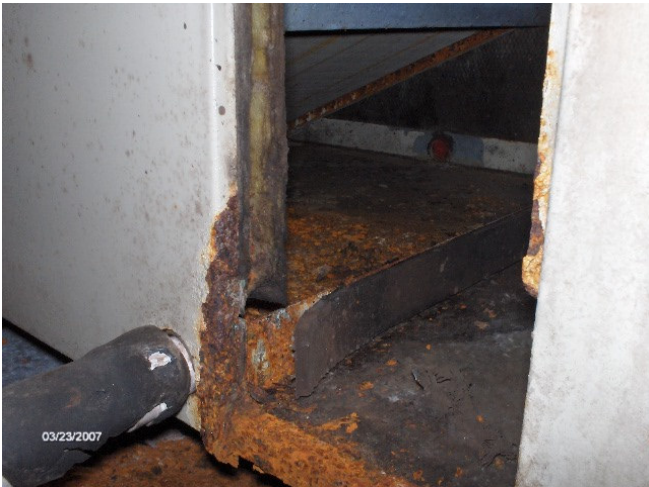
Air handler is located in the attic.
 *Heat pump should not be tested in the heat mode with the exterior temperature above 65 degrees, tested in cooling mode.
 Air handler was extremely rusted at interior and exterior, as was the overflow pan. The access door on unit was being loosely secured by only 2 screws and was not air-tight.
 Recommend additional evaluation and professional repairs and cleaning by a licensed HVAC contractor.

Rust and decay inside air handler.

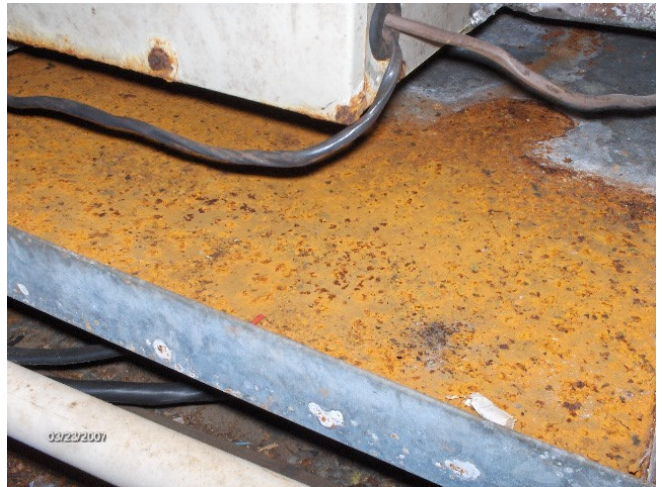
Rust in overflow pan of air handler.

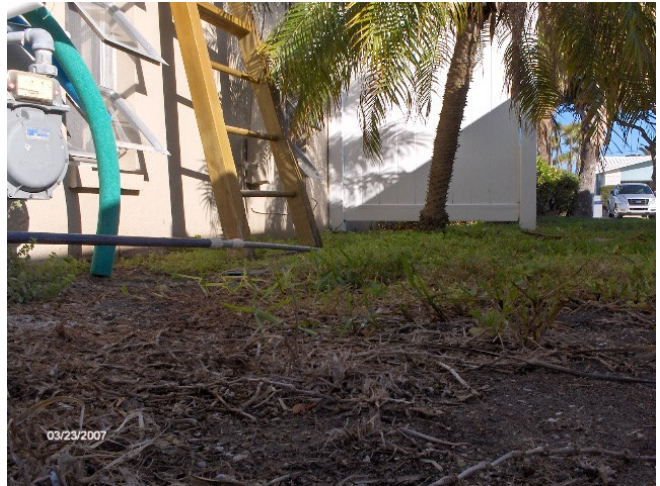
Areas of yard are near & negative level grading; monitor during heavy rainfall. Grading and drainage are probably the most significant aspects of a property, simply because of the direct and indirect damage that moisture can have on structures. More damage has probably resulted from moisture and expansive soils than from most natural disasters, and for this reason we are particularly diligent when we evaluate site conditions. In fact, we compare all sites to an ideal. In short, the ideal property will have soils that slope away from the house, and the interior floors will be at least several inches higher than the exterior grade. Also, the residence will have gutters and downspouts that discharge into area drains with catch basins that carry water away to hard surfaces. If a property does not meet this ideal, or if any portion of the interior floor is below the exterior grade, we will not endorse it, even though there may be no evidence of moisture intrusion, and recommend that you consult with a grading and drainage contractor. We have discovered evidence of moisture intrusion inside homes when it was raining that would not have been apparent otherwise.

Near level/negative grading at areas of yards.

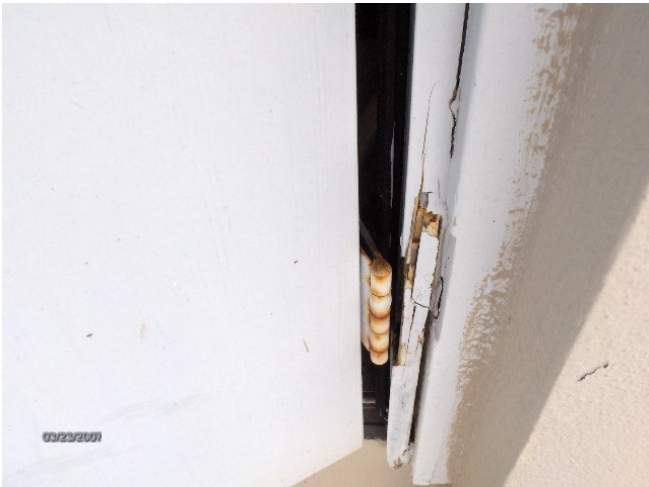
The garage utility door does not operate properly. The door jamb is decayed and damaged and the lower hinge is detached. Safety hazard of intrusion. Screen door on rear bedroom sliding glass door did not operate properly. Recommend repairs as needed by a licensed contractor. Doorbell inoperative.

Damage to door and door jambs at garage utility door.

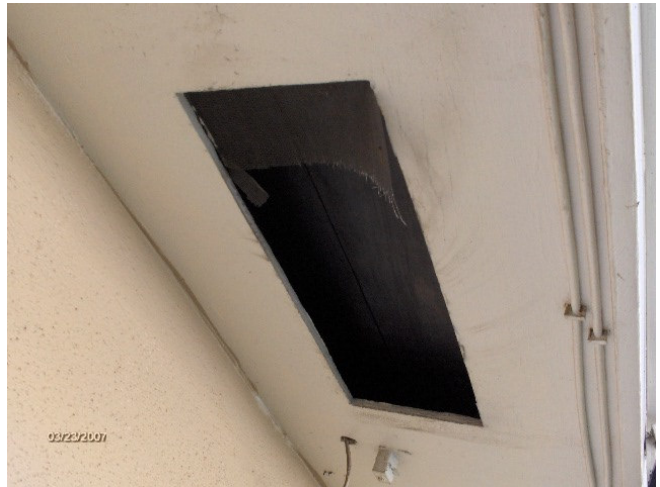
Several of the soffit vents have torn or missing screens; possible animal intrusion. Plastic soffit vent at s/e corner is loose. Recommend repairs by a licensed contractor.

Missing/torn/loose soffit vents at eaves.
