National Property Inspections

1415 Alamitas Ave
Monrovia, Ca 91016

1 Executive Summary

A property condition assessment was performed by National Property Inspections on the Alamilos Apartment Complex, located at 1415 Alamilos Ave, Monrovia, Ca 91016. The Walk Through Survey was conducted on May 29, 2007. The lot and the buildings were not measured in the field, the information for the approximate size of the lot was gathered from the Los Angeles County Assessors office.

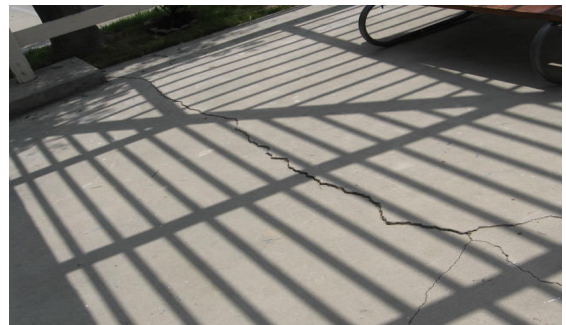
Overall, the condition of the concrete walkways and patio is in fair condition. There are areas of the walkway where repairs have been made and there are some large cracks on the patio surface.

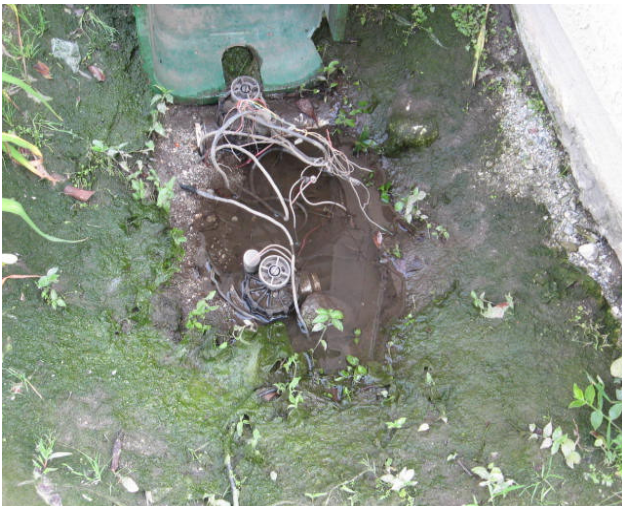
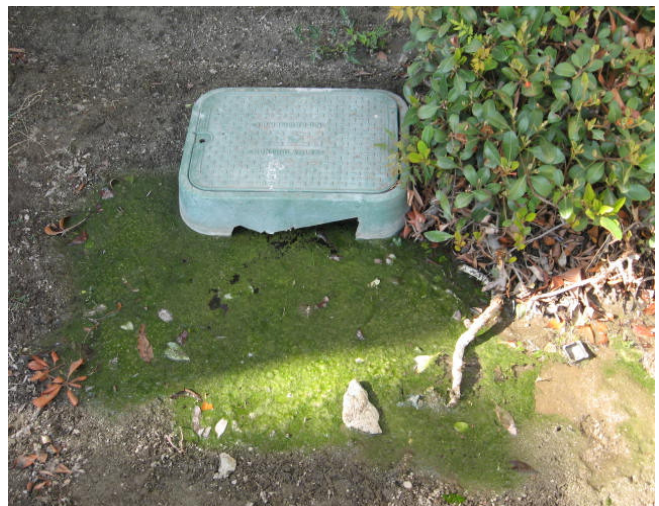
Landscaping is professionally maintained. Leaks were observed on at least two irrigation control valves. One at the East side of the exterior wall of Bldg #1416 and the other at the South side of Bldg #1420.

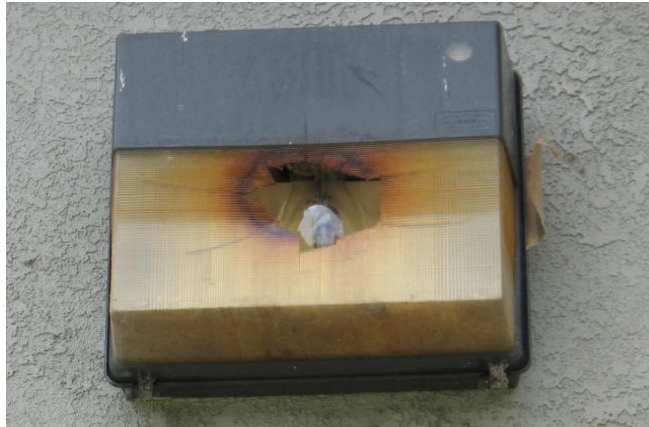
The lights were not observed at night, although according to some of the tenants, the fixtures offered adequate lighting at the time of the assessment. There are some covers on the mounted fixtures that need replacement; there is one in particular at the East side of Bldg. #1419 that has a large hole.

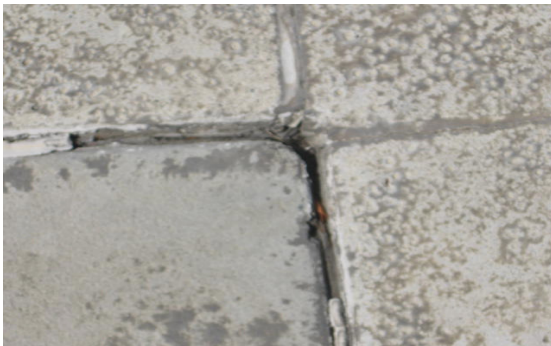
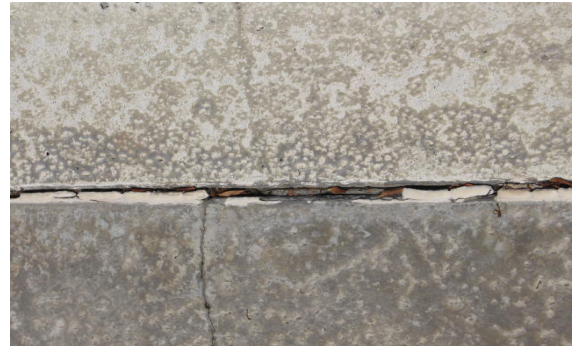
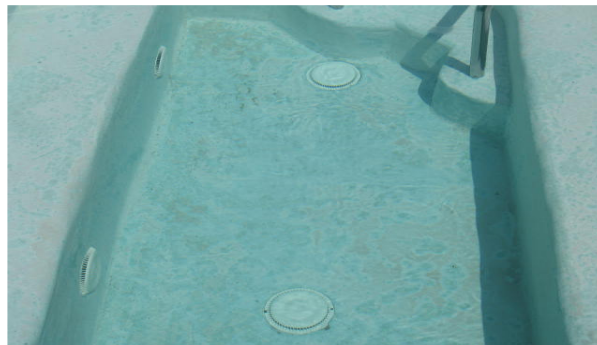
The shell of the pool is in fair condition but the some areas of the mast on the concrete deck need to be repaired or replaced. The spa is in fair condition, although there is some discoloration and staining present on the shell of the spa. Regular maintenance is recommended to prevent any algae build-up.

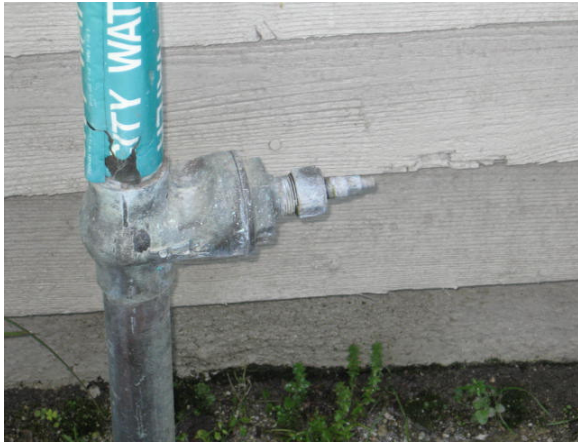
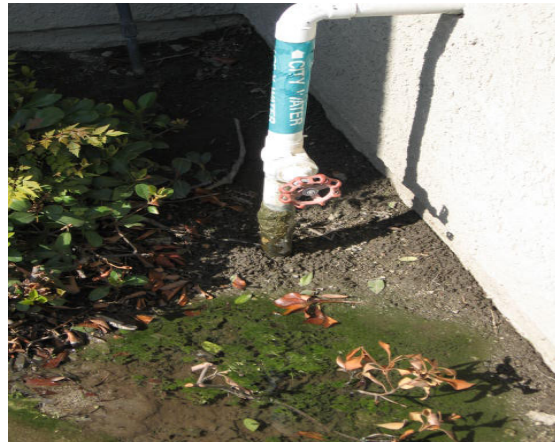
There is a leak detected at the valve of the main water line of Bldg. #1415, located at the Eastern exterior wall. There is also a leak around the main water line at the Southern wall of Bldg. #1420, although it may be a leak from the nearby irrigation control valve. Recommend further evaluation from a licensed plumber

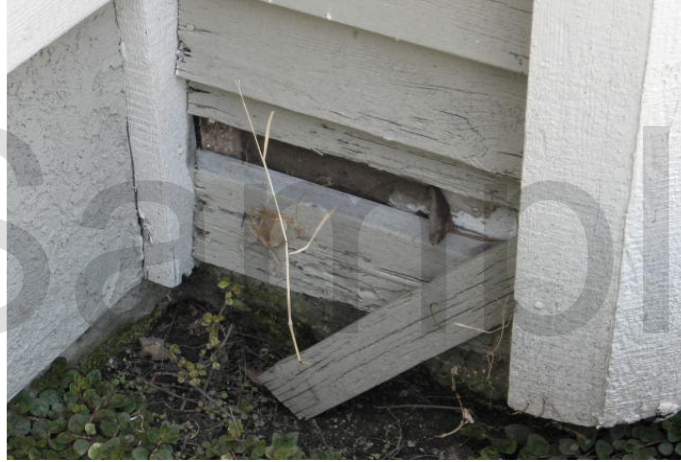
The exterior stucco is in overall good condition. The wooden areas that are in close contact to the soil can rot over a period of time due to moisture as shown on the picture on the next page, which is located at the East side of Bldg. #1416.

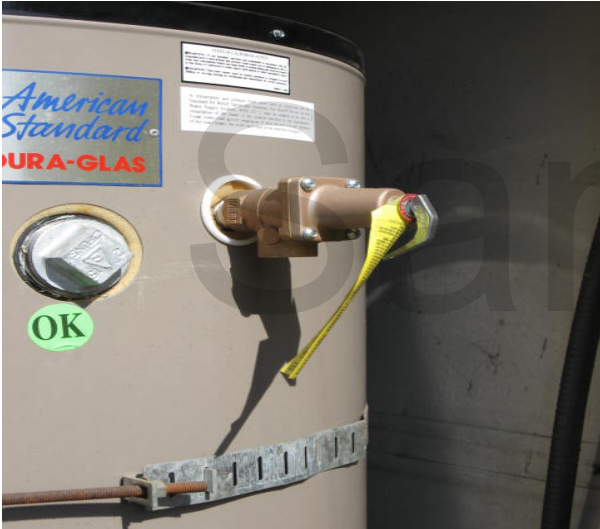
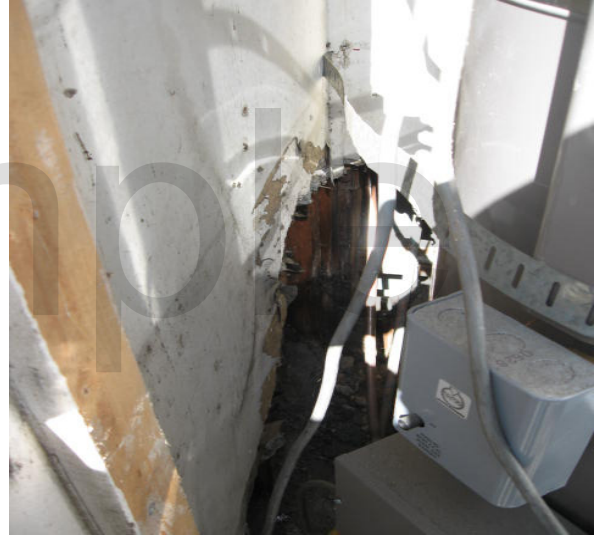
The water heater providing #1415 does not have an extension pipe coming from the TPR valve and there is extensive drywall damage in the closet.

The water heater providing #1416 is in generally fair condition, although there is extensive drywall damage in the closet. Recommend all repairs be completed by a licensed contractor of the appropriate trades.

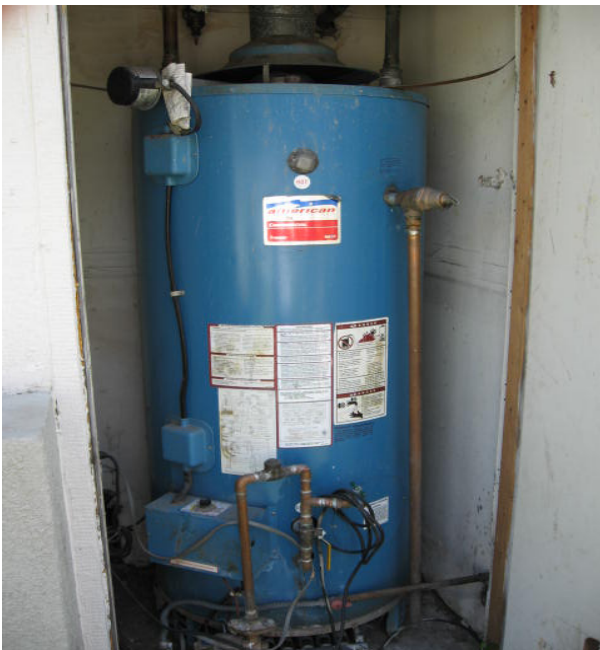
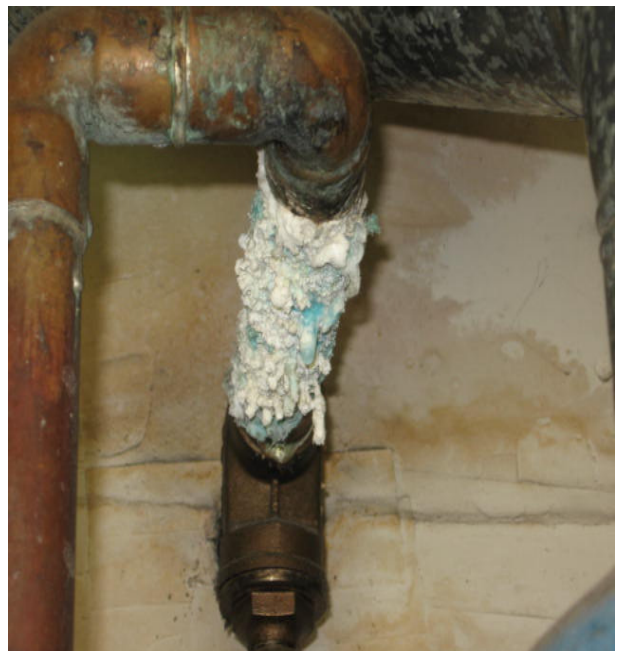
The water heater providing #1419 is not seismically strapped and corrosion is present on one of the supply lines.

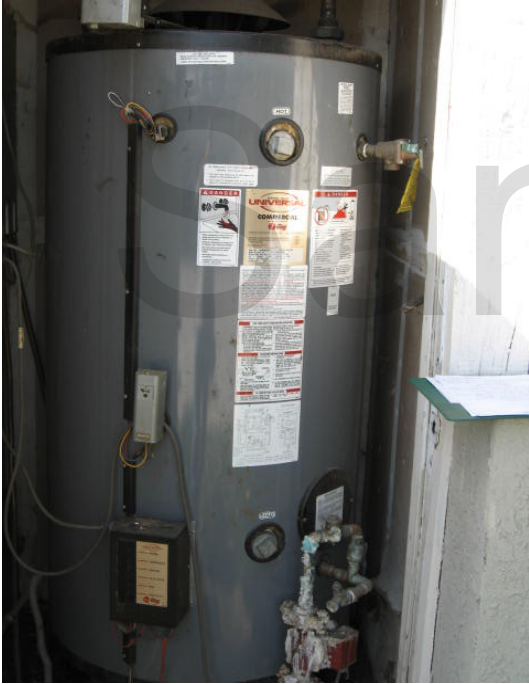
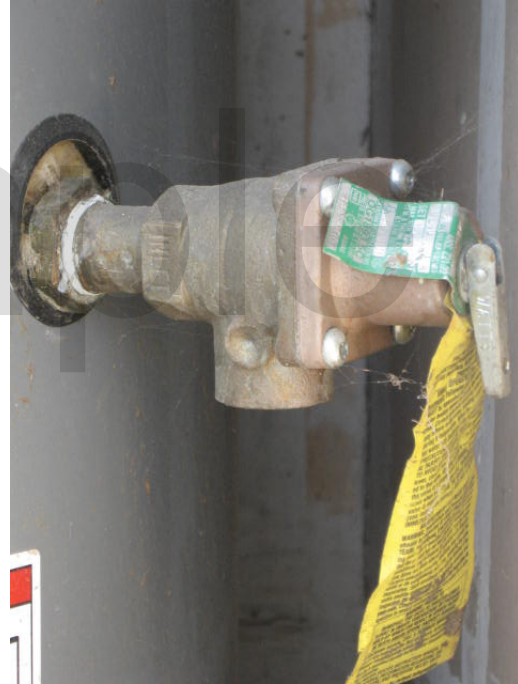
The water heater providing #1420 is not seismically strapped, no extension pipe coming from the TPR valve and major corrosion is present on the hot water pipe and mechanism.

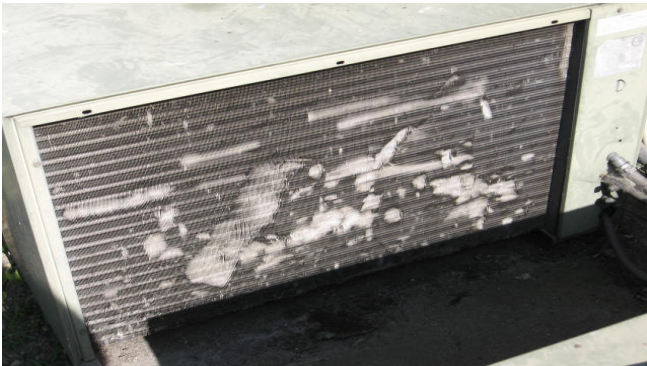
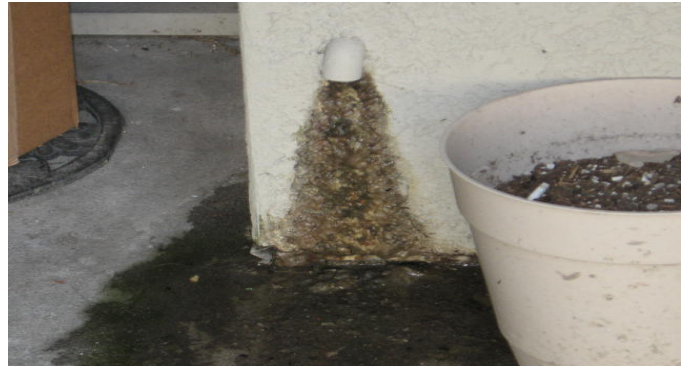
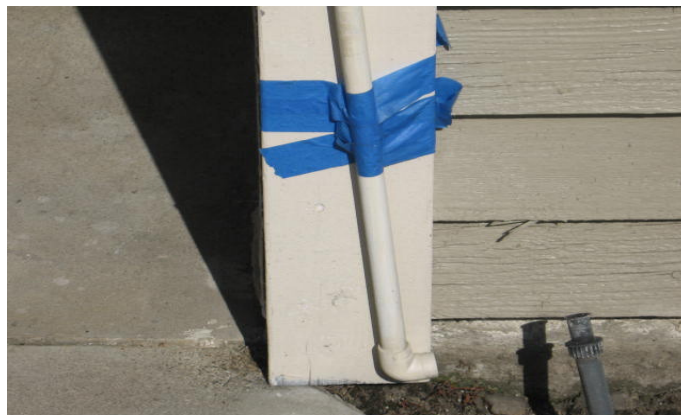
The units were not tested in the heat mode at the time of the observation due to high outside temperatures. The Whirlpool models have reached their design life and will all eventually in the near future have to be replaced, there were signs of dented fins on many of the units. Many units were being run in the air conditioning mode at the time of the inspection. The air conditioning equipment appeared to be in fair condition at the time of the observation, but there are some apartment units which the condensation pipe has caused moist conditions on the walkways and discoloration of the stucco because the pipe is not extending to the grass area. Recommend extending the pipe avoid any problems that may arise.

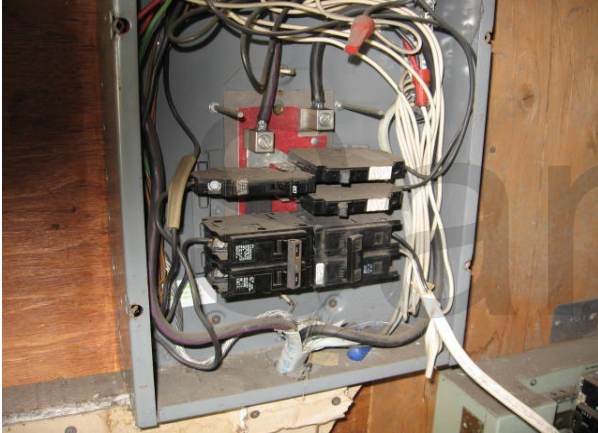
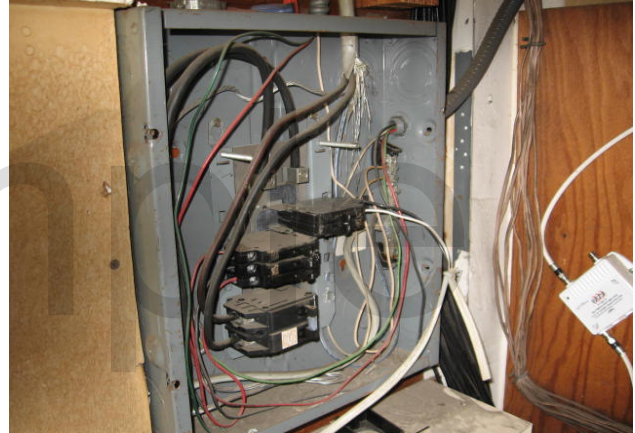
Detailed load calculations were not performed during the observation. The electrical system appears to be in fair condition, but the problem is with the sub panels for the Fire Alarm System. The covers of the panel are not installed correctly or they are completely off altogether. There is also romex wiring added to the panel which is not running in a conduit for protection. All deficiencies must be further evaluated by a licensed electrician. Pictures of deficiencies are shown on the next page.
