National Property Inspections

Property Location

Riverside, Ca 92507

1. Executive Summary

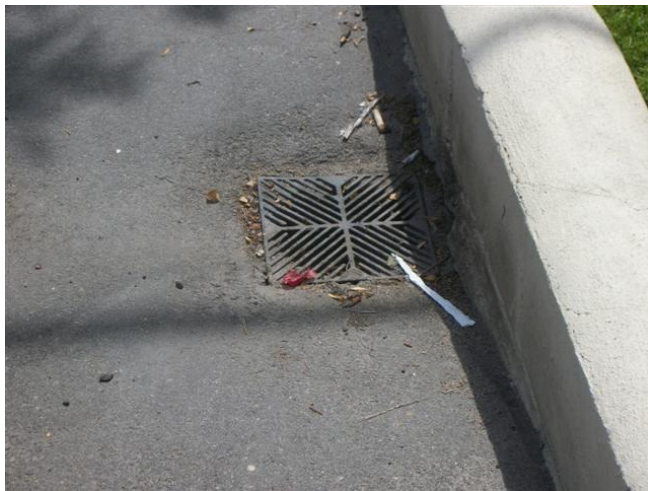
Slow drain in parking lot

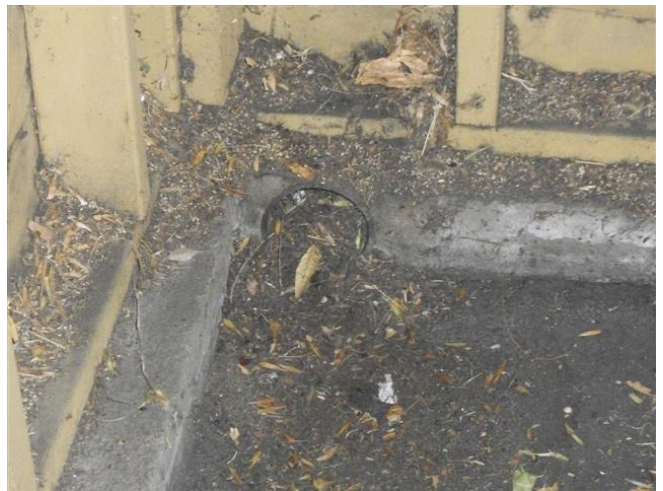
Obstructed drain line in carport

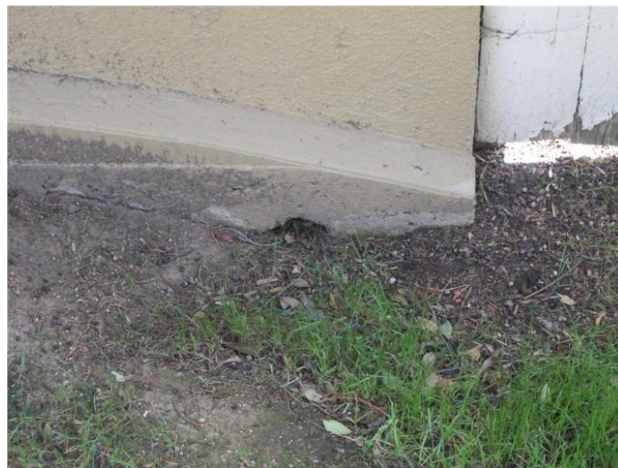
Dirt needs to be graded back from drain opening

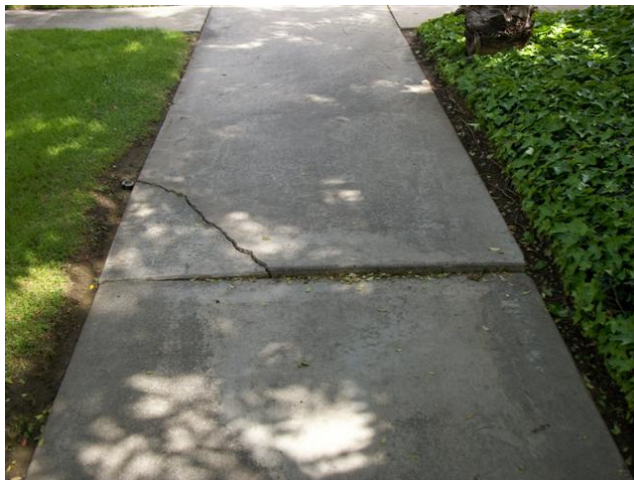
A section of the pedestrian street walkway on the left side of the property has lifted and created a trip hazard. An injury from a fall can produced litigation. Recommend contacting the City of Riverside to determine which party is responsible to repair this deficiency. There is some typical cracking atop the walkways in side the complex. There is evidence of pooling on the concrete slab on the right side of the laundry room. There is excessive cracking around the perimeter of the swimming pool. Recommend further evaluation and repairs to seal cracks be completed by a licensed concrete contractor.

Damaged sidewalk – trip hazard

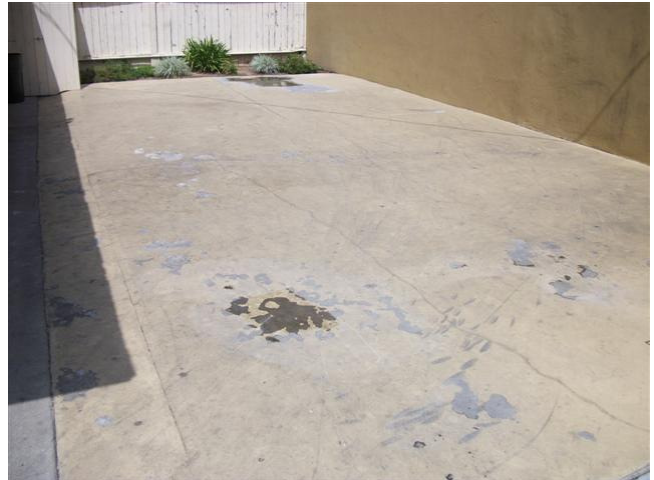
Pooling on slab

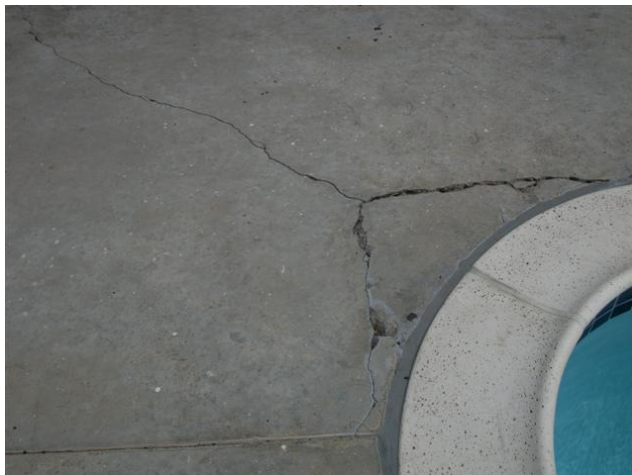
Excessive cracking around pool perimeter

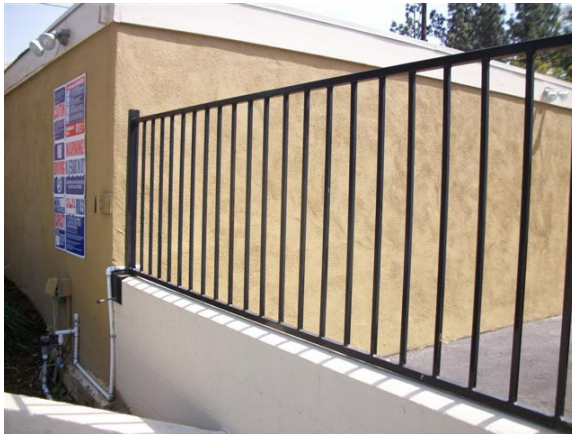
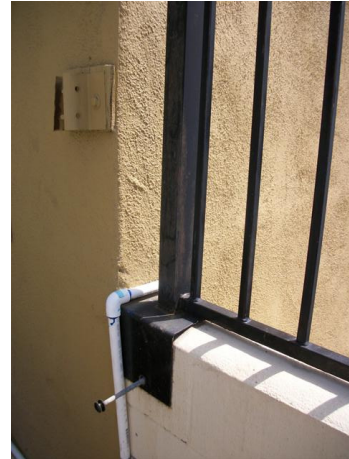
Fence loose

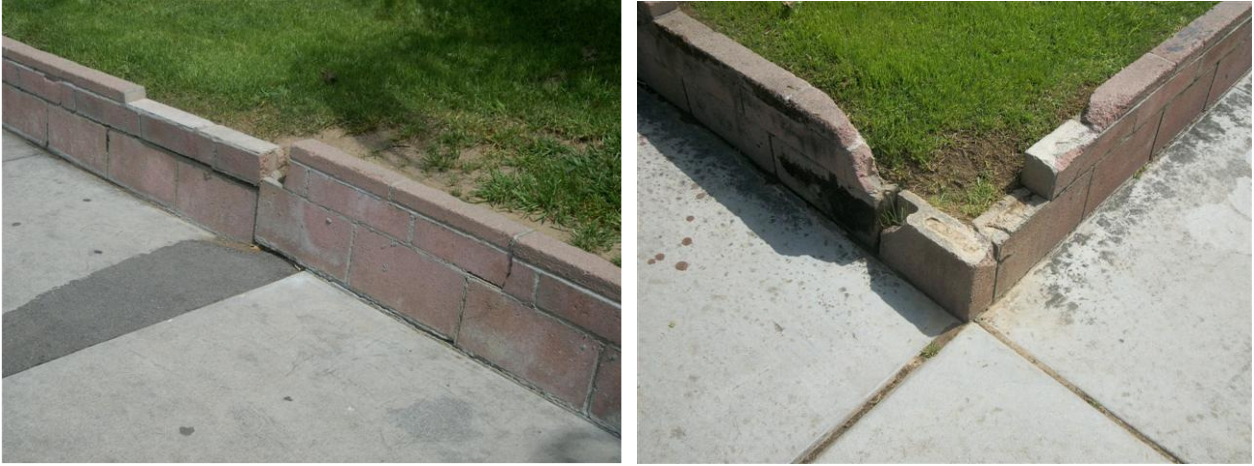
There are some damaged and/or missing portions. Recommend contacting a licensed contractor to further evaluate and perform repairs.

Damaged areas of the retaining wall

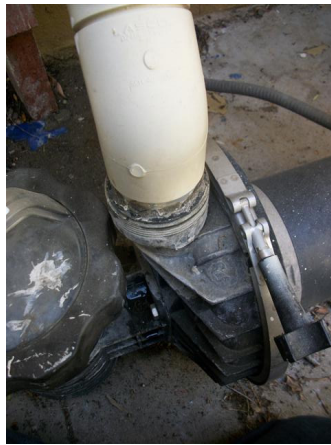
View of leaks

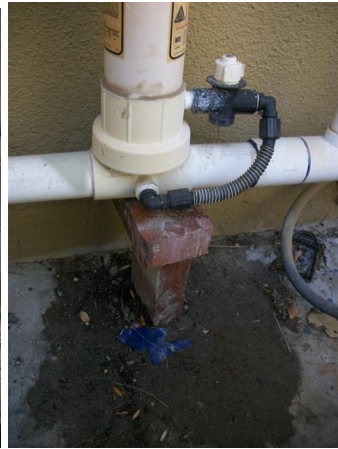
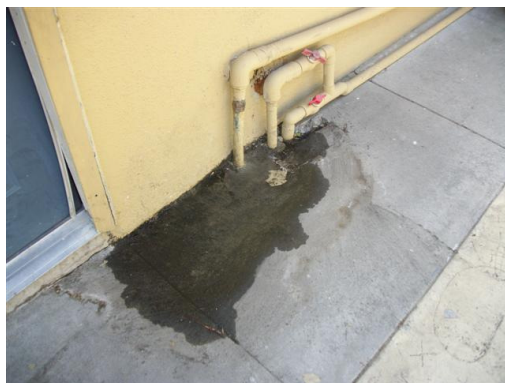
Additional leaks at pool supply line

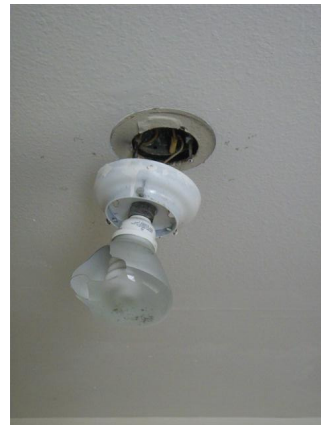
Detached light fixture

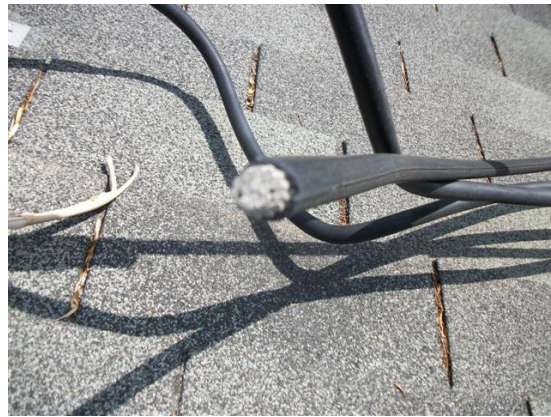
One of the main electrical wires from the service drop at the right side of the building is exposed at the end, which may be live. Recommend contacting Southern California Edison to further evaluate and insure a safe atmosphere.

Exposed service drop

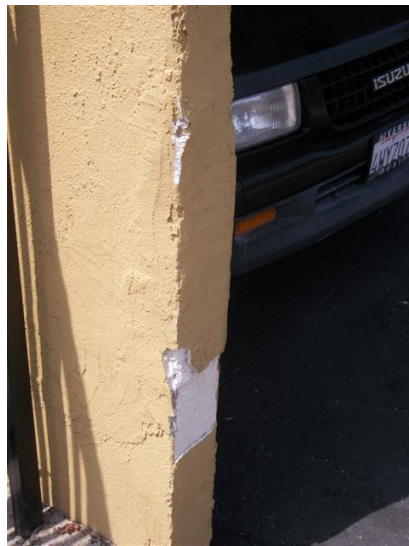
The plaster appears to be in fair condition, except for the damage located at the corner of the carport by the gate entrance of the secured parking lot. There does appear to be some dry rot on some of the surfaces of the fascia boards. Recommend reviewing the termite report for recommendations.

Damaged plaster

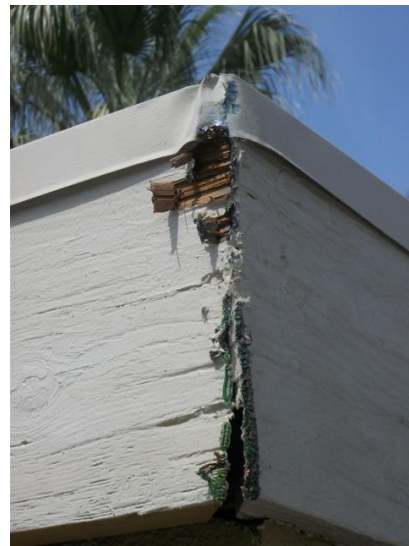
Dry rot wood damage

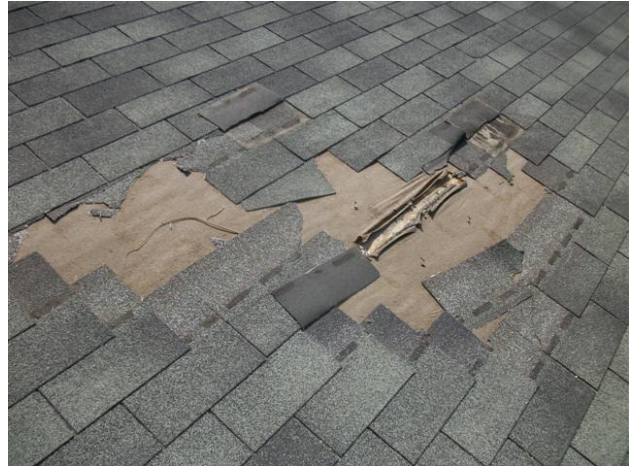
Missing shingles

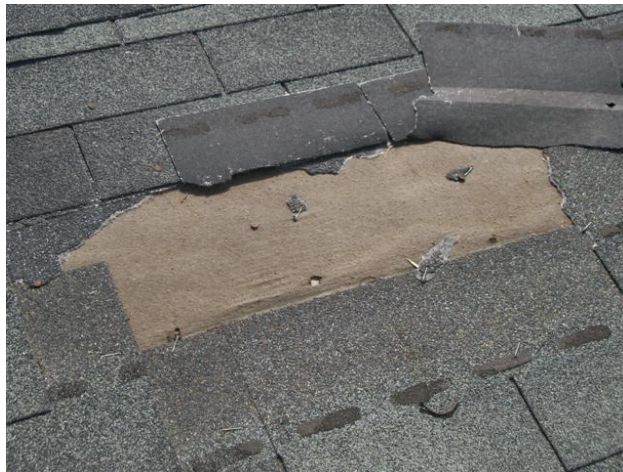
Additional damaged area

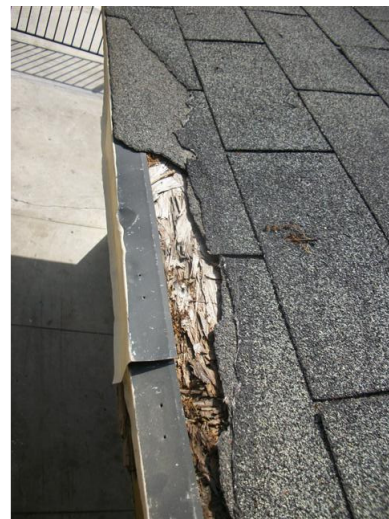
Damages on edge

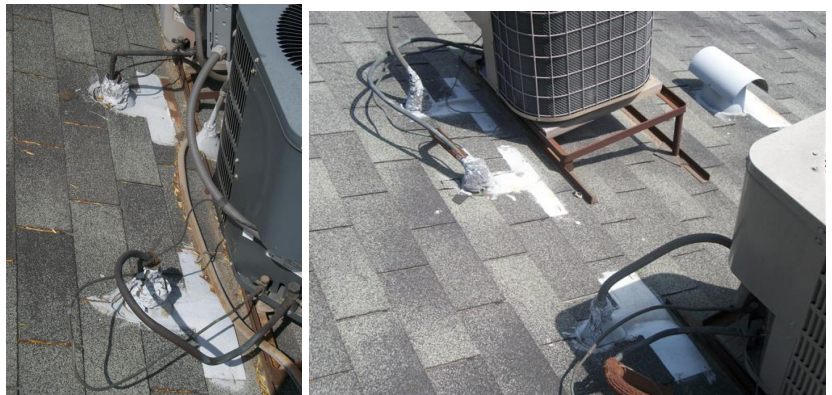
The operation the HVAC system will be addresses in the individual apartment unit section of this report. Some of the pressurized lines exiting from the condensers are missing insulation. Recommend applying insulation were needed to insure efficiency while the air conditioning is in use.

Missing insulation from lines

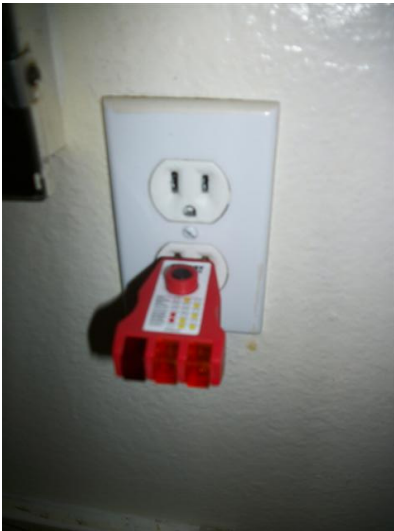
No GFCIs

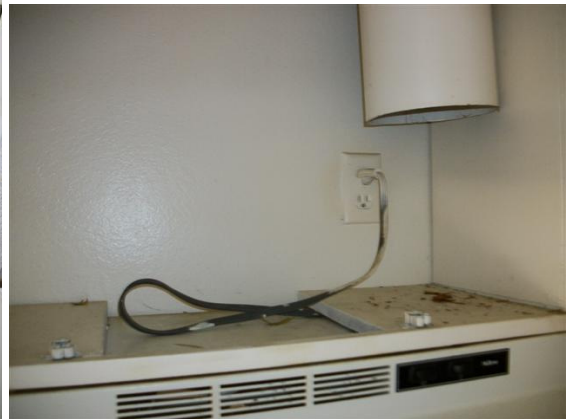
Improper exhaust venting

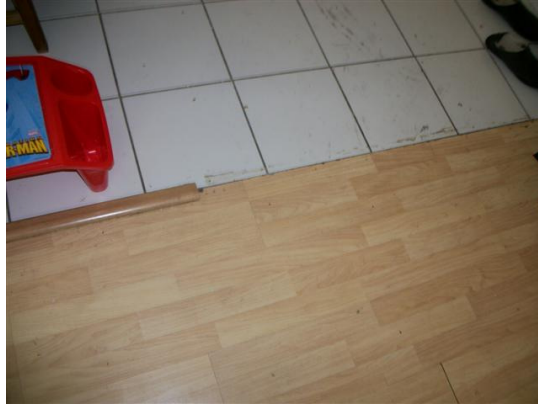
Missing threshold

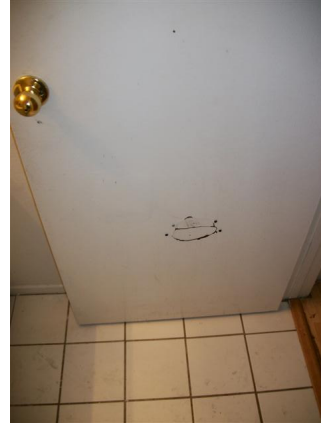
Damaged bathroom door

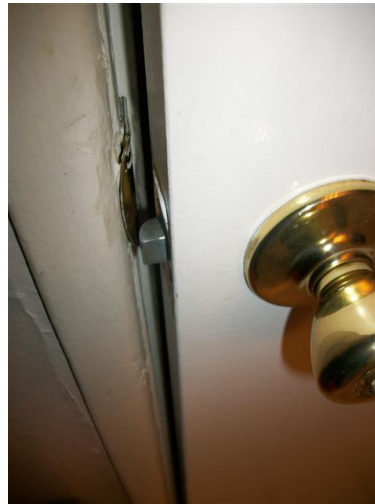
Not latching

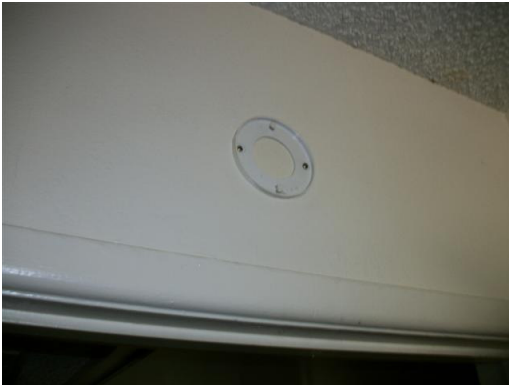
Missing smoke detectors

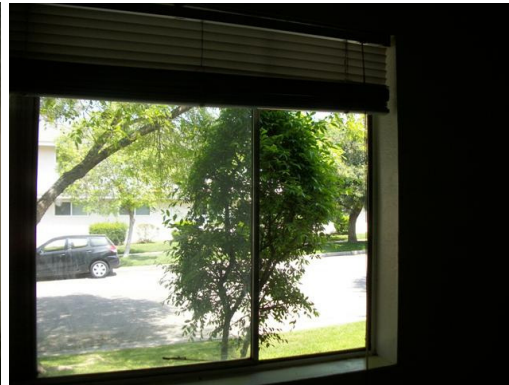
Missing window screen

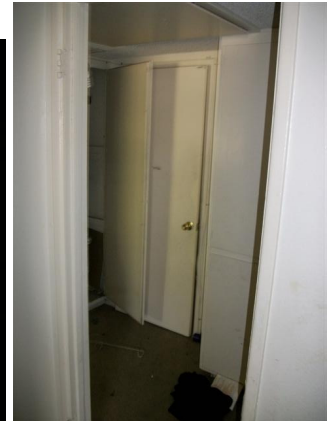
Missing interior door

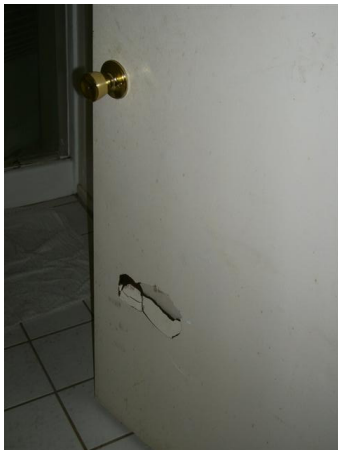
Damaged interior door

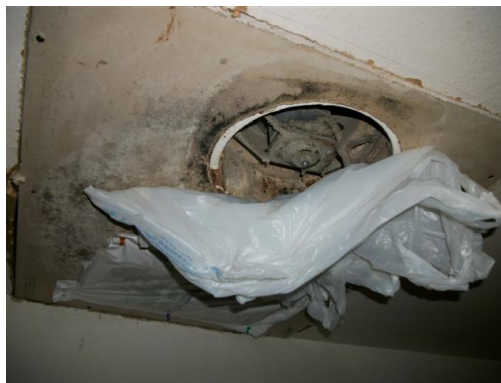
The section of the ceiling in the hallway bathroom has been replaced and covered. It appears there may be a plumbing leak from above. Recommend further evaluation be completed by a licensed plumber. Also, the shower head is missing.

Bathroom ceiling damage

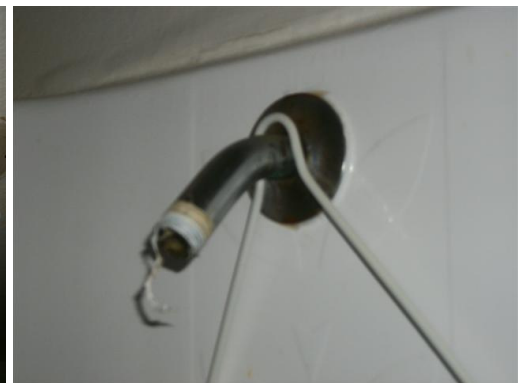
Missing shower head

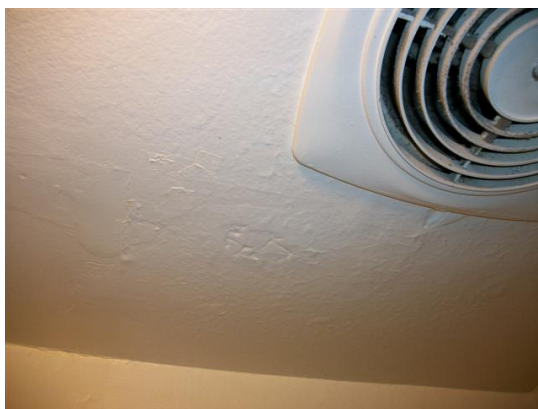
Excessive moisture

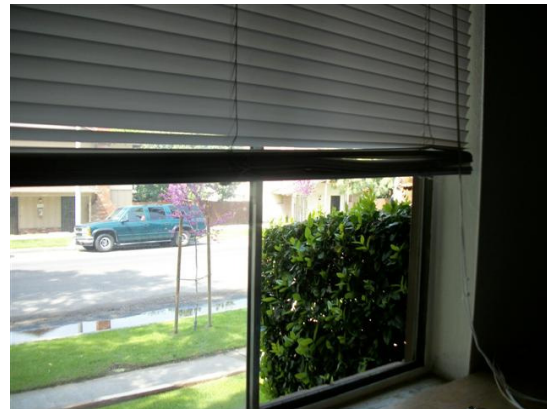
No window screen

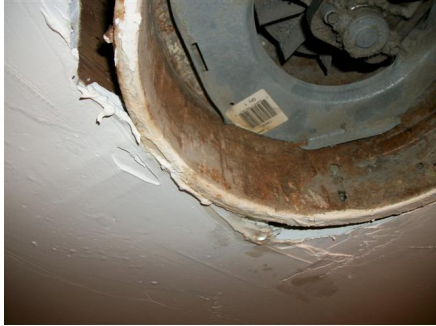
Plumbing leaks above ceiling

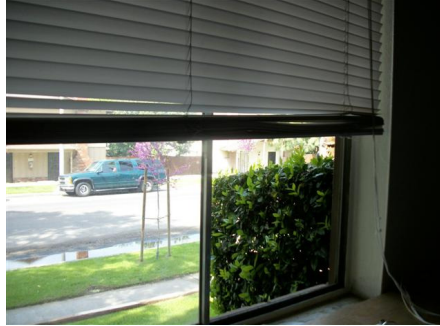
Missing window screen

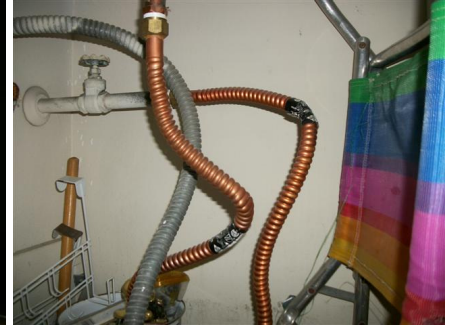
Missing insulation

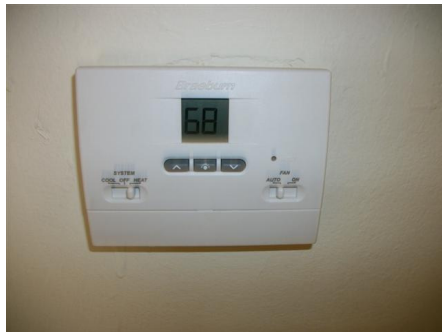
No heat

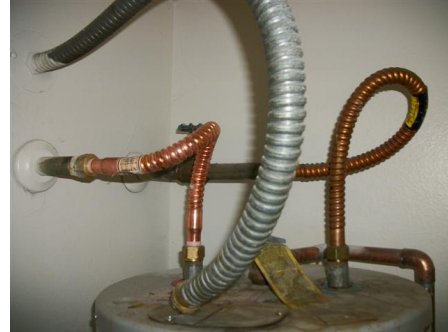
Missing insulation

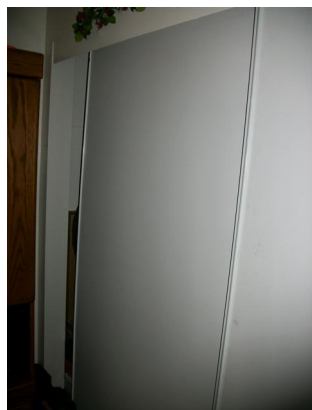
Inoperable closer door

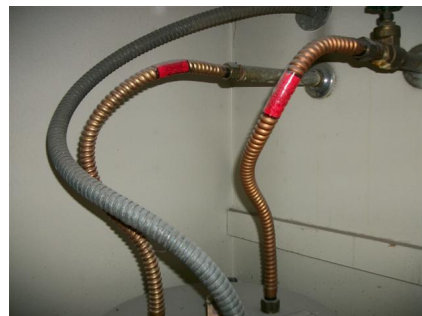
Missing insulation

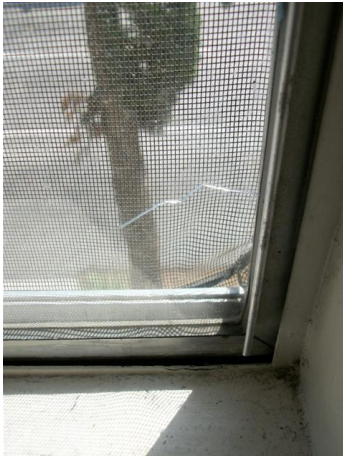
Cracked window pane

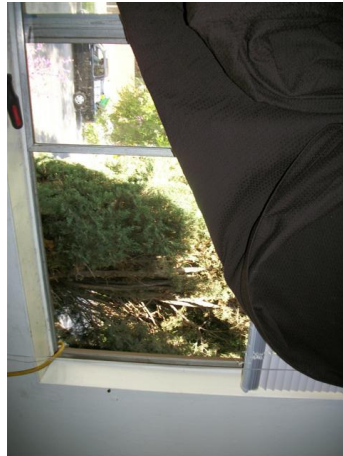
Missing screen

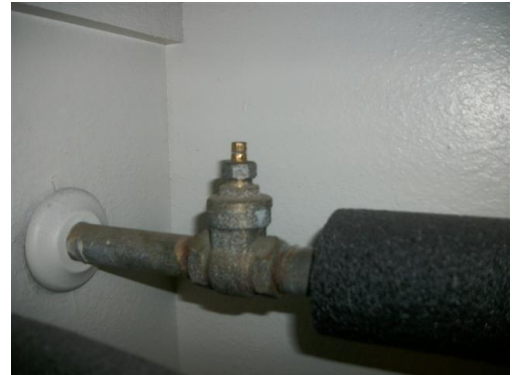
Missing valve at water heater

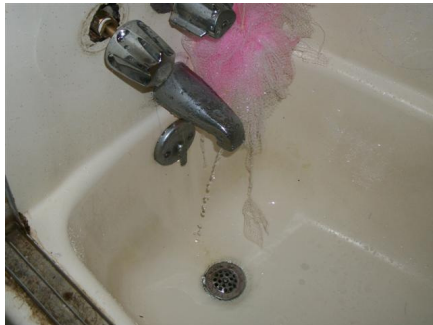
Tub faucet dripping

Recommend repairs be completed by a licensed plumber.

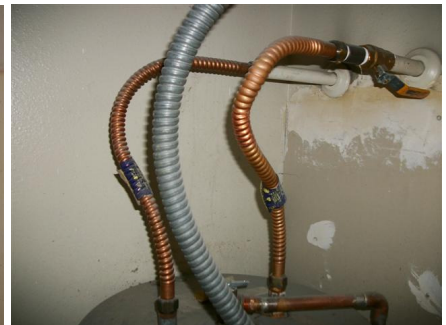
Missing insulation

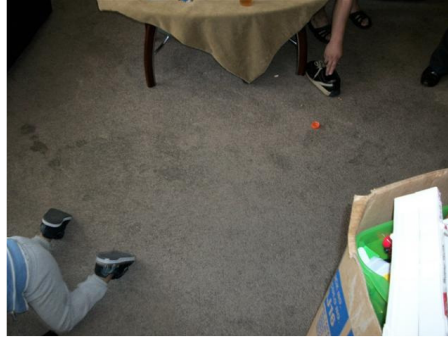
There appears to be damaged floor boards below the carpet in the family room. Recommend removing carpet to further evaluate.

Damaged floor boards under carpet

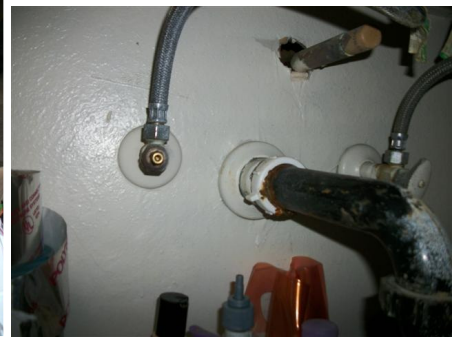
Missing supply valve

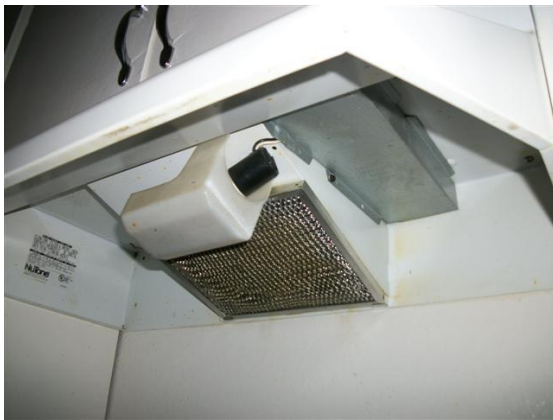
Inoperable exhaust fan

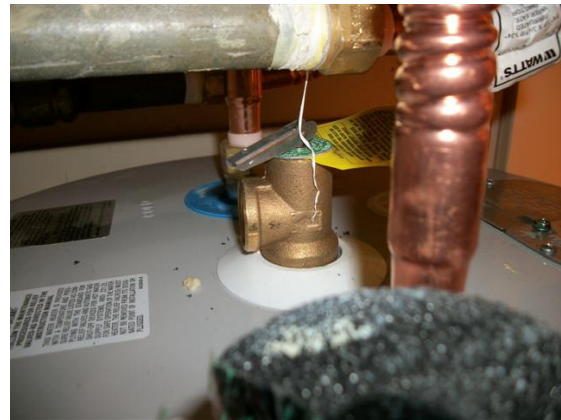
Missing pipe from TPR valve

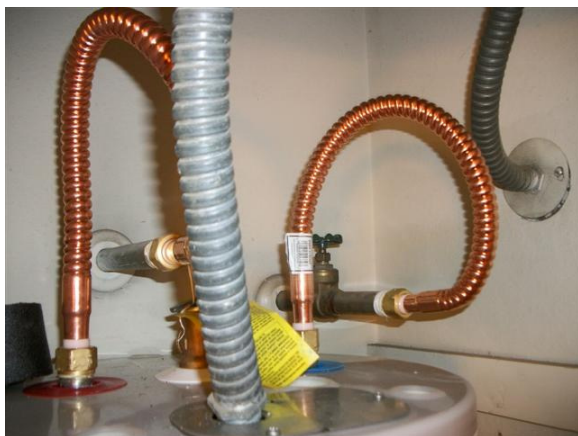
Missing insulation

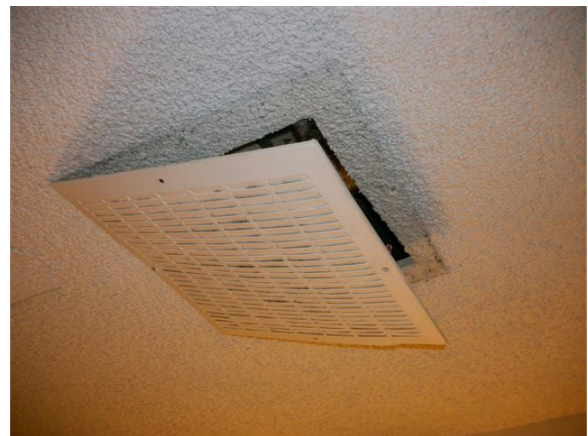
Detached cover

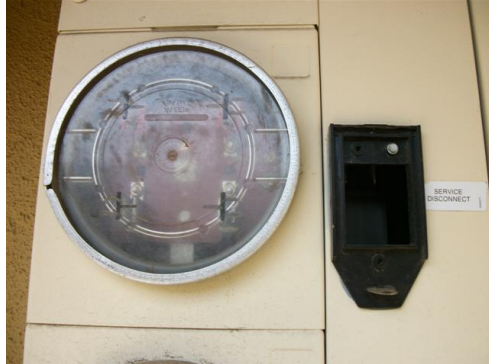
Missing electrical meter

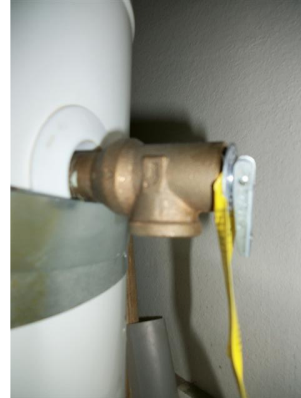
Missing pipe

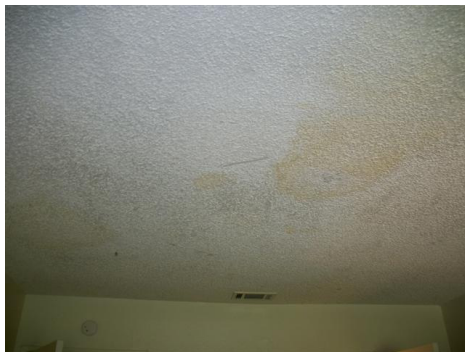
Unit #15 – There are excessive water stains on the surface of the ceiling texture. It appears moisture is intruded from the roof above.

Ceiling stains

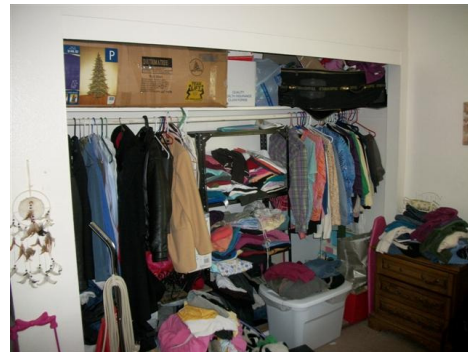
Missing closet doors

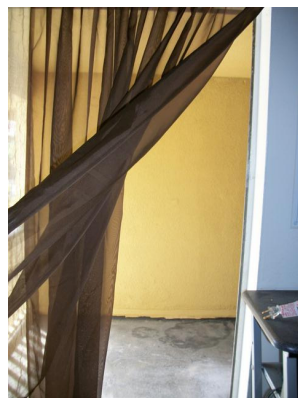
Missing window screen

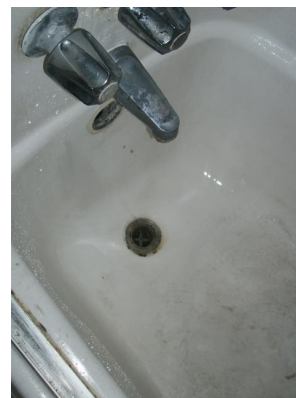
Slow drain
