**PROPERTY CONDITION REPORT**

Client(s): Daniel Chavez  
 Property Address: 3722 W Fallen Leaf Ln  
 Glendale, Az 85310  
 Realtor: Michael St Paul,  
 Date: 09/27/2019  
 Inspector: Zach Shawd  
 Report #: Z092702-19RT

**Report:** Z092702-19RT

**Inspection Address:** 3722 W Fallen Leaf Ln, Glendale, Az 85310

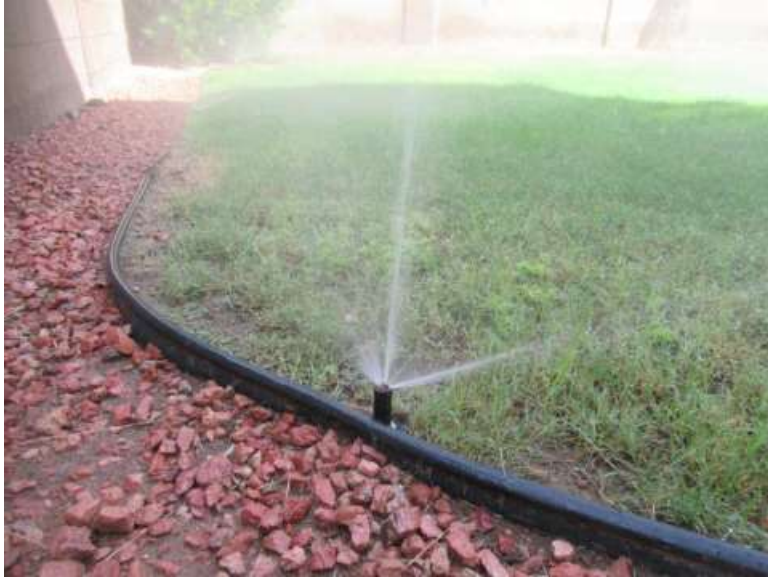
**Repair:** Although not every head or emitter was checked, it was observed that one or more of the emitters/heads were missing or broken and needs repair by a qualified contractor.

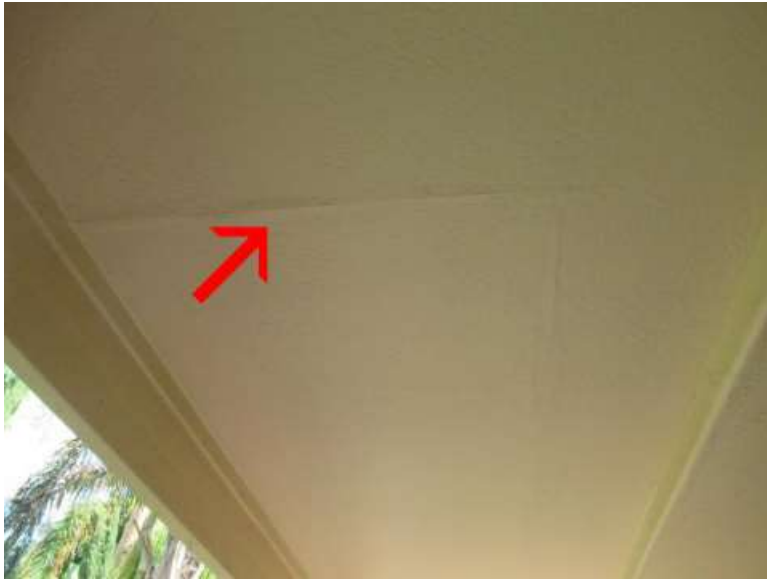
**Repair:** The patio ceiling has loose and visible seams. Repair by a licensed contractor is recommended.

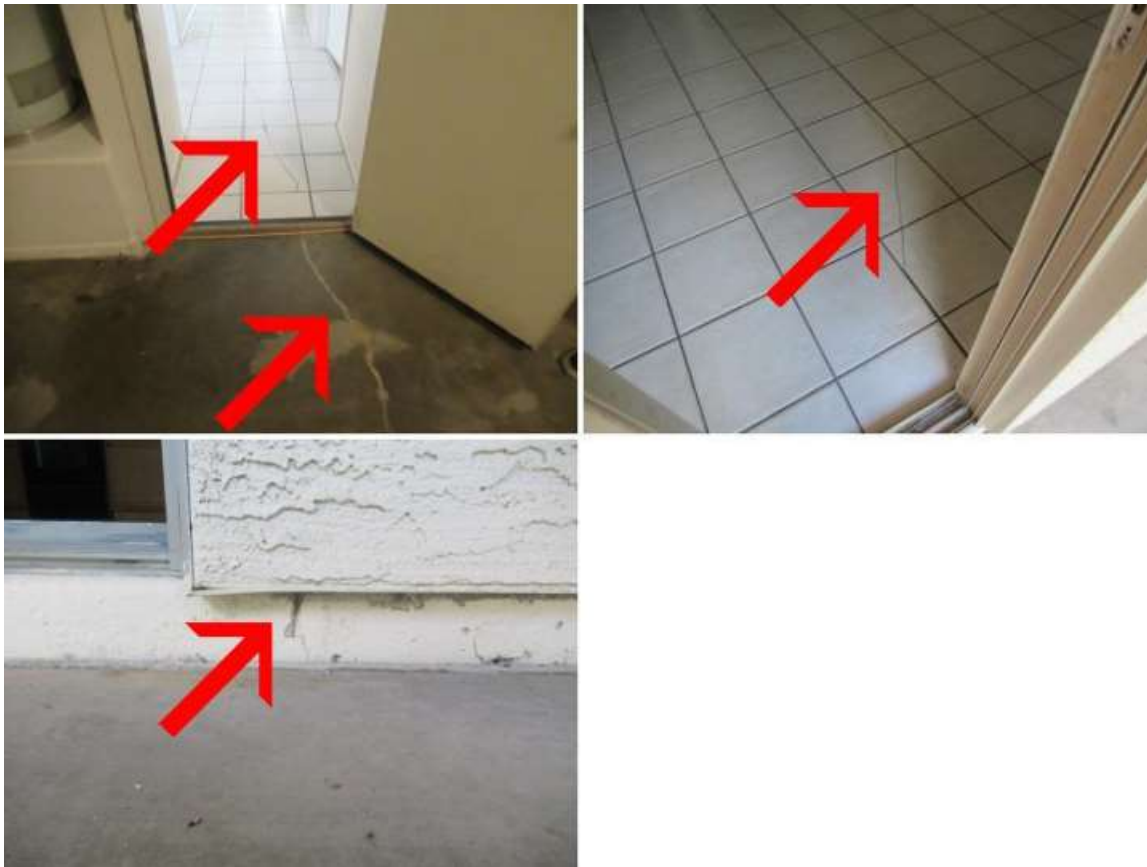
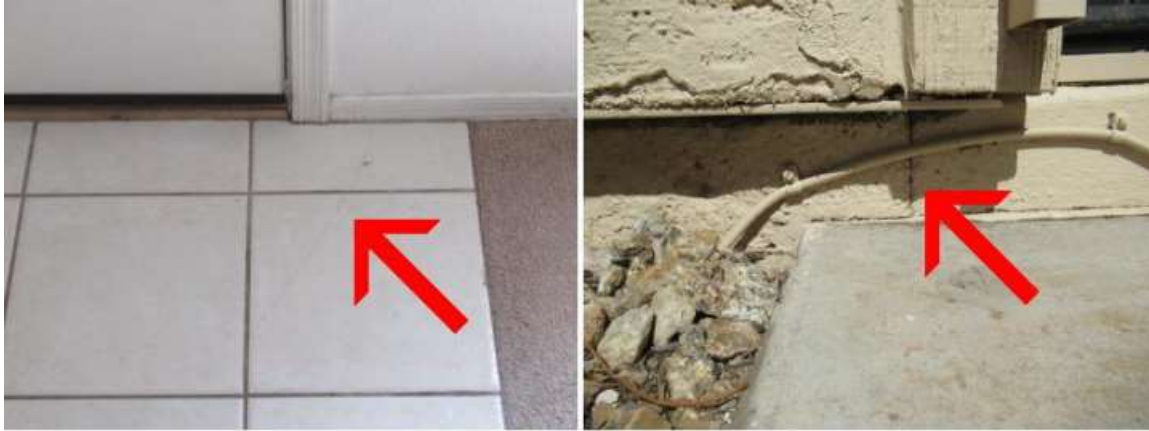
**Further Review:** Due to the sellers disclosure of interior floor cracking and the corresponding stem wall cracks. Further evaluation and repair by a licensed contractor is recommended.

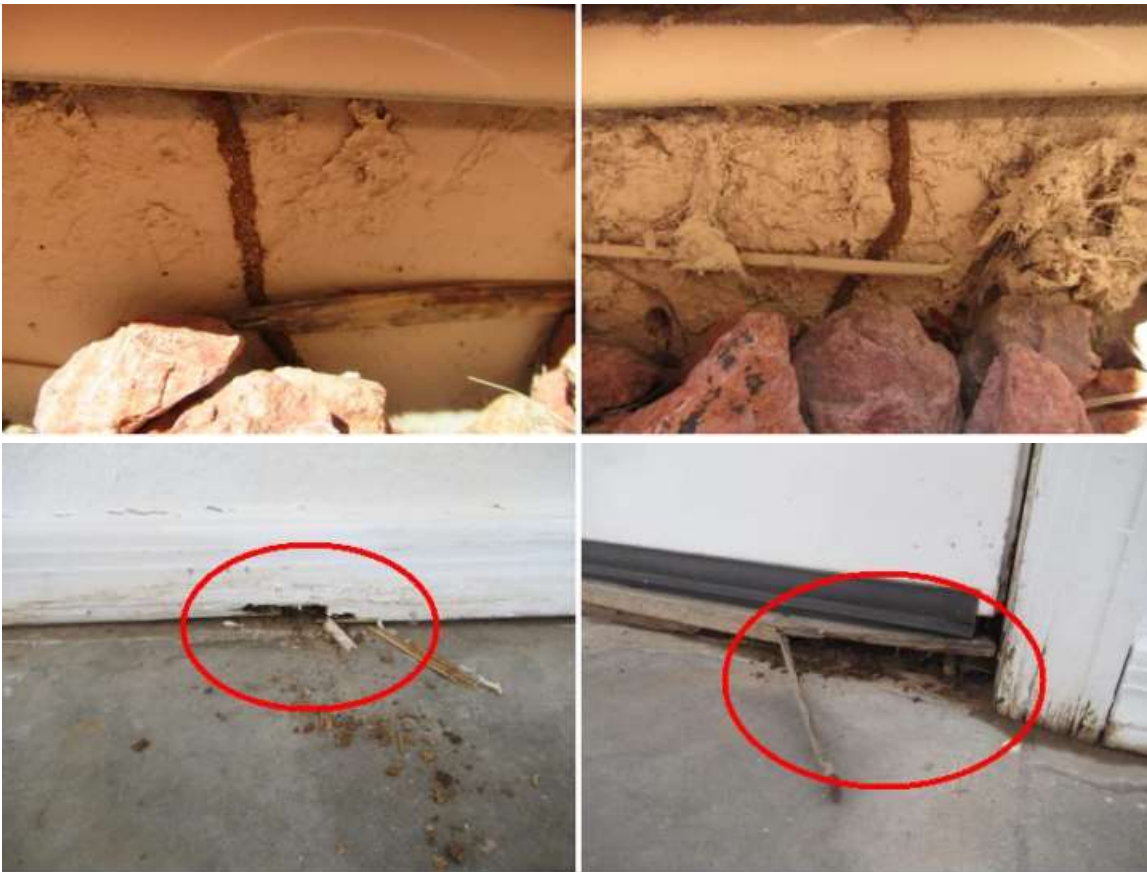
there is evidence of wood destroying insect damage at the garage north wall baseboard and at the garage side door threshold. Contact a qualified Pest contractor for further review and information.

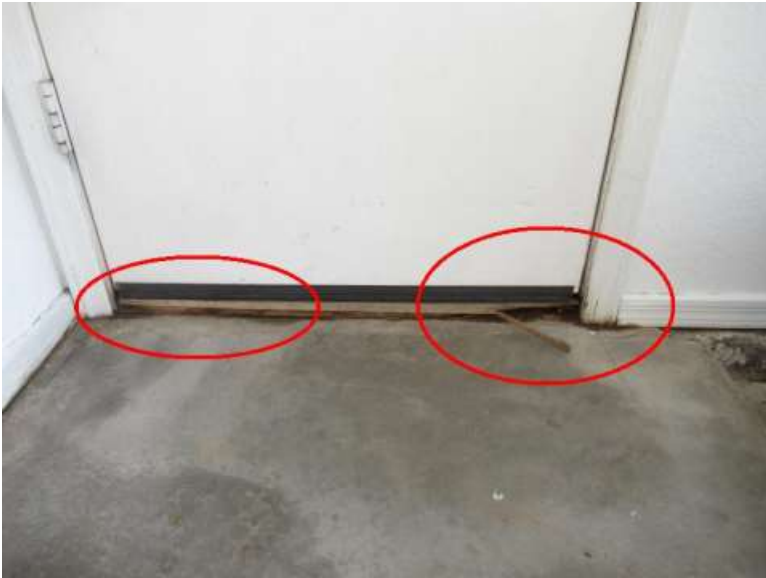
**Repair:** The outside entry door is not adequately sealed, resulting in some water intrusion. The presence of any water intrusion should be addressed immediately by a qualified contractor.

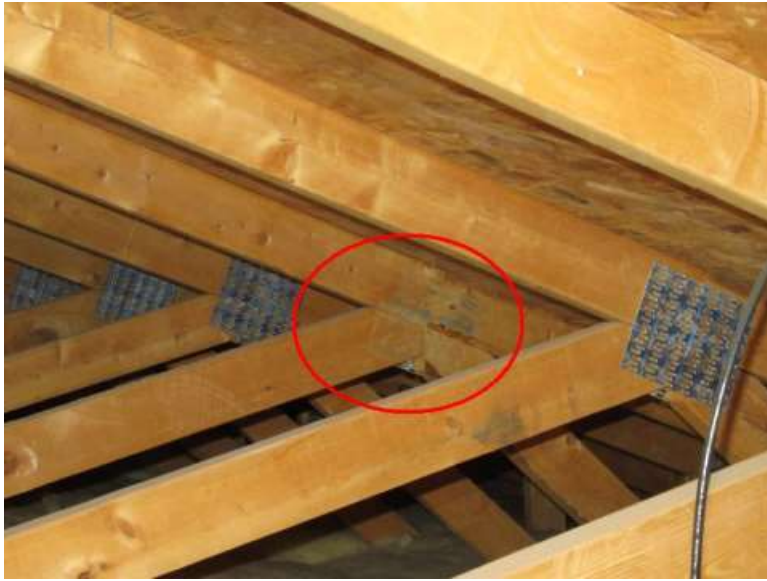
**Further Review:** The gusset plate (gang-nail connector) is missing on one of the trusses. Since the plate is required and a part of the original truss, it will need to be corrected and engineering will be required (8 1/2" X 11 sheet of paper show truss and repair with engineers stamp).

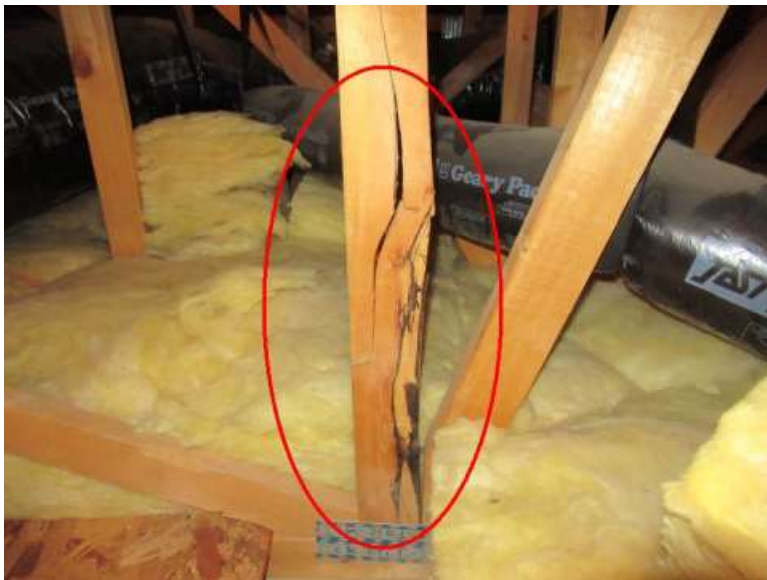
**Further Review:** There is a damaged truss south of the attic access. Truss modifications or repairs require a structural engineer certification. Evaluation and repair by a licensed structural engineer is recommended.

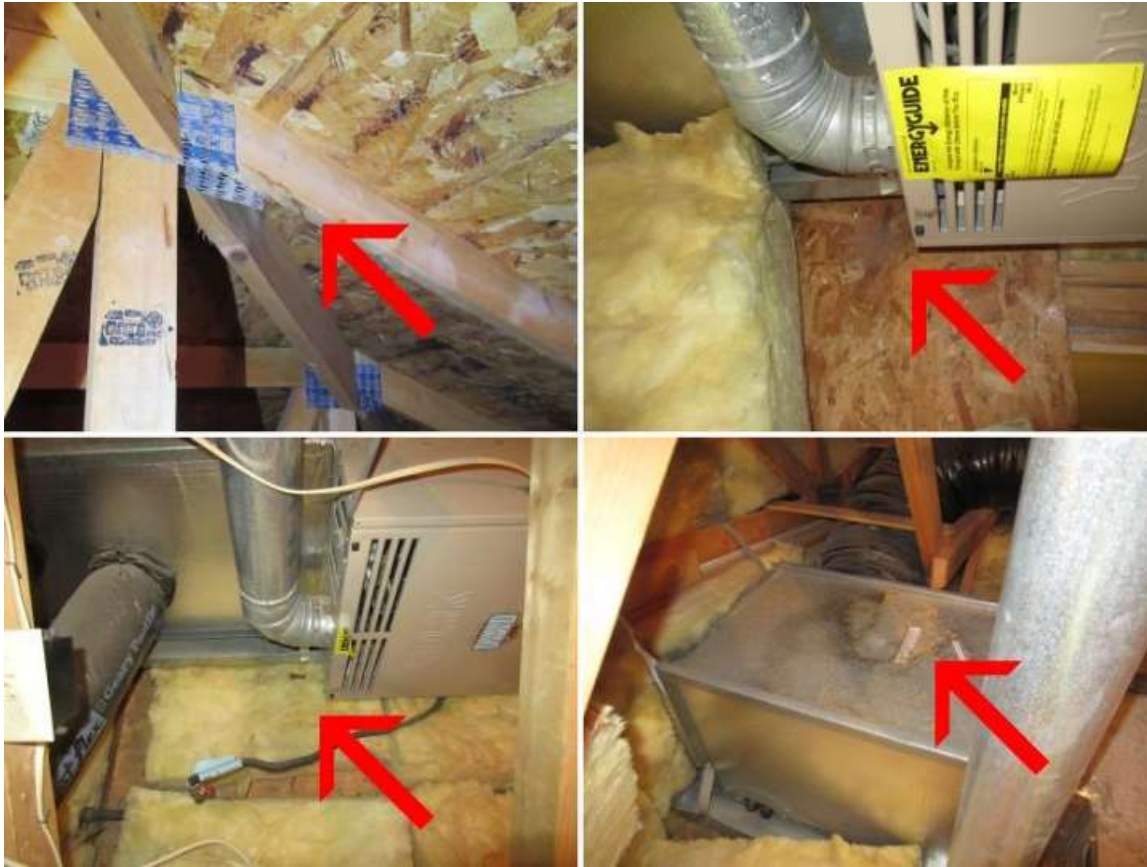
**Further Evaluation:** There is water staining on the underside of the roof decking, trusses, below the furnace flues and on top of the air handlers. The stains are not currently wet nor do they have an elevated moisture content. The inspector was unable to determine if the noted leaks have been repaired.

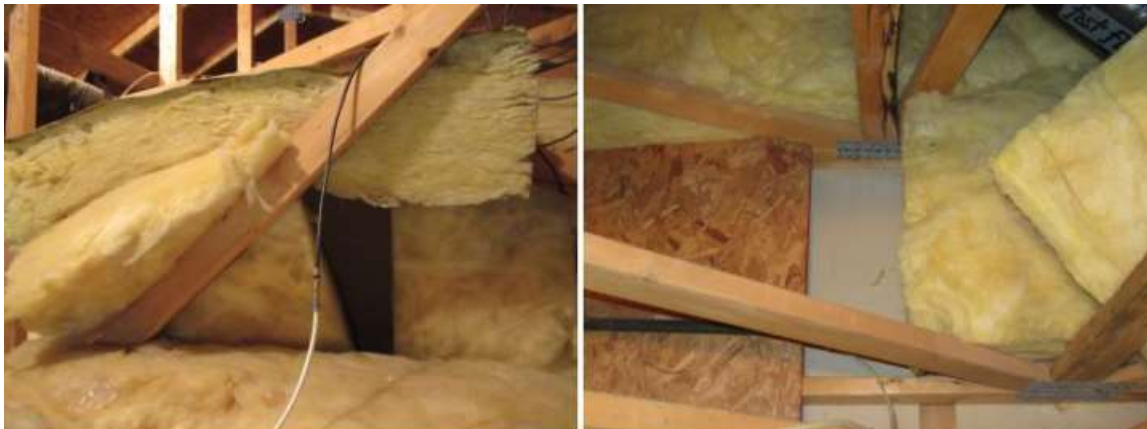
**Repair:** One or more of the insulation batts have fallen, are missing and/or have been displaced. They should be reinstalled to reduce thermal loss between the home and the attic.

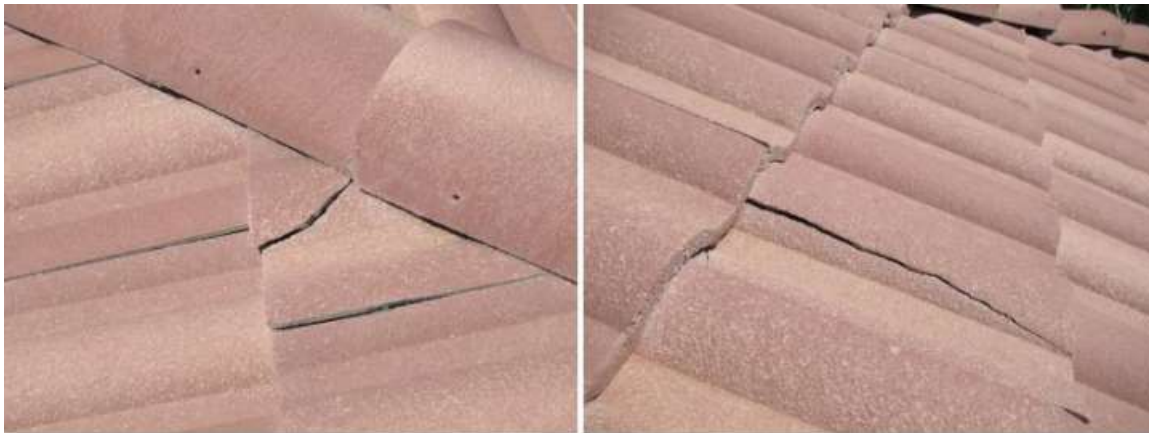
**Repair:** Several cracked/broken field tiles are noted and should be repaired and/or replaced to prevent the possibility of water draining under the tiles and having access to the underlayment and needs to be repaired by a qualified contractor. The tiles are spread evenly throughout the roof.

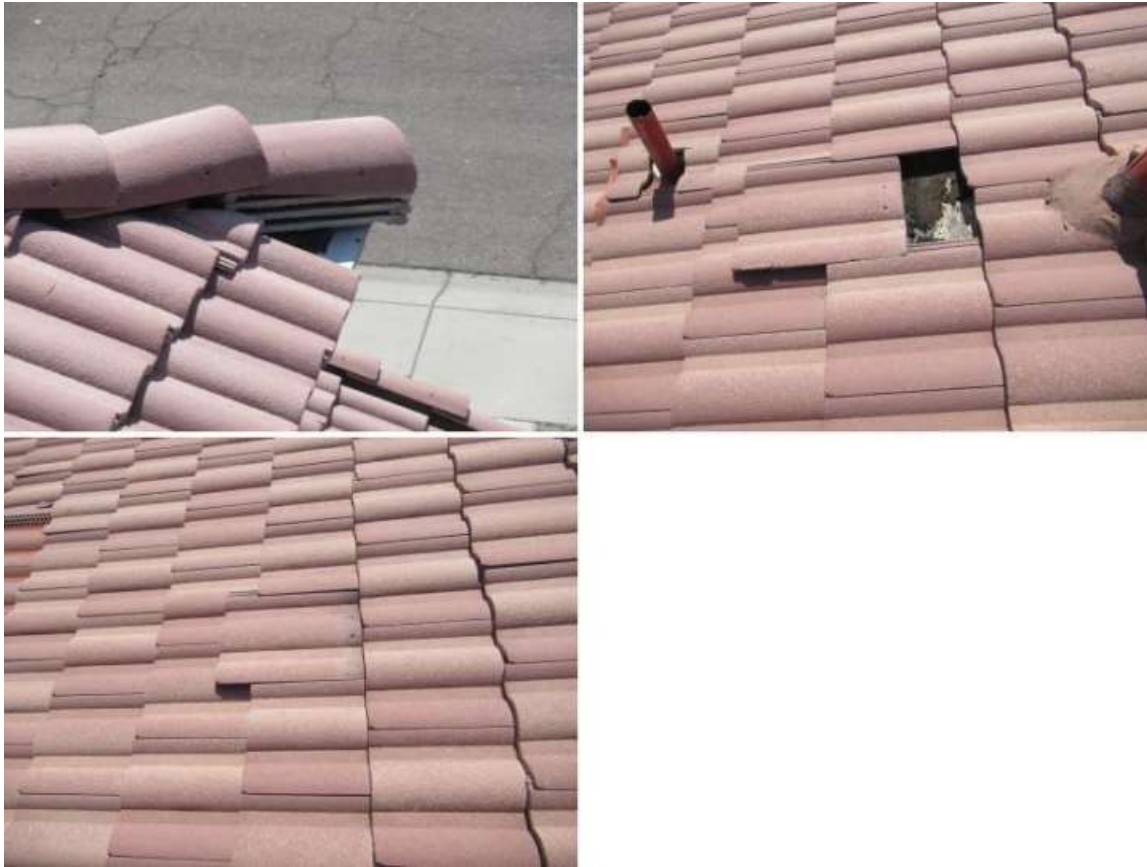
**Repair:** There displaced and missing roof tiles. Repair by a licensed roofing contractor is recommended.

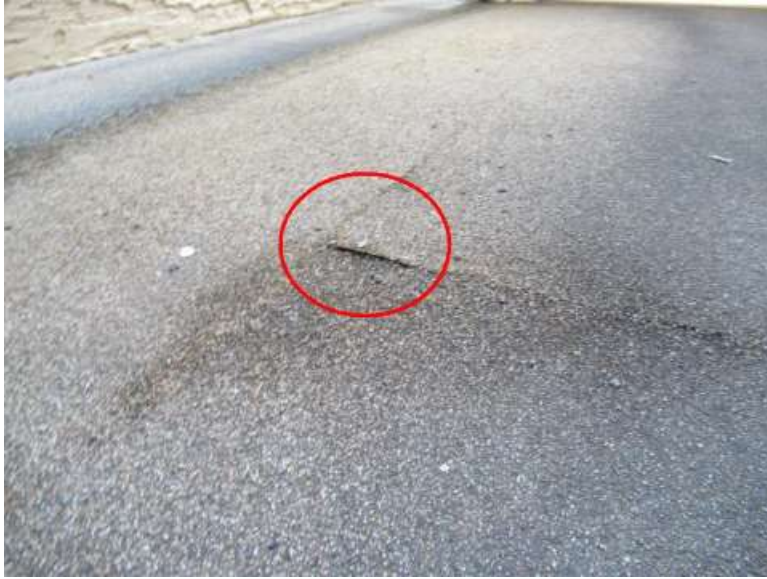
**Repair:** There are gaps noted along the lap joints and/or seams. Repair by a licensed roofing contractor is recommended.

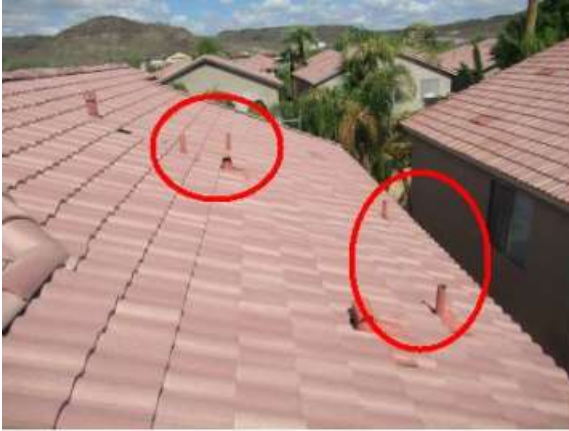
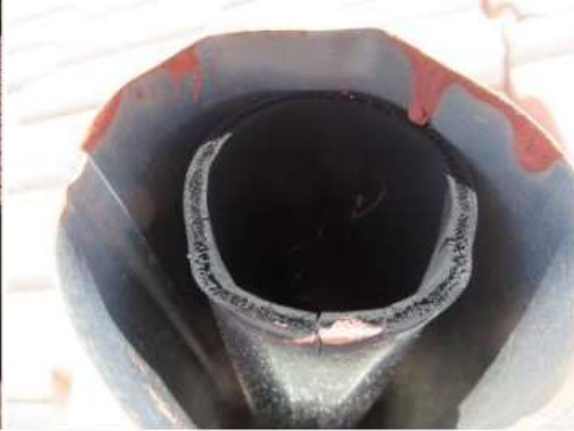
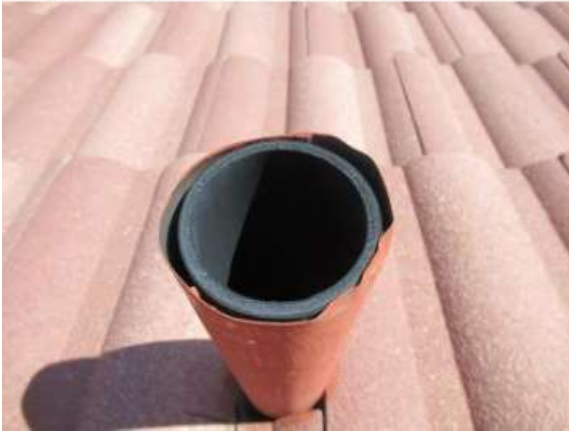
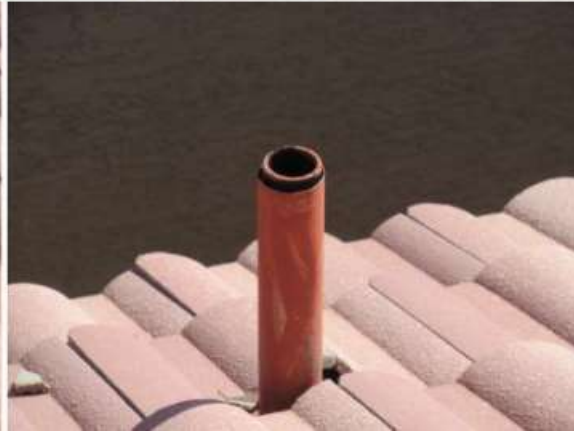
**Repair:** The flashing for the plumbing vents were never wrapped around the pipes as they should have been to keep water from getting under the flashing and needs to be repaired by a qualified contractor.

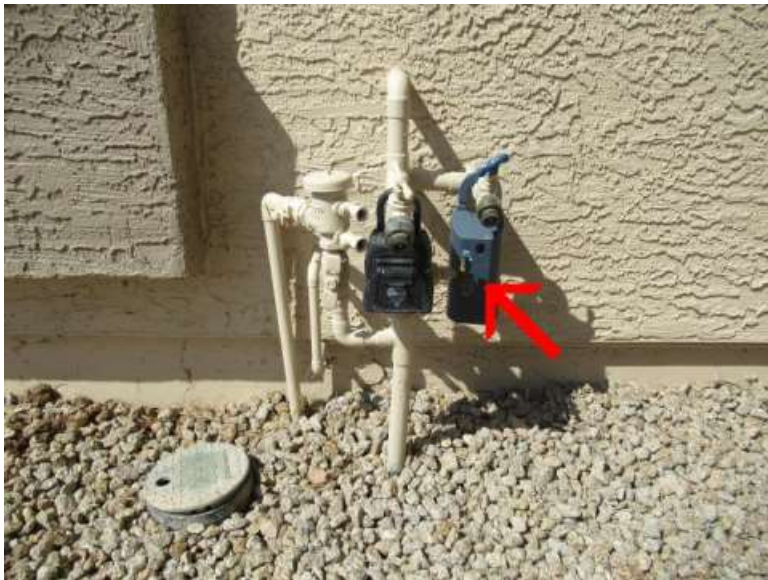
**Repair:** The old gate type main water valve is beyond reliable service life. Replacement by a licensed plumbing contractor is recommended.

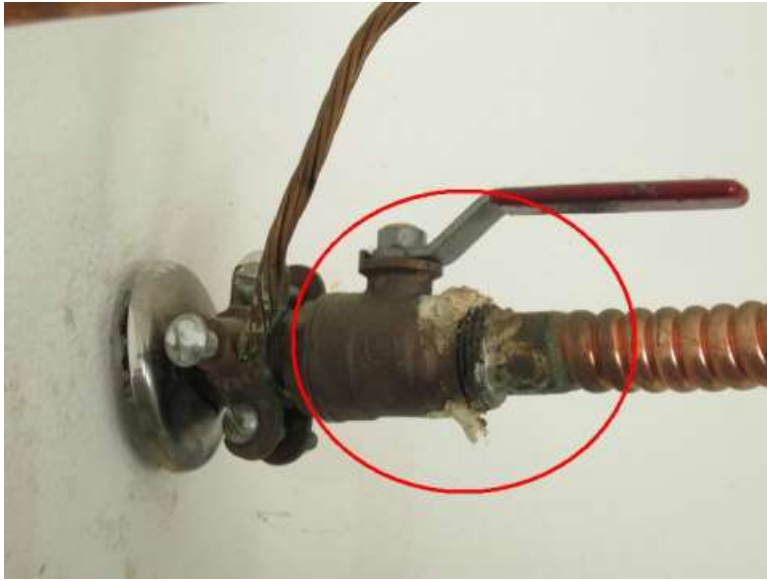
**Repair:** There is corrosion on the supply line connections just above the water heater indicating it was leaking.

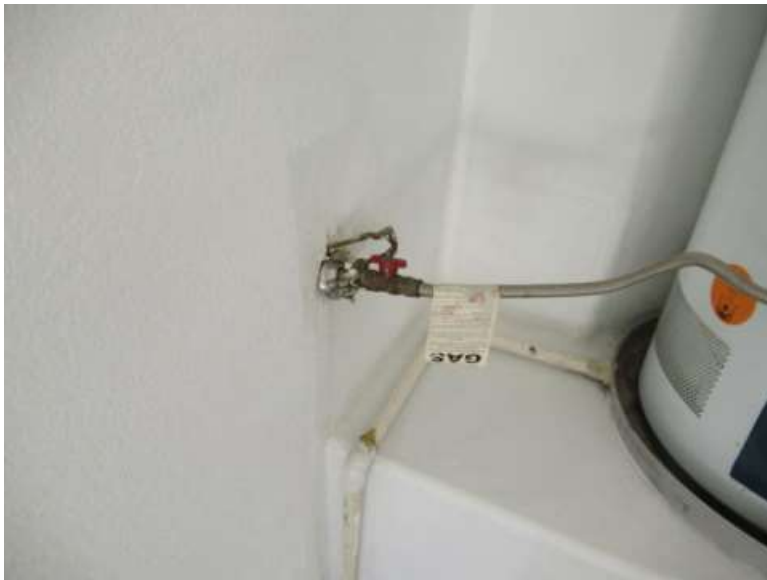
**Further Review:** There is no drip leg (settlement trap) installed at the water heater gas connection. It should be determined by checking with the manufacturer if a drip leg was required.

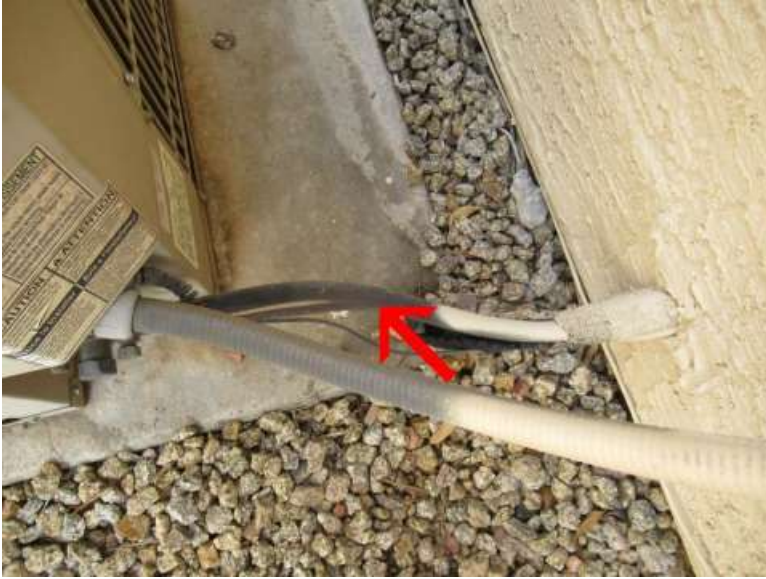
**Repair:** The refrigerant line is exposed at the south condensing unit. Repair by a licensed HVAC contractor is recommended.

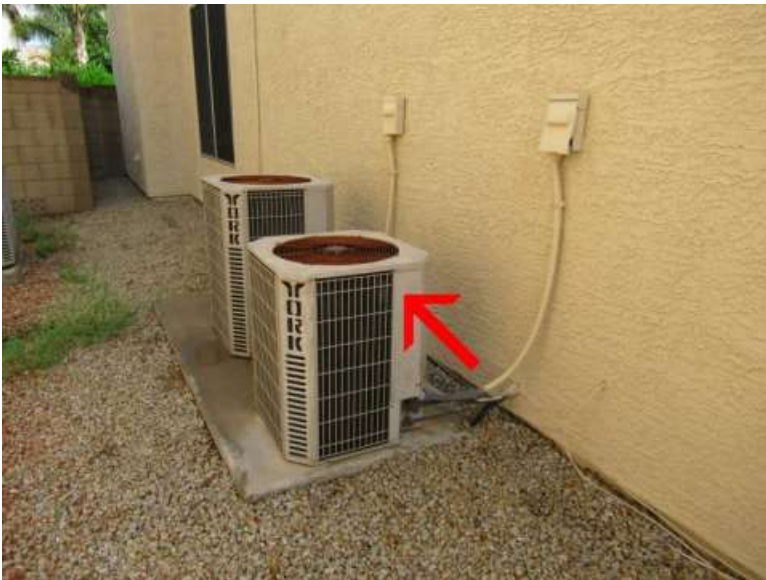
**Further Review:** The condensing unit serving the lower level was excessively noisy, the fan did not respond and the unit is excessively hot. Further evaluation, repair or replacement by a licensed HVAC contractor is recommended.

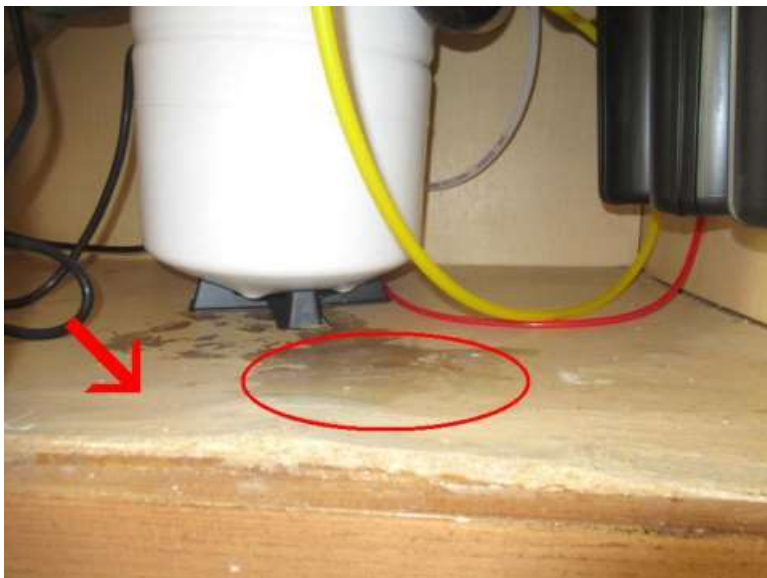
**Repair:** The kitchen cabinet floor is sagging and has moisture damage. Repair by a licensed contractor is recommended.

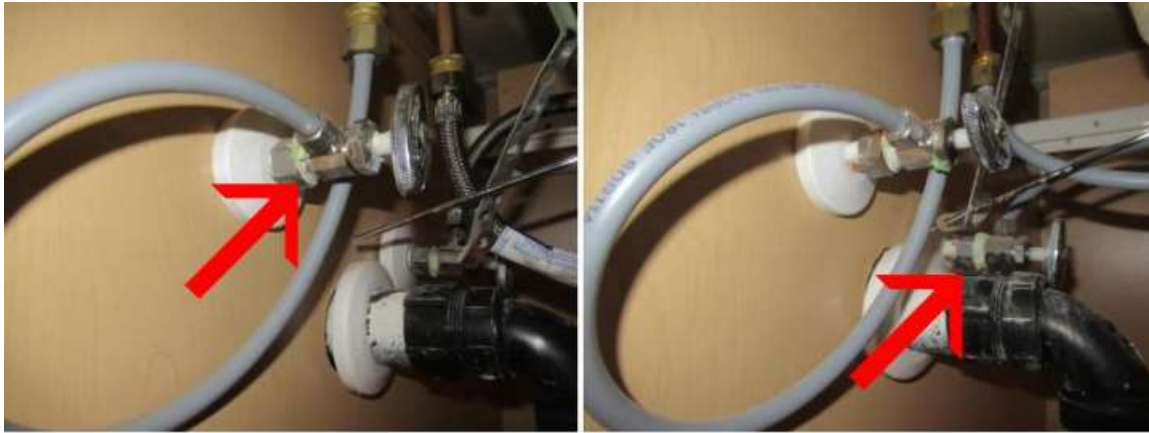
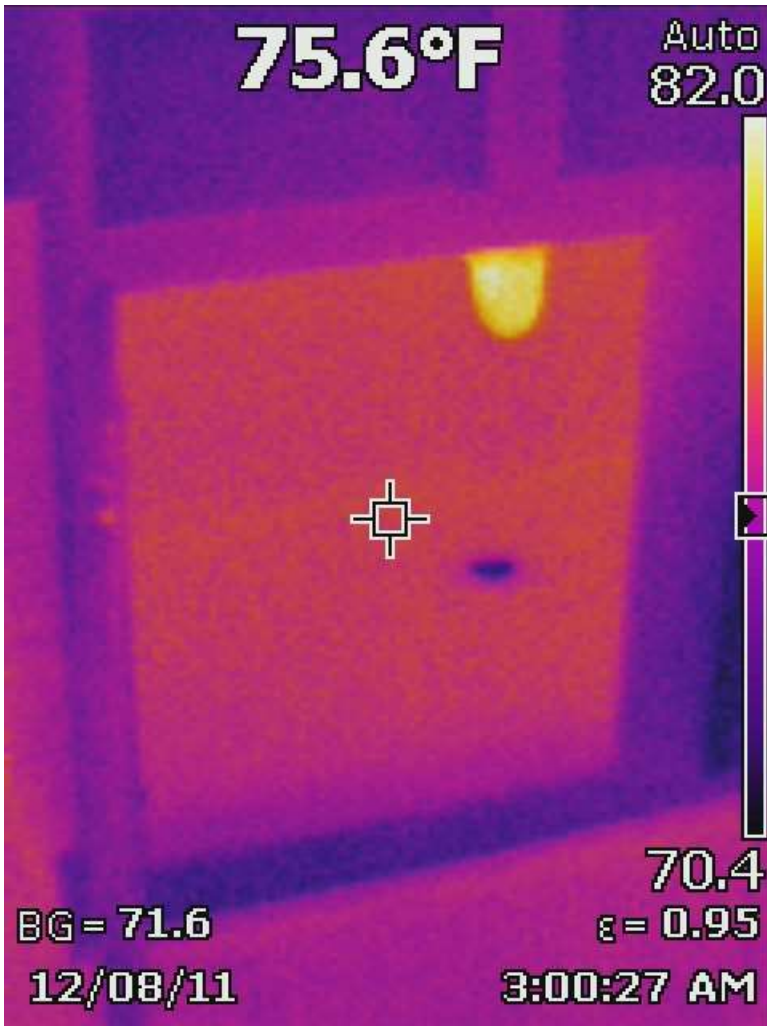
**Repair:** Water is leaking from under the master bathroom south sink at one of the drain connections and needs repair by a qualified contractor..

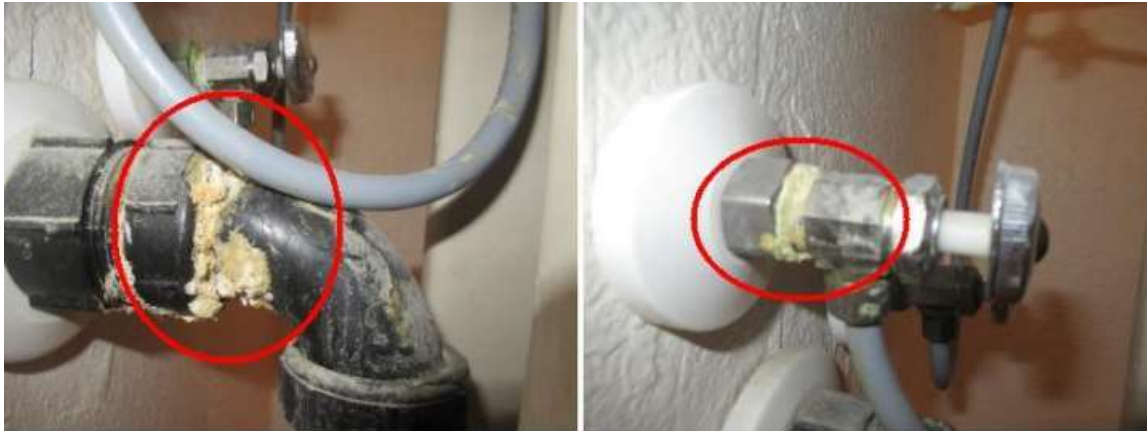
**Repair:** The powder room drain pipe and water supply valves are corroded. Repair by a licensed plumbing contractor is recommended.

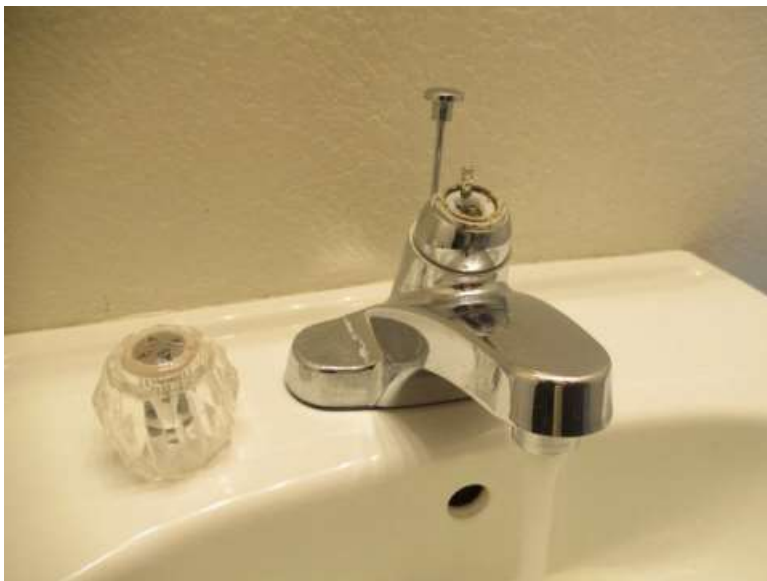
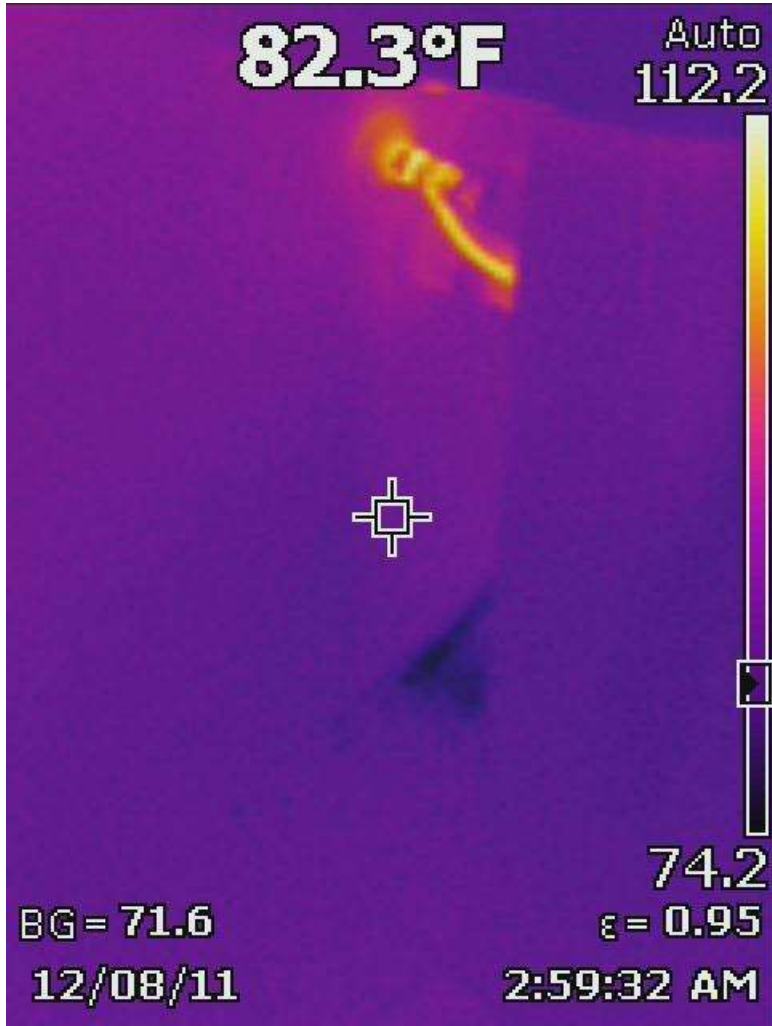
**Repair:** The powder room sink faucet handle is not installed. Installation by a licensed plumbing contractor is recommended.

**Repair:** Water is leaking from under the powder room sink at one of the drain connections and must be repaired by a qualified contractor..

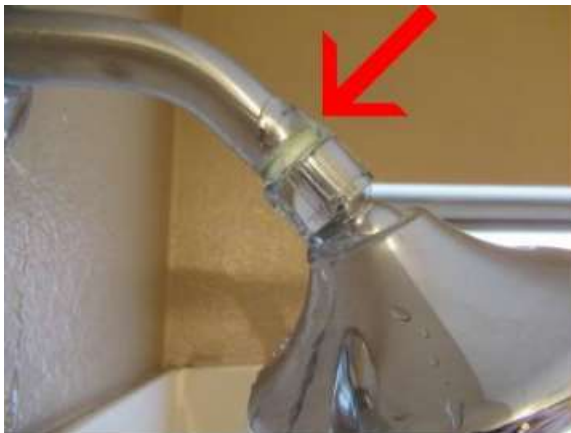
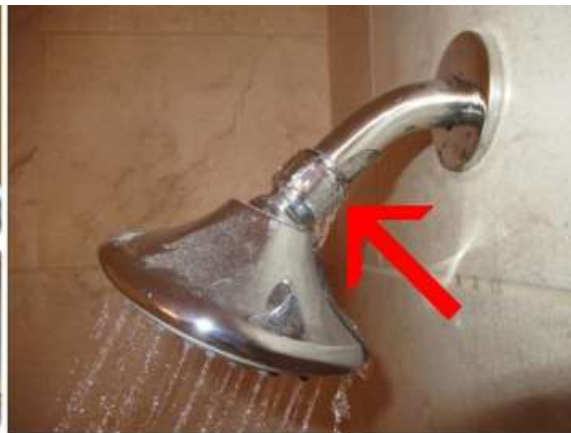
**Repair:** The guest and master bathroom shower heads are leaking. Repair by a licensed plumbing contractor is recommended.

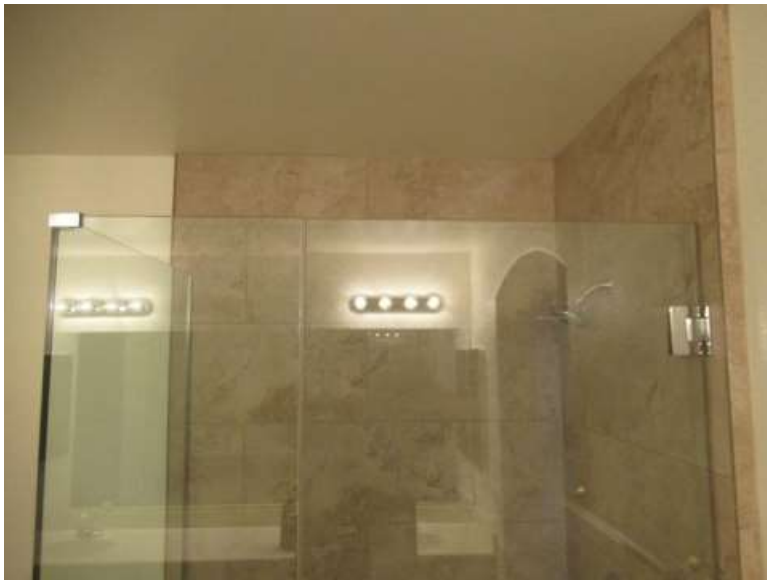
**Safety Concern:** The master bathroom shower wall is only supported on two sides. A third upper support should be installed. Installation by a licensed contractor is recommended.

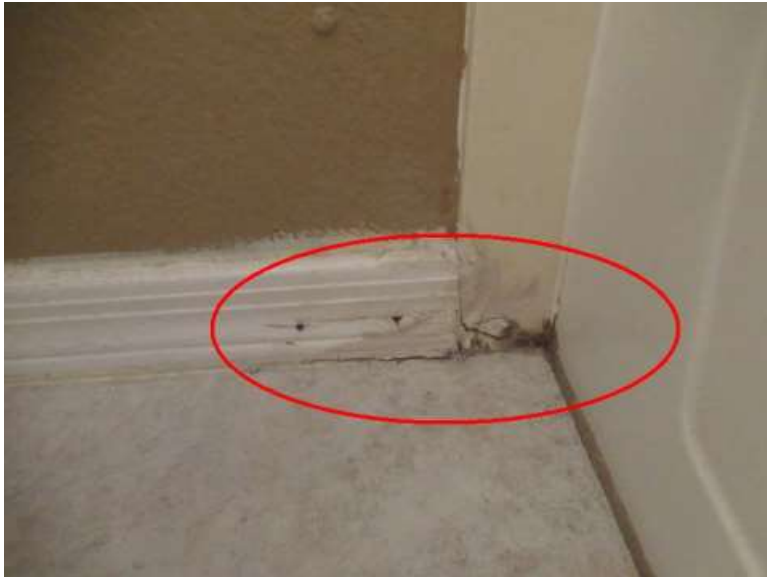
**Note:** There were repairs to the drywall, which is not unusual and should be disclosed by the seller.
