National Property Inspections

Sample Report , 123 Any Street, Anytown, USA,

Inspection Date :
9/7/2008

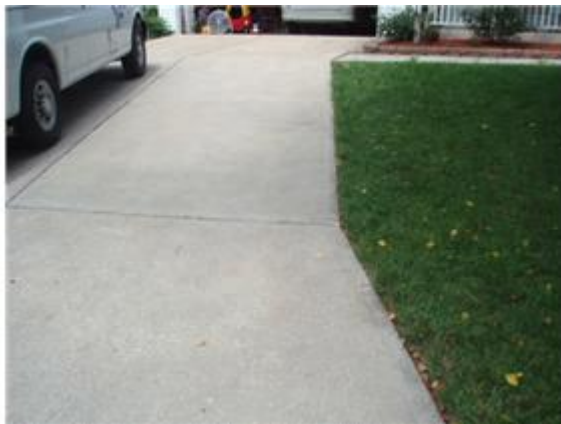
Comments : Drive is concrete in good condition for age of home.

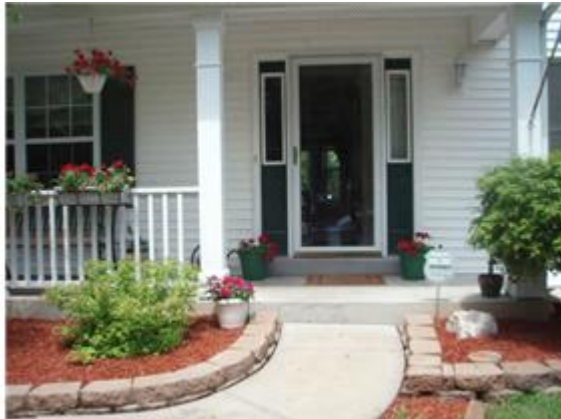
Comments : Concrete front porch in good condition.

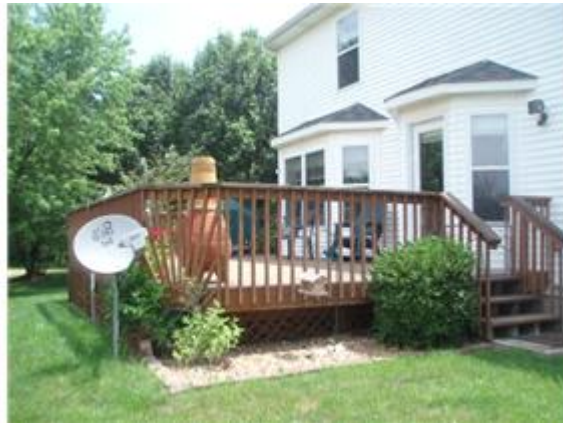
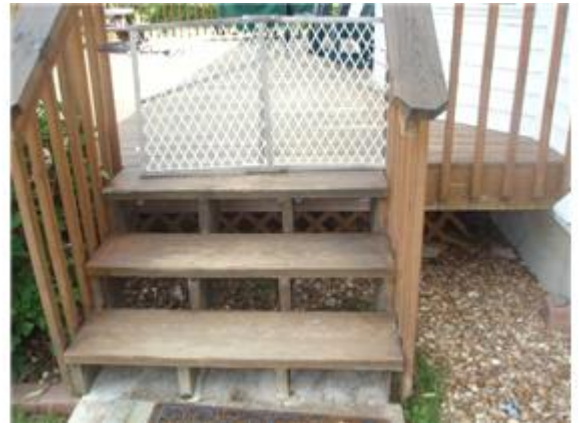
Comments : Rear deck is treated wood in good condition. Recommend stain/seal annually to preserve material.

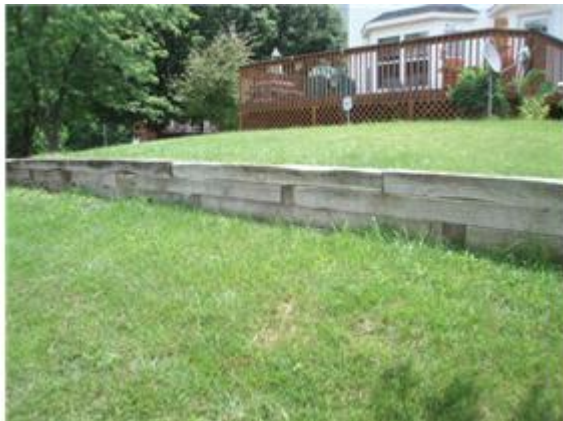
Comments : Wood timber retaining wall in the rear yard in good condition.

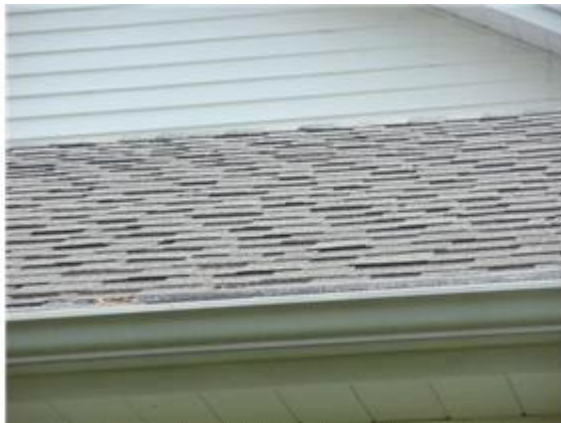
Composite shingles over 1/2" thick wood sheathing.
All penetrations such as plumbing vents are correctly flashed and sealed.

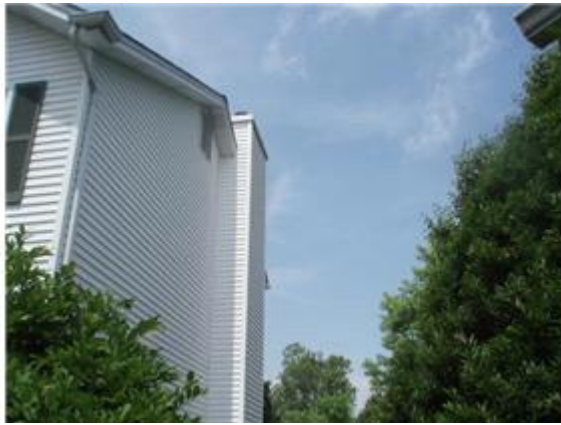
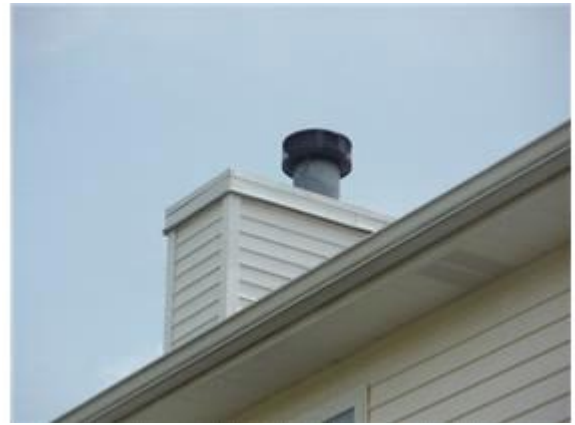
Framed metal chimney for wood burning fireplace on main level with gas logs installed. Proper rain cap and spark arrestor screen installed.

Comments : Flue not inspected. Annual cleaning is recommended.

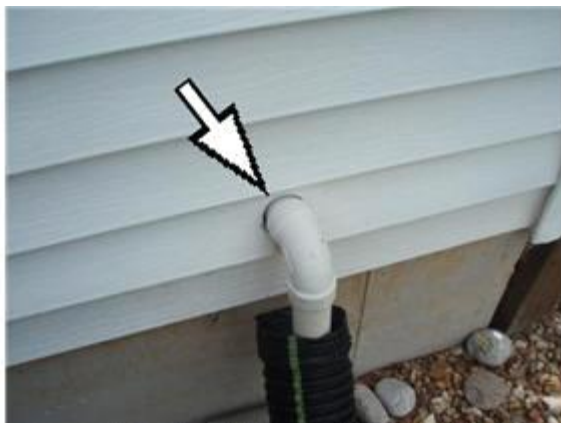
Comments : Vinyl siding in good condition.

Seal wall penetration for sump pump discharge pipe to prevent weather and insect intrusion.

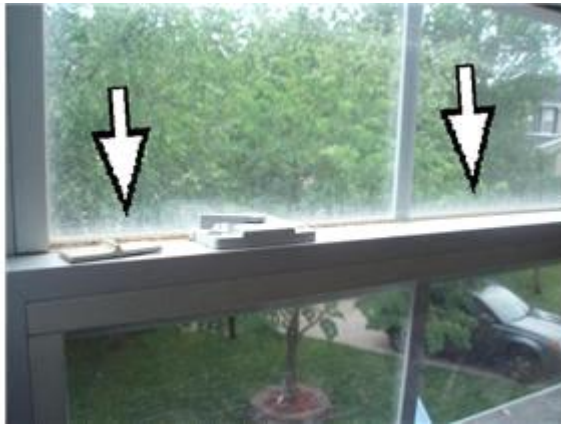
Approx 6-8 windows thru out the home are showing early signs of leaking seals in the upper sash. Also the fixed panel in the Master Bathroom. I recommend repairs as needed by a qualified window contractor.

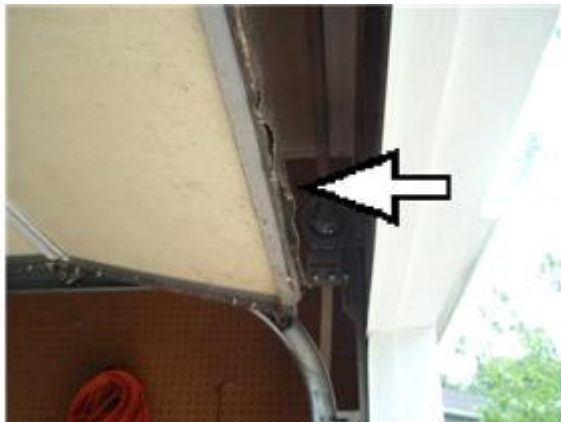
Comments : Photo eye reverse works OK. Manual jam reverse does not operate properly. Recommend adjustment, repair or replacement of the opener by a qualified garage door technician. The rubber seal on the bottom of the overhead door is deteriorated and should be replaced.

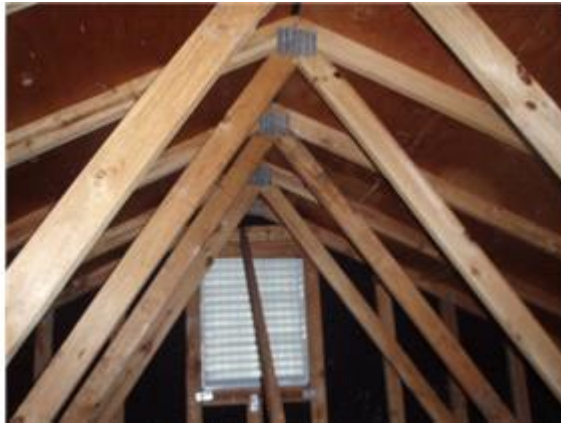
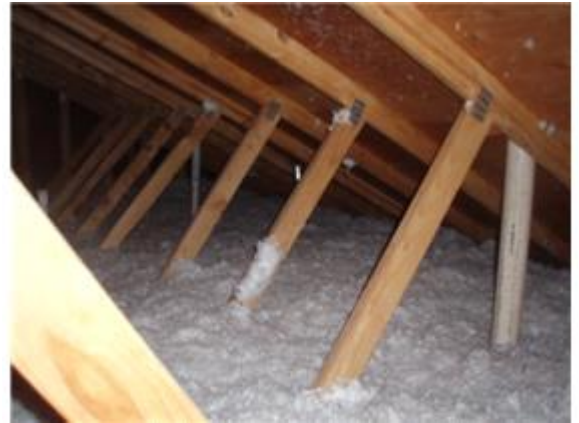
Roof is constructed of engineered trusses.
 Interior walls are 2 x 4 wood frame construction.
 Exposed exterior wall is 2 x 4 wood with F/G batt type insulation.

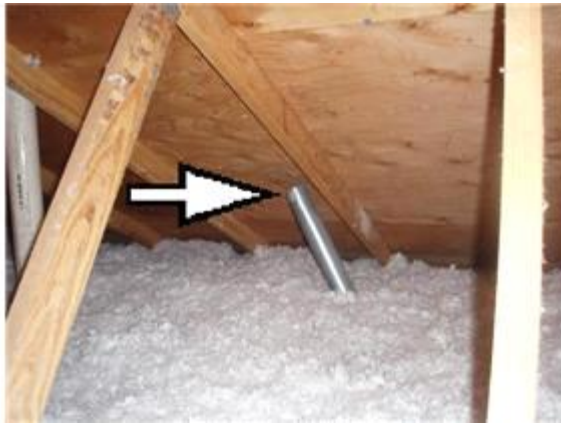
Comments : No insulation or vapor retarders over garage area.
Proper venting into attic. No additional vents recommended.

Exhaust fan for both bathrooms on upper floor exit into attic space. Recommend going thru roof, route to gable vents, or to static vents to prevent moisture accumulation on roof sheathing.

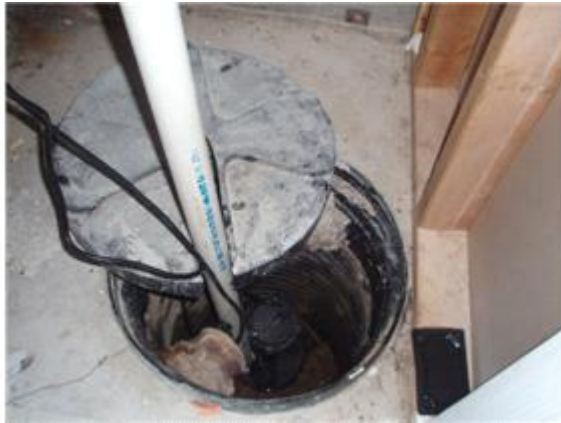
Comments: Sump had water in it. Pump motor worked when tested. Cover in place.

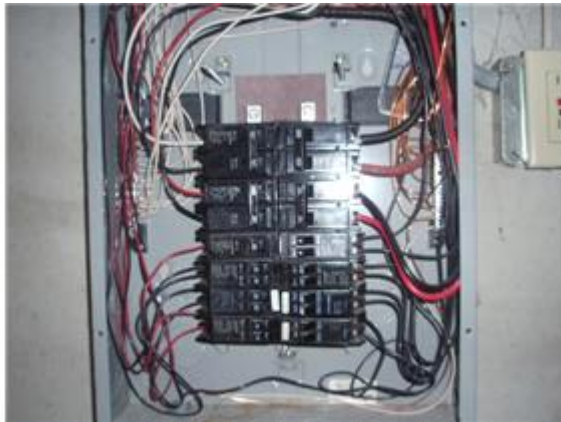
Comments : ***Smoke Detectors / GFCI's checked with test button only. Monthly Test Recommended.**
 Wiring consists of romex type.

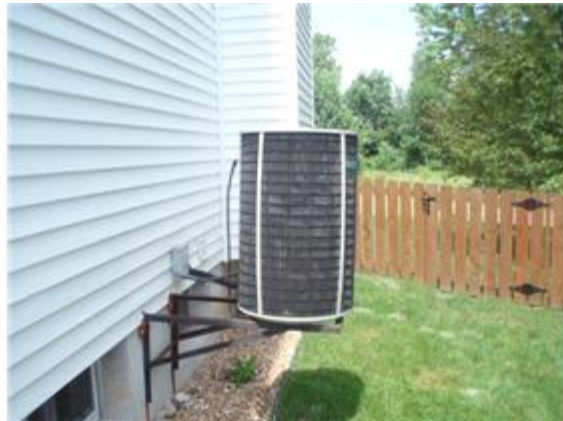
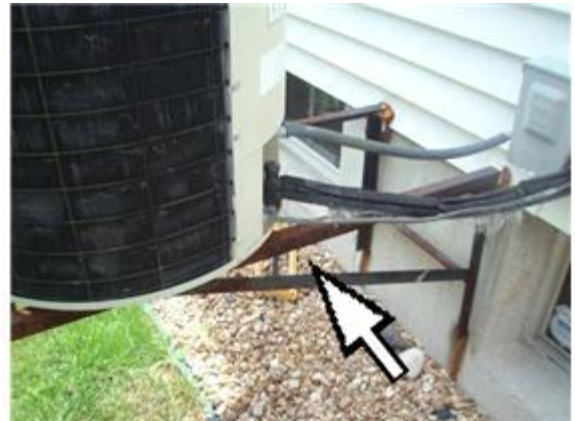
Comments : Temperature differential within industry standards. 20 deg drop.
 Recommend scrape and paint the metal angle supports to prevent further rusting.

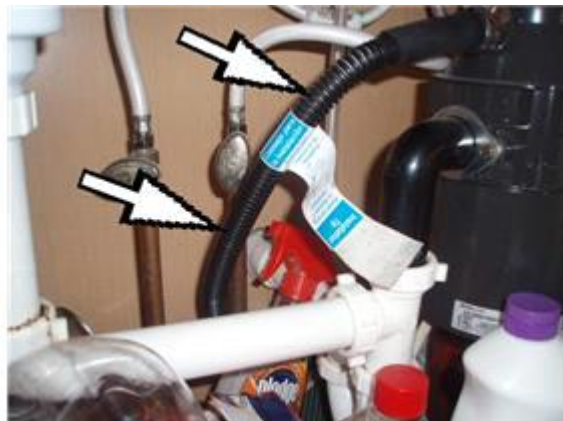
Comments : Ceiling structure is supported by upper level floor joists.
 Wall structure is 2 x 4 wood construction covered with drywall.
 Dishwasher drain hose should be secured in manner to be above lowest sink level to prevent backflow of sink into dishwasher. Recommend attaching drain hose higher under sink.
 No anti-tip bracket installed for stove.

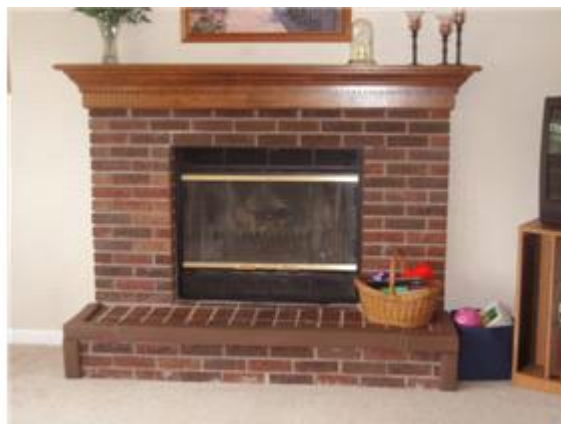
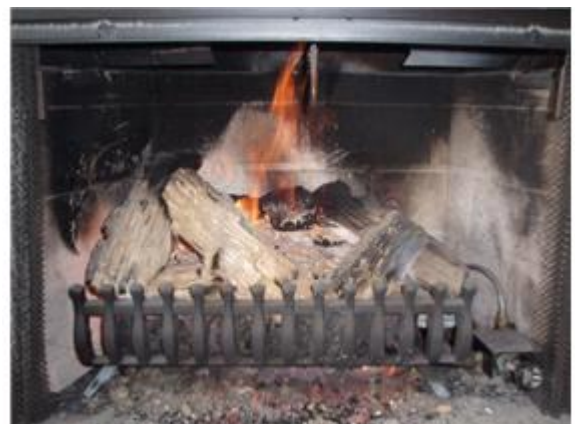
Fireplace is metal box type construction with metal flue and chimney. Gas logs in place worked as designed.

Comments : Recommend annual cleaning - Fireplace design and soot / creosote buildup, in most cases, prevents view of chimney liner / cracks.

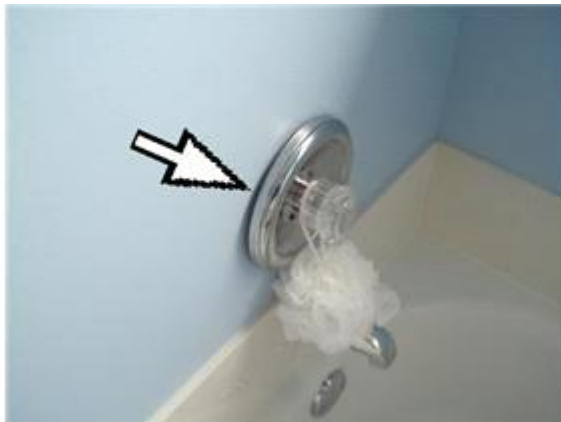
Comments : Ceiling structure is supported by wood trusses.
 Wall structure is 2 x 4 wood construction covered with drywall.
 Tub faucet cover plate is not sealed to the wall. Position plate to prevent water intrusion behind the wall.

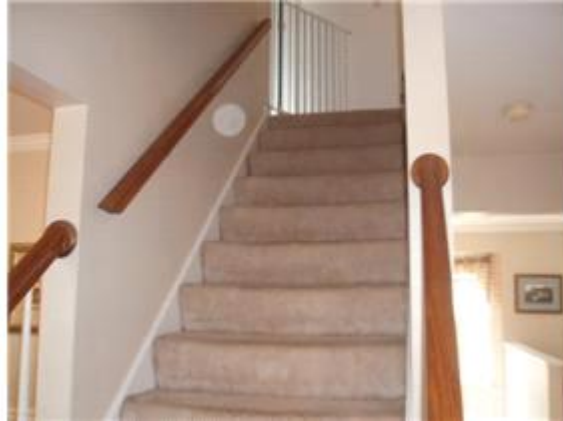
Comments : Open stairwell to upper level in good condition.

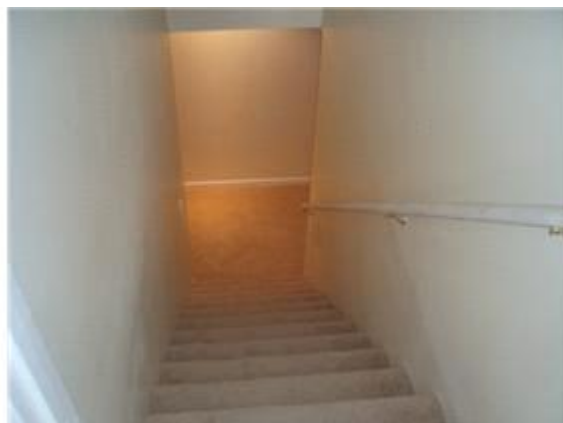
Comments : Closed stairwell with handrailing and door at the top to lower finished level. All in good condition.
