National Property Inspections

Mr. and Mrs. Jones, 1715 Beach Dr., Oak Island, NC, 28465

Saturday, June 30, 2018

GENERAL INFORMATION

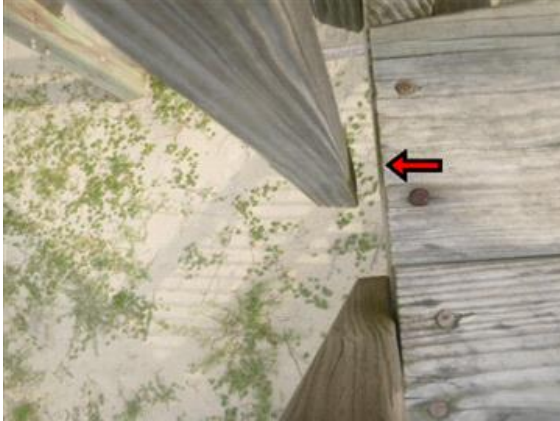
There is a loose baluster on the rear upper stairs on the left hand rail. See photo. Evidence suggests this condition has created a safety hazard. Recommend a qualified contractor to evaluate and make the necessary repair.

Loose Baluster

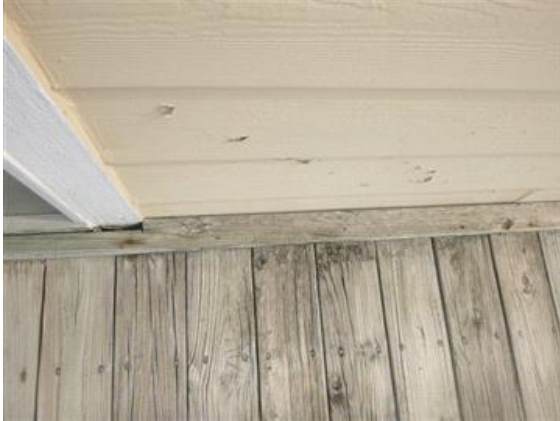
There was no visible flashing between the deck and the house connection. It may be there but it is not readily visible. Recommend a licensed general contractor to evaluate and determine that flashing is present and if not, make the necessary repair.

Board Over Deck Connection To The House

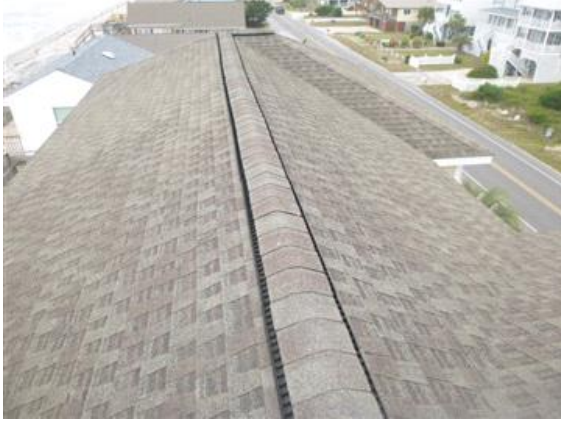
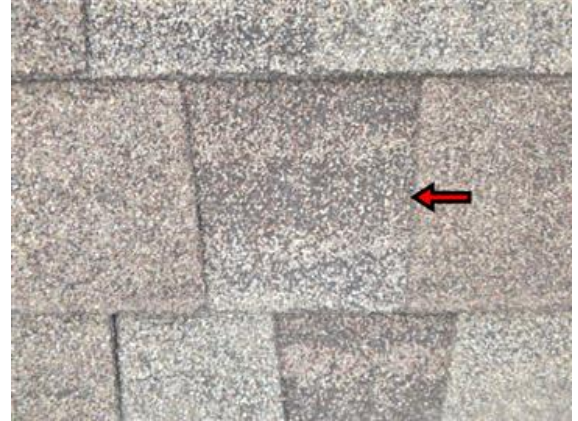
NOTE: There is minor granular loss on the shingles. See photo. This is typical of an aging roof, especially in an ocean environment. Over the next several years monitor the roof for any worsening of the granular loss and if necessary, have a qualified roofing contractor to evaluate the overall condition of the roof.

Minor Granular Loss

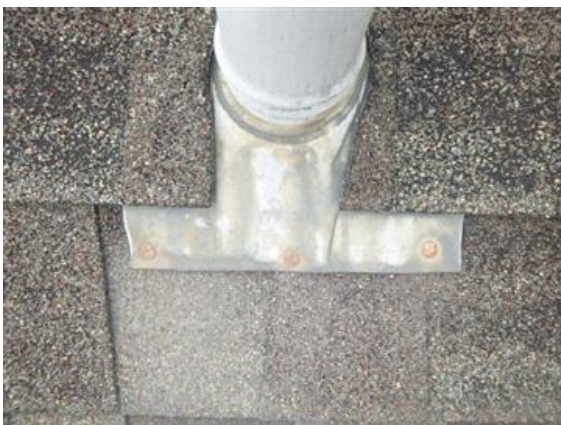
The PVC plumbing vent pipes have a lead flashing covering them which will help prevent the PVC vent pipes from getting brittle and cracking from exposure to the sun. The bottom of the front plumbing vent lead flashing has exposed nail heads. See photo. Evidence suggests this condition can create an avenue for water intrusion. Recommend a qualified roofing contractor to evaluate and make the necessary sealing repair.

Exposed Nail Heads

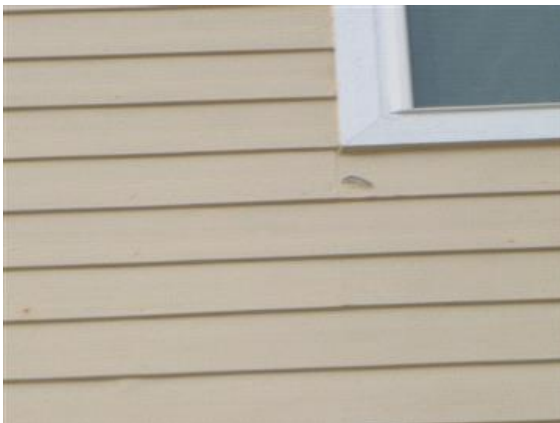
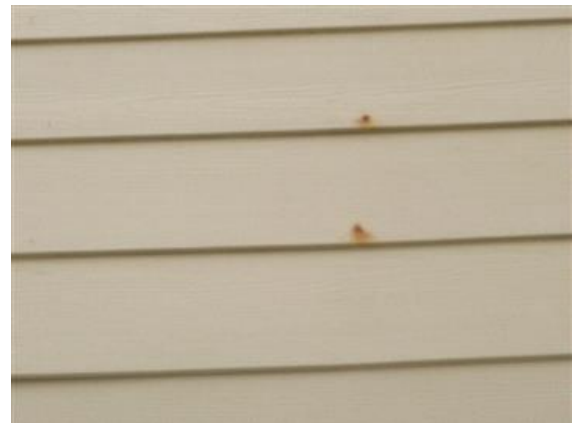
- 2) There are areas of chipped/peeled paint and rusted nail heads throughout the siding, in particular on the ocean facing side of the house. See photos. Evidence suggests the salt air can decay the composite material and the rusted nails can loose their fastening strength. Recommend a qualified painting contractor to evaluate and make the necessary repairs.

Rusted Nail Heads

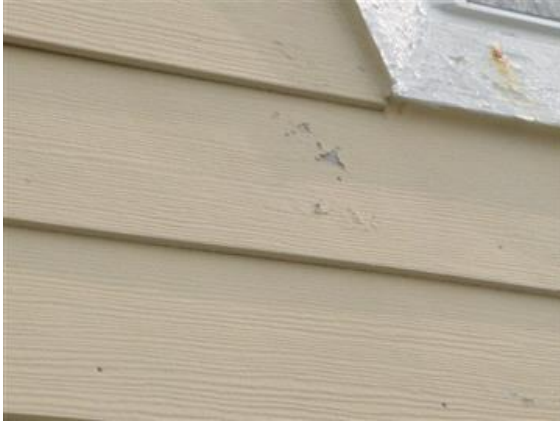
Chipped/Peeled Paint

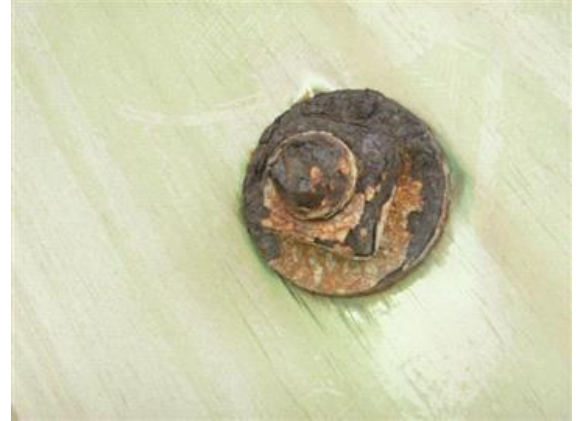
- 3) Most of the bolts/nuts used to fasten the piling bracing and the porch/deck framing are heavily corroded. See photo. Evidence suggests it is hard to determine the full extent of the corrosion. Recommend a licensed general contractor to evaluate the bolting and make an necessary repairs. Also determine the best way to minimize future corrosion.

Typical Heavily Corroded Bolt/Nut

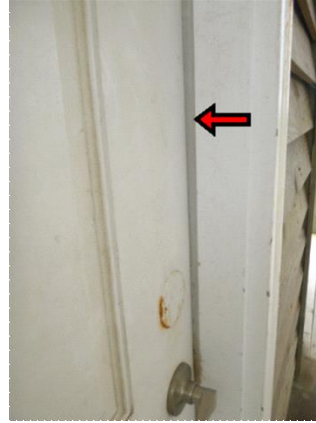
The entry door to the storage room is missing locking hardware (dead bolt and handle lock) and the door is not closing against the door frame properly, indicating it may not be hanging squarely in the frame. See photos. Evidence suggests the security of the door is compromised. Recommend a qualified contractor to evaluate and make the necessary repairs.

Storage Room Door Not Closing Properly

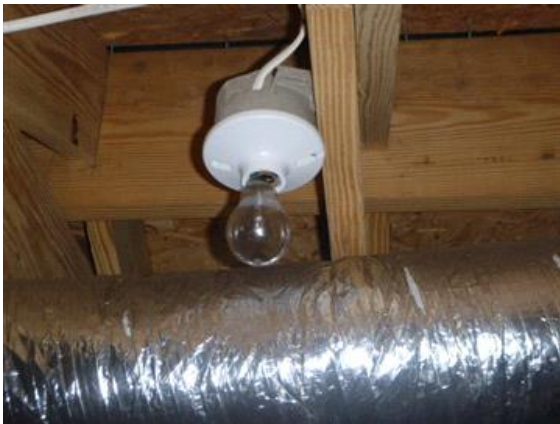
Service Light Out

Suggest changing the bulb first, and if it still does not work, recommend a licensed electrician to evaluate and make the necessary repair.

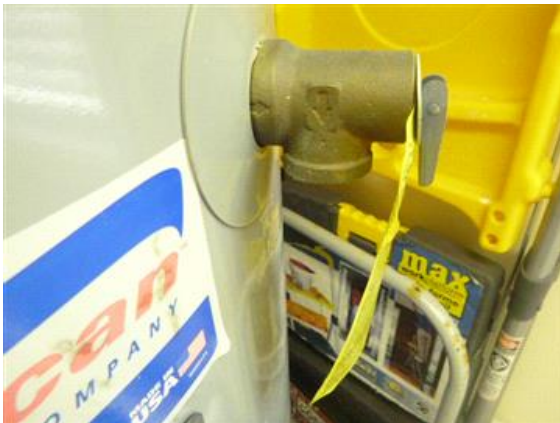
No T/P Relief Valve Extension

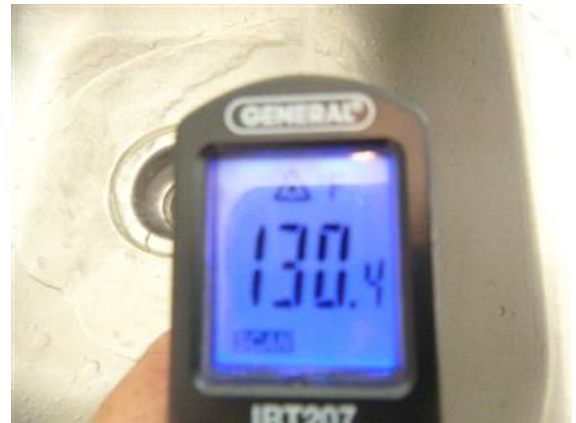
- 1) The water temperature appears to be set too high at 130 degrees. Water at this temperature could cause scalding to the skin if left under the water for approximately 30 seconds. Recommend a licensed plumber to evaluate and make the necessary adjustment or repair to turn the temperature down to the manufacturers recommended setting of 120 degrees.
- 2) The T/P relief valve on the water heater is missing the extension pipe that is needed to divert the hot water down and away from harm's way in the event the safety valve opens. See photo. Recommend a licensed plumber to evaluate and make the necessary repair.
- 3) Due to the age of the water heater, recommend having a licensed plumber to evaluate the overall condition, in order to plan for any future repairs or replacement.

Hot Water Temperature

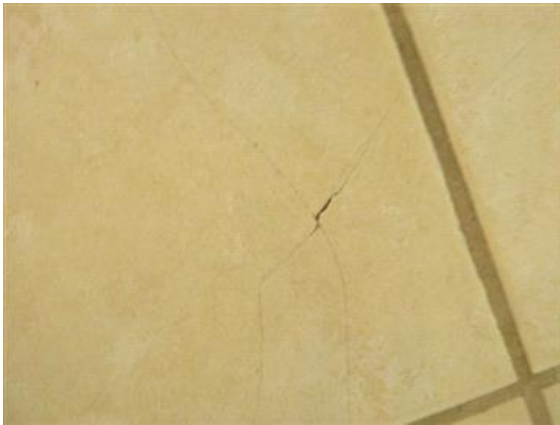
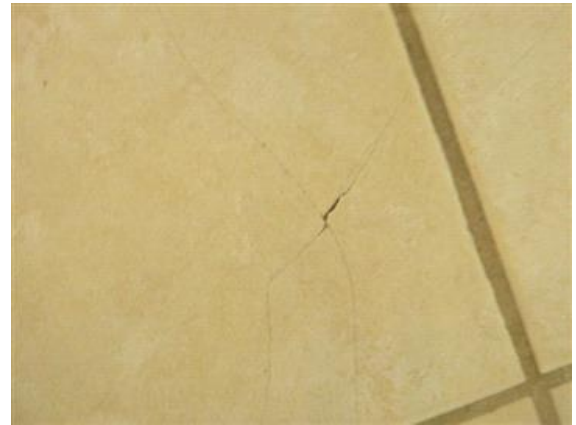
- 2) The tile floor has cracks present at several areas. See photo. Recommend a qualified tile flooring contractor to evaluate this condition and make any necessary repairs.

Cracked Floor Tile

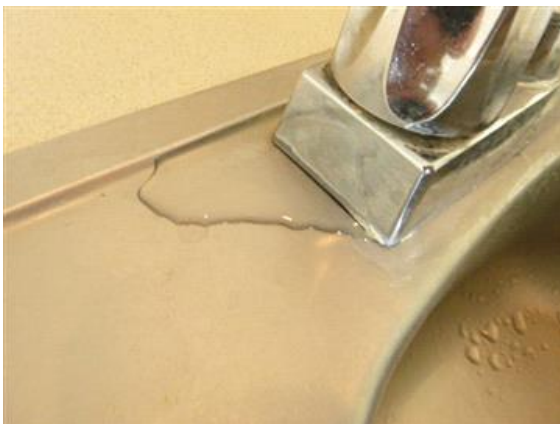
- 3) When turning the bar sink cold water on, there is a leak on top of the sink from the fixture. See photo. Evidence suggests this condition can lead to water intrusion into the cabinet below. Recommend a licensed plumber to evaluate and make the necessary repair.

Leak At Bar Sink Fixture

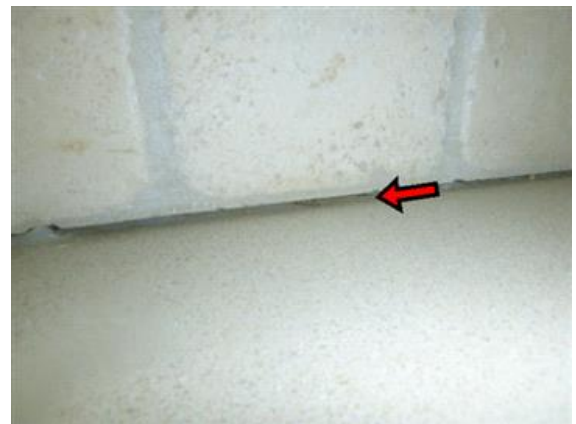
- 4) There is an open calking/grout joint where the countertop and the back splash meet. See photo. Evidence suggests this condition has created an avenue for water intrusion. Recommend a qualified contractor to evaluate and make the necessary repair.

Open Calking/Grout Joint Countertop Back Splash

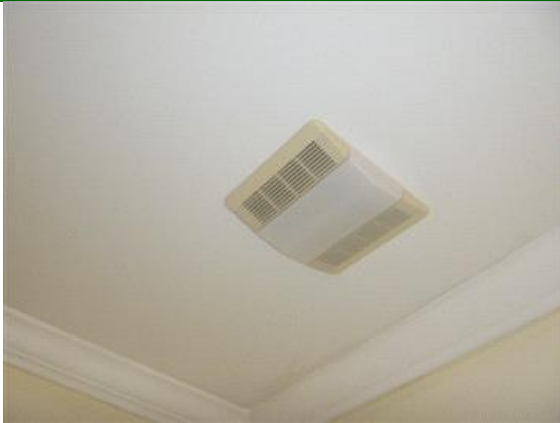
The light inside of the exhaust fan does not come on when turning on the wall switch. See photo. Suggest replacing the bulb **first** and if it still does not work, recommend a licensed electrician to evaluate and make the necessary repair.

Exhaust Fan Light Out

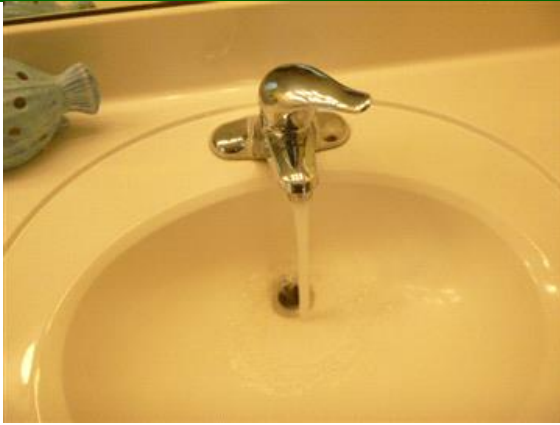
- 2) The right sink is missing the stopper. See photo. Evidence suggests the sink basin can not be filled. Recommend a licensed plumber to evaluate and make the necessary repair.

No Sink Stopper

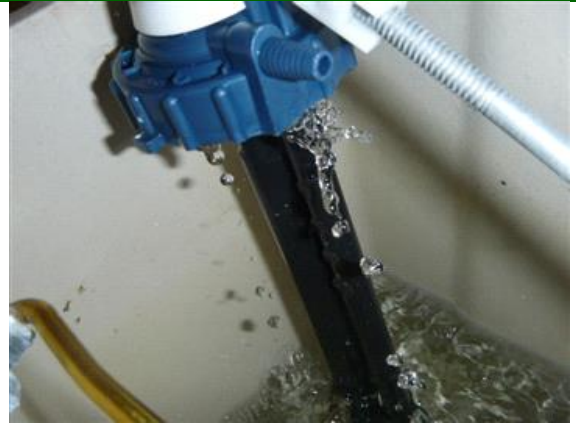
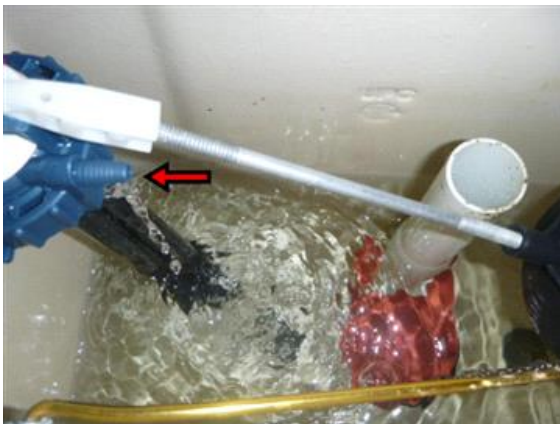
- 3) The toilet fill valve, located inside the tank, had water spraying out from the bottom side of the fill valve assembly when the toilet was flushed and the fill tube is missing. See photo. The toilet fill valve assembly does not function as intended and is in need of evaluation and replacement by a licensed plumber.

Leak At Bottom Of Toilet Fill Valve

Missing Toilet Fill Tube

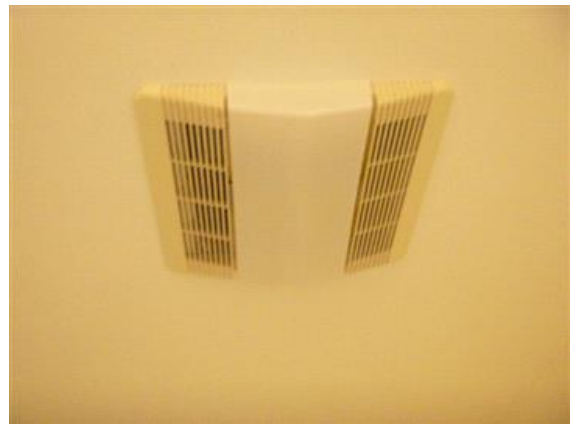
- 4) The light inside of the exhaust fan does not come on when turning on the wall switch. See photo. Suggest replacing the bulb **first** and if it still does not work, recommend a licensed electrician to evaluate and make the necessary repair.

Exhaust Fan Light Out

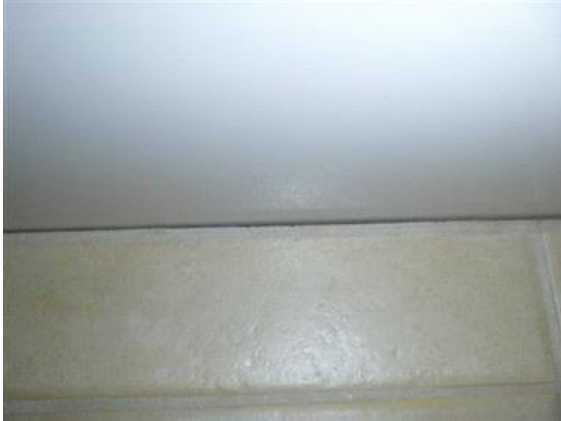
- 1) The bathroom tile floor grout seam, located along the bathtub, is open. See photo. Evidence suggests this condition creates an avenue for water intrusion. Recommend a qualified contractor to evaluate and make the necessary repair.

Open Floor Grout Joint at Tub

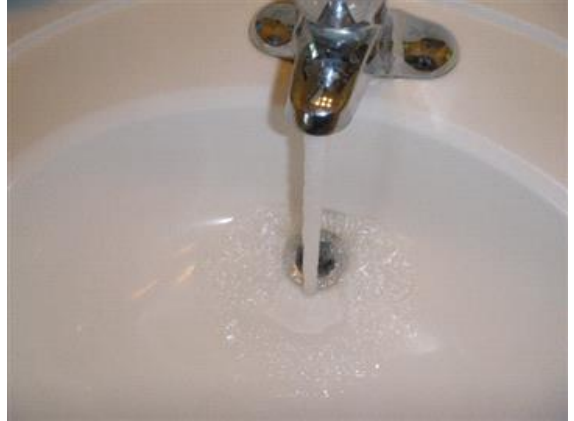
- 4) The sink is missing the drain stopper. See photo. The stopper is needed to fill the sink basin and to prevent items from accidentally going into the drain. Recommend a licensed plumber to evaluate and make the necessary repair.

No Sink Stopper

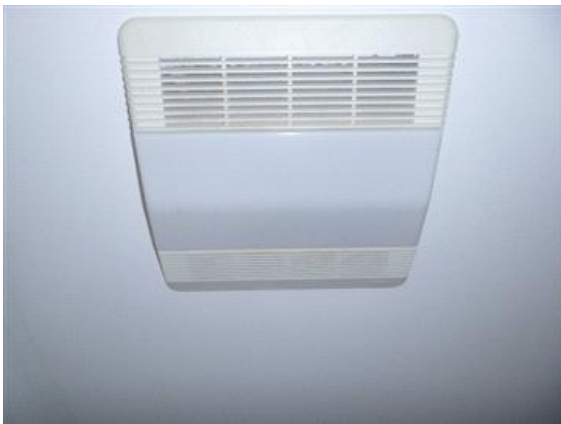
- 3) The light inside of the exhaust fan does not come on when turning on the wall switch. See photo. Suggest replacing the bulb **first** and if it still does not work, recommend a licensed electrician to evaluate and make the necessary repair.

Exhaust Fan Light Out

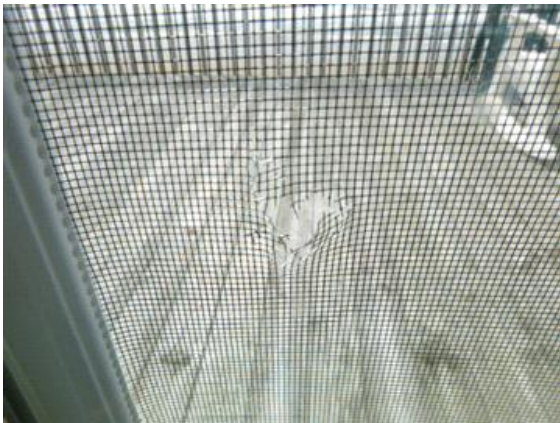
The following window and screen defects were observed; the left rear window is stuck shut, the left rear window screen is damaged, the third from the left rear window is difficult to close due to coming down unevenly in the frame and the right and left side windows slam shut when opened. Evidence suggests the defective windows have created a safety hazard. All windows are required to be operational for emergency egress. Recommend a qualified window contractor to evaluate and make the necessary repairs.

Hole In Window Screen

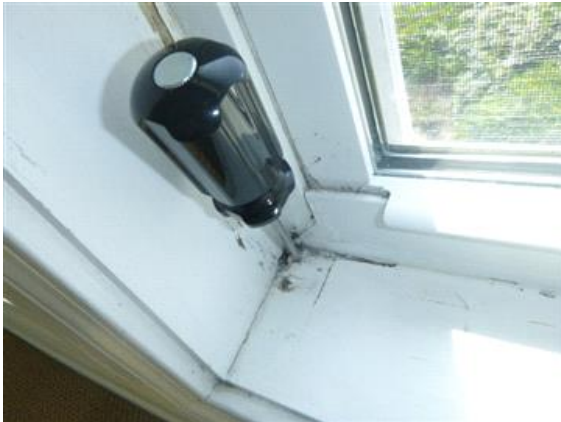
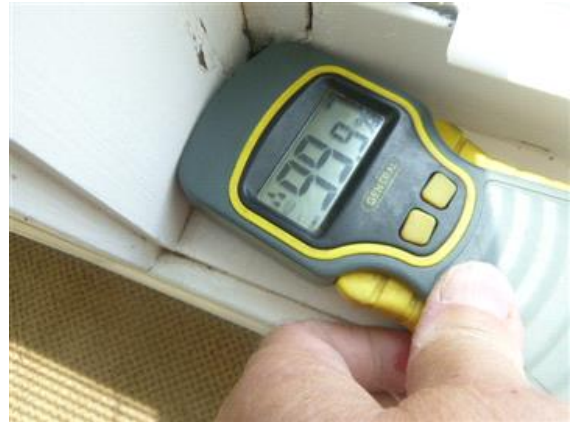
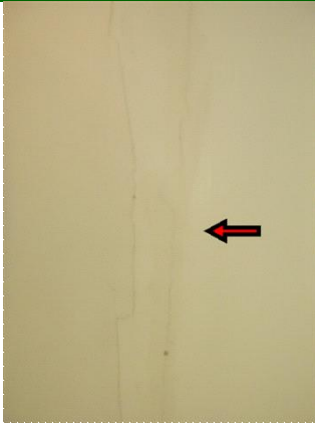
The right rear window sill has slight wood decay present in the left corner and there is a damaged area of drywall under the window frame. A moisture meter test produced a high reading, suggesting there is an active leak present. Recommend a qualified contractor to evaluate and determine the cause of the leak, determine the extent of damage and make the necessary repairs.

Decayed Window Sill Wood

High Moisture Meter Reading

Damaged Drywall Under Right Window

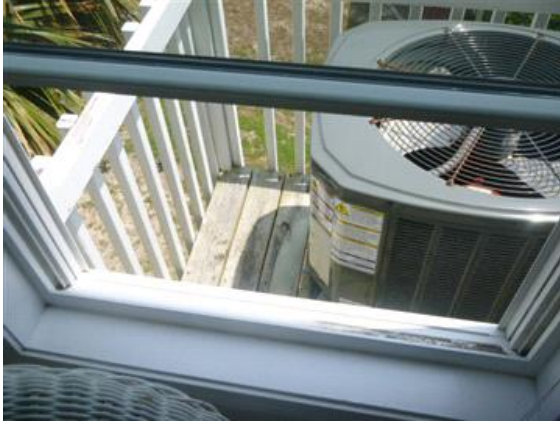
- 1) The side window screen is missing. Evidence suggest this condition does not allow the window to be used for ventilation without letting insects into the room. Recommend a qualified window contractor to evaluate and make the necessary replacement.
- 2) The entry door is hitting the tile floor, making it difficult to open and close. Evidence suggests the door needs adjustment to open and close freely. Recommend a qualified contractor to evaluate and make the necessary repair

Missing Screen

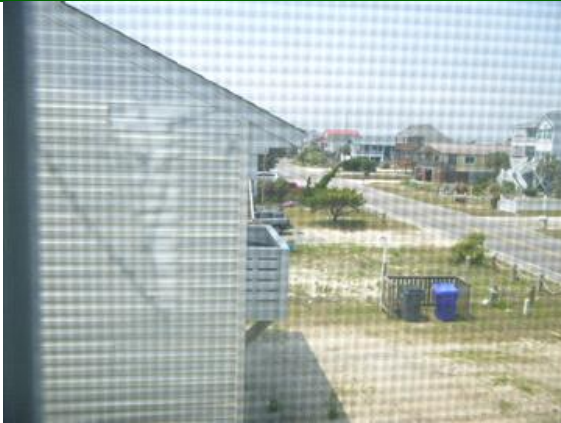
The side window screen is damaged. See photo. Evidence suggests the damaged screen creates an avenue for insects to enter the room. The window screen does not function as intended and is in need of repair or replacement by a qualified window contractor.

Damaged Window Screen

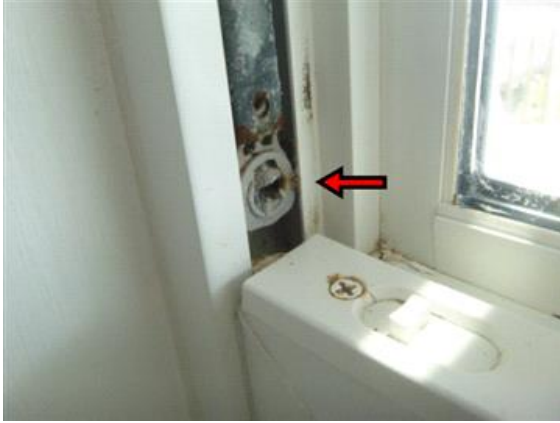
The left rear window, left sash cord is stuck and the window will not open and the side window slams shut. Evidence suggests the windows do not function as intended and have created a safety hazard. All windows are required to be operational for emergency egress. Recommend a qualified window contractor to evaluate and make the necessary repairs.

Sash Cord Mechanism Stuck
