National Property Inspections

Jack & Jill Hill, 62 Button Ct, Southport, NC, 28461

Inspection Date:
06/30/2018

GENERAL INFORMATION

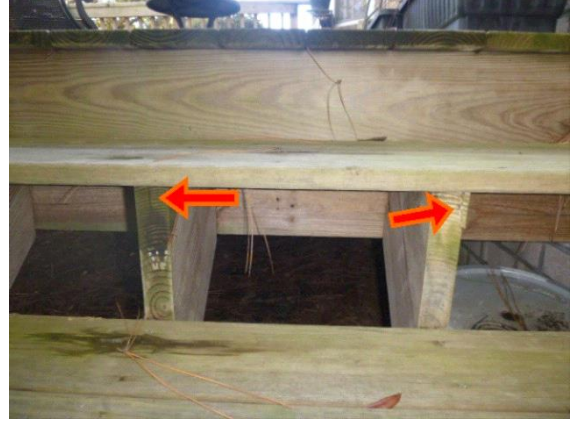
1. The wood stairs leading up to the rear wood deck have multiple cracks in the stair stringers. See photos. Evidence suggests this condition creates a safety hazard.
2. The wood step located on the left side of the house, at the garage side entry door, is loose when operating. See Photo. Evidence suggests this condition creates a safety hazard.

Walks / Steps: View of one location of cracked staircase stringers

**Recommend a licensed general contractor evaluate items 1 and 2 and make the necessary repairs.

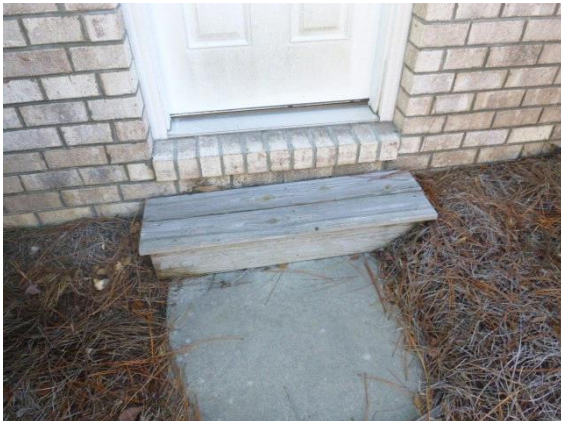
Walks / Steps: View of loose wood step at left side

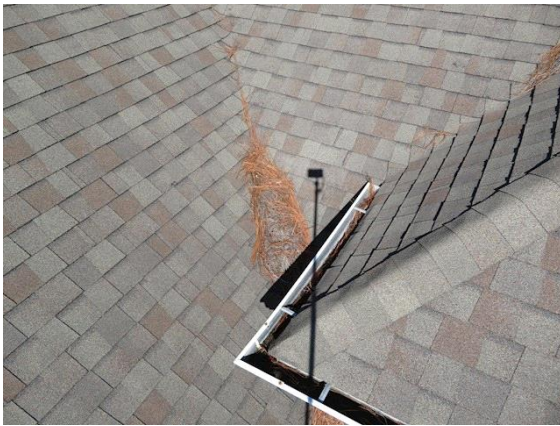
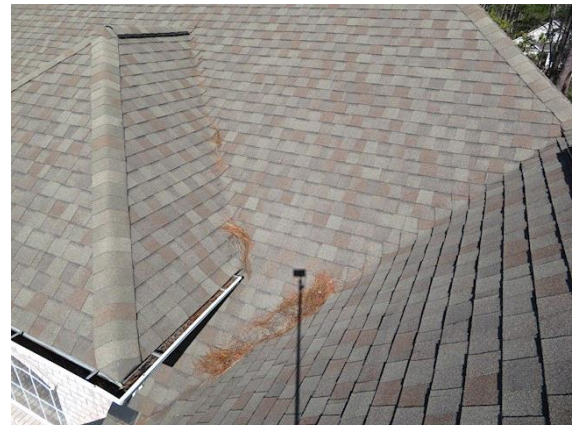
The roof valleys have excessive debris present. See Photos. Evidence suggests this condition will inhibit water from draining off of the roof and into the gutters and downspouts properly. Recommend a qualified contractor evaluate and make the necessary repairs.

Flashing/Valleys: View of one location of debris in roof valleys

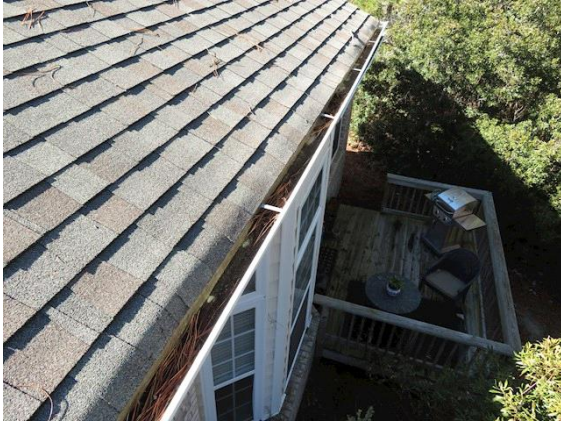
1. Several areas of the gutters are filled with debris. See Photos. Evidence suggests this condition is inhibiting water draining off the roof, and flowing through the gutters and down spouts properly.
2. There are no splash blocks or extension hoses present on many of the downspouts. See photos. Small holes are starting to form in the ground at the bottom of the downspouts and evidence suggests this condition will inhibit water from draining away from the foundation. **Recommend a qualified contractor evaluate items 1 and 2 and make the necessary repairs.

Gutters/Down Spouts: View of debris inside the roof gutters

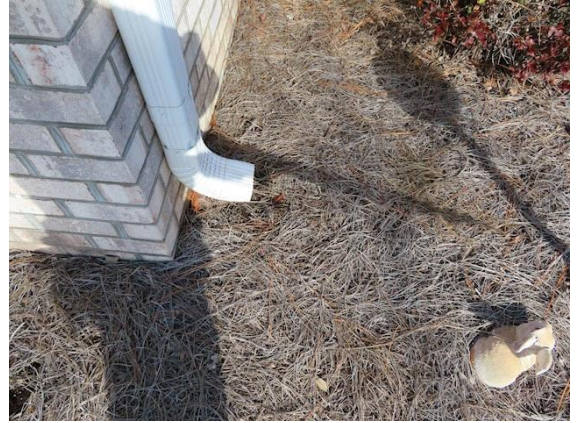
Gutters/Down Spouts: View showing one location of missing splash blocks/extension hoses at the end of downspouts

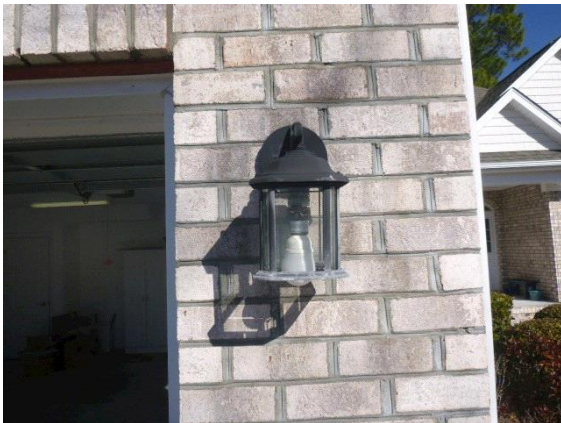
3. The exterior light, located to the right of the garage roll up door, does not light when the wall switch is turned on. See photo. Recommend changing bulb(s) first.

Exterior Surface: View of defective light fixture located next to garage roll up door

- **Recommend a licensed electrician evaluate items 1, 2, 3, and 4 and make the necessary repairs.
5. The coated metal trim throughout the exterior of the house is starting to bubble in many locations. See photos. Evidence suggests this is an indication that water may have penetrated between the metal and the outer coating of the trim, and that corrosion has started. Recommend a qualified contractor evaluate, determine the cause and extent of any damage, and make the necessary repairs.

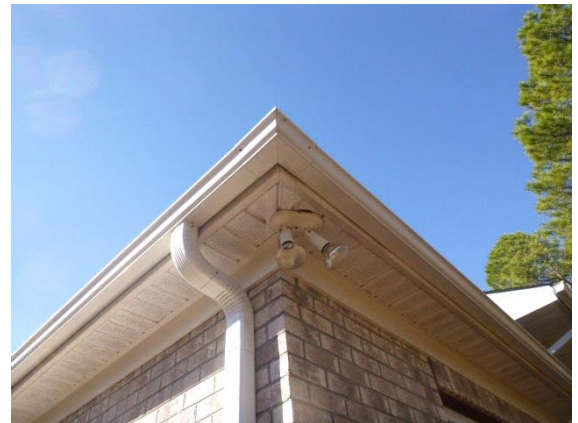
1. The exterior spotlight located at the right rear corner of the house does not light when the wall switch is turned on. See photo. Recommend changing bulb(s) first.

Exterior Surface: View of defective spotlight located at the right rear of house

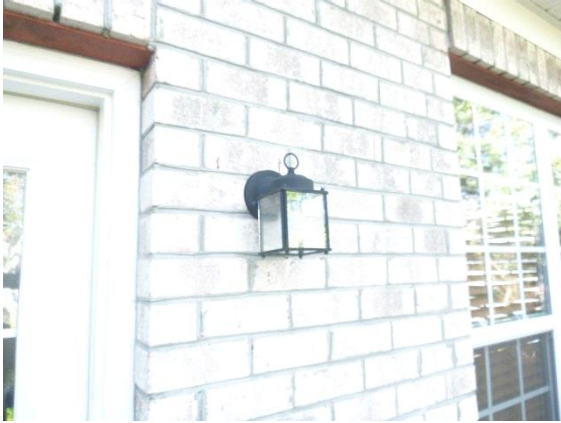
4. The exterior light, located next to the entry door on the rear deck, does not light when the wall switch is turned on. See photo. Recommend changing bulb(s) first.

Exterior Surface: View of defective light fixture located next to rear entry door

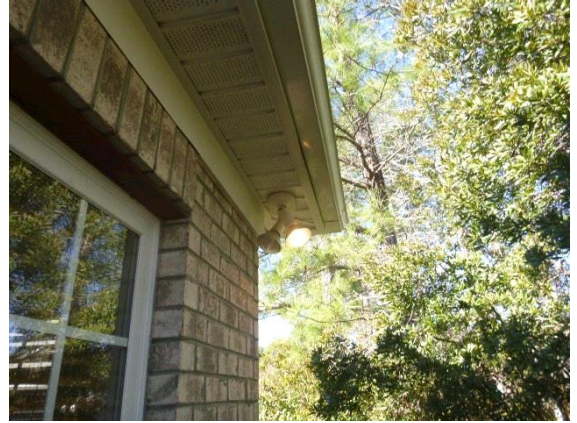
2. One bulb in the exterior spotlight located at the left rear corner of the house does not light when the wall switch is turned on. See photo. Recommend changing bulb(s) first.

Exterior Surface: View of defective spotlight located at the left rear of house

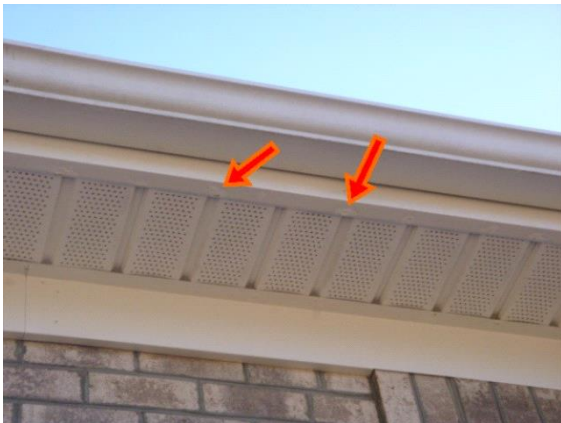
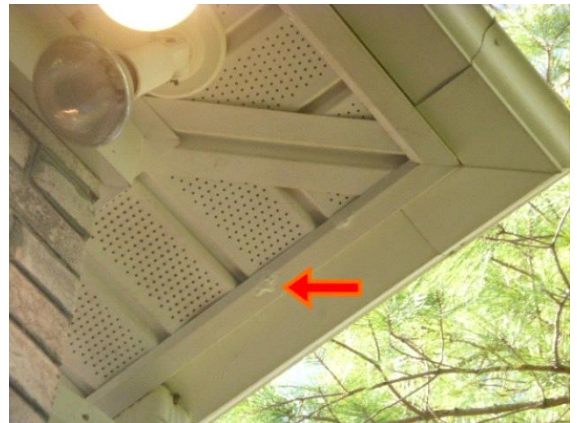
Exterior Surface: View of one location of peeling coated metal trim

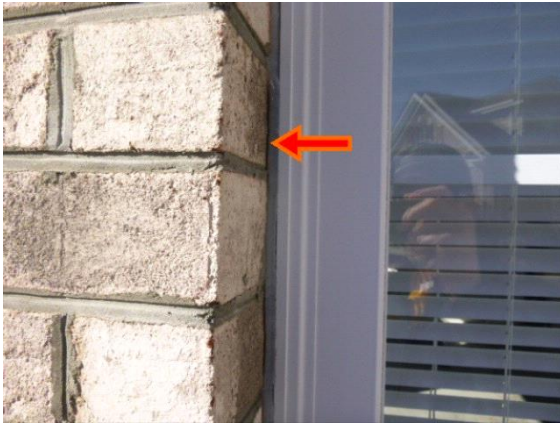
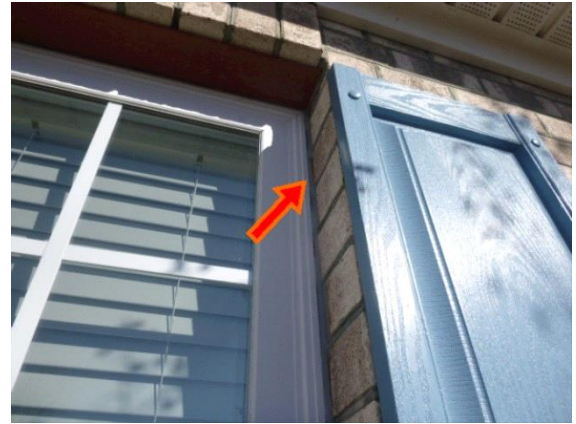
The caulking located on the exterior of many of the vinyl windows has separated from the window and brick siding. See Photos. Evidence suggests this condition creates avenues for water intrusion. Recommend a qualified contractor evaluate and make the necessary repairs.

Windows: View of one location of separated caulking at windows

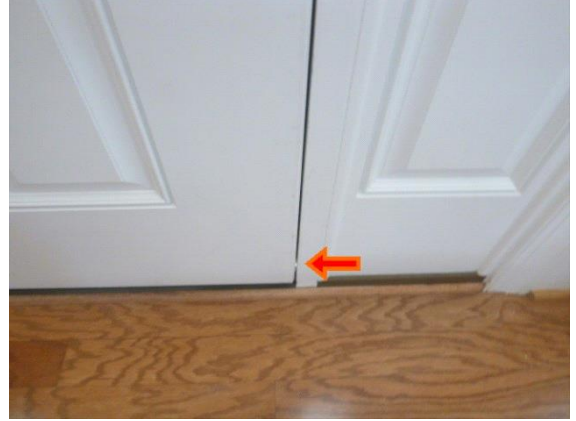
2. There is a gap with daylight visible along the lock side of the weather-stripping at the front entry door. See photo. Evidence suggests this condition has created an avenue for energy loss. Recommend a qualified contractor evaluate and make the necessary repairs.

Exterior Doors: View showing daylight between front entry door and door jamb

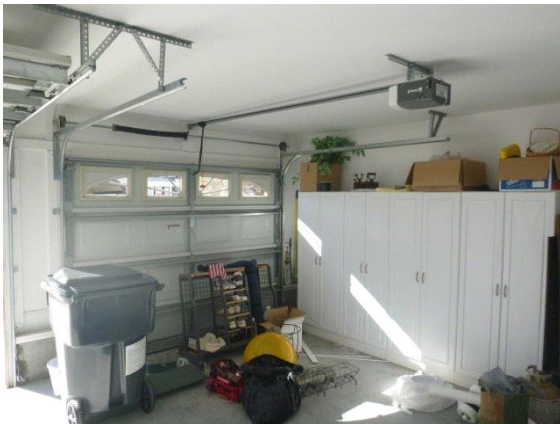
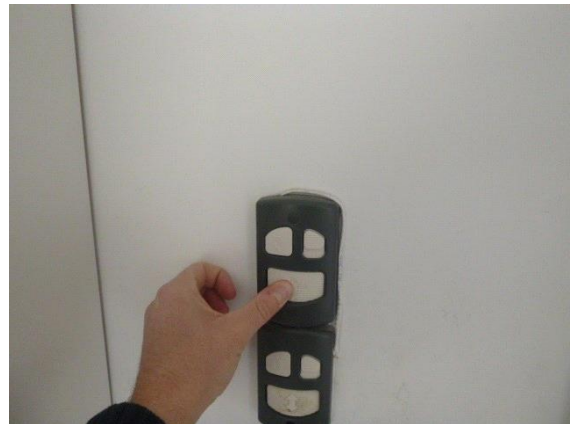
The left side garage door opener did not operate when tested at the time of the inspection. See Photo. Evidence suggests the door opener does not function as intended. Recommend a qualified contractor evaluate and make the necessary repairs.

Overhead Garage Doors: Overall view of left garage door that did not operate

Overhead Garage Doors: View testing left side garage door opener

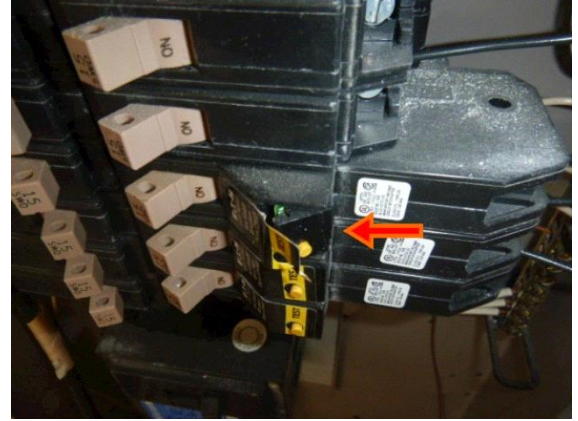
1. The upper Arc Fault 15 amp breaker located in the right side of the panel is damaged and could not be tested at the time of the inspection. See Photo. Evidence suggests that the breaker does not operate as intended and has created a safety hazard. Recommend a licensed electrician evaluate and make the necessary repairs for safety purposes.
2. There are no CO detector(s) present outside the bedrooms. Although it was not required to have a CO detector(s) when the home was built, North Carolina now requires all homes with fuel sources present such as; **gas fireplaces**, gas stoves, gas furnaces, **attached garages**, and any gas appliance, etc., to have CO detector(s) present outside the bedrooms. Recommend a qualified contractor or licensed electrician install CO detector(s) for safety purposes.

Electrical: View of damaged Arc Fault breaker

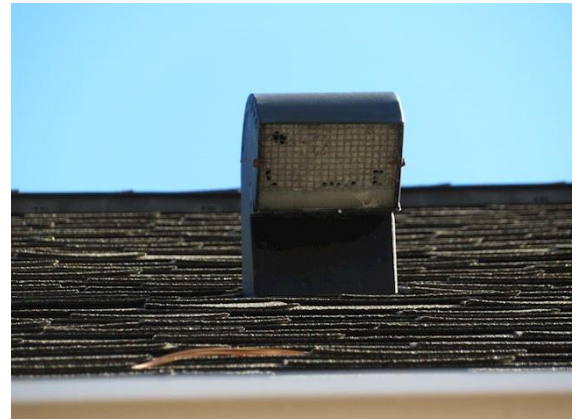
The dryer vent cap, located on the left side of the roof, is obstructed with dryer exhaust lint. See Photo. Evidence suggests the dryer vent does not operate as intended and that this condition has created a safety hazard. Recommend a qualified contractor evaluate and make the necessary repairs for safety purposes.

Laundry Facilities: View of lint filled dryer vent cap located on the left side of house

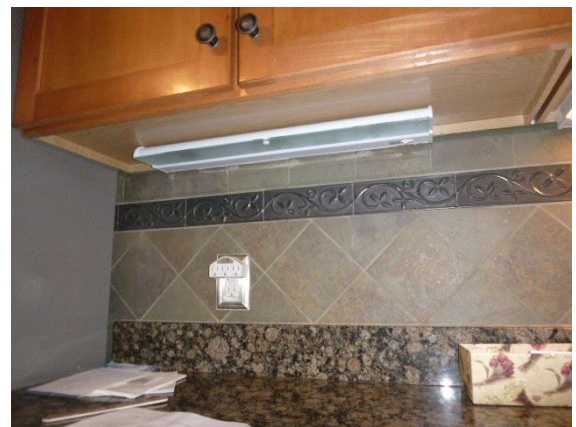
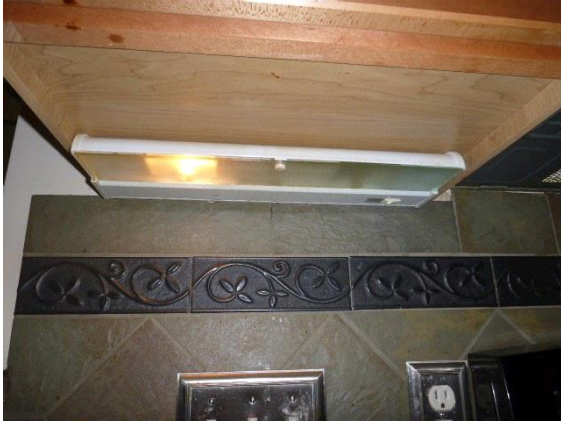
1. The under cabinet light fixture located to the right of the refrigerator and one bulb in the fixture to the right of the sink did not light when the switches were turned on. See Photos. Recommend changing the light bulbs first, and if the lights still do not work, have a licensed electrician evaluate and make the necessary repairs.
2. The kitchen sink hand sprayer is missing the operating button. See photo. Evidence suggests the kitchen sink sprayer does not function as intended. Recommend a licensed plumber evaluate and make the necessary repairs.
3. One of the tabs used to secure the dishwasher to the countertop is missing a screw. See photo. Evidence suggests this condition may allow the dishwasher to move when operating the door.
4. Several operating control buttons on the dishwasher are damaged. See Photo. Evidence suggests the buttons on the unit do not operate as intended.

Kitchen: View of one location of defective kitchen light fixture

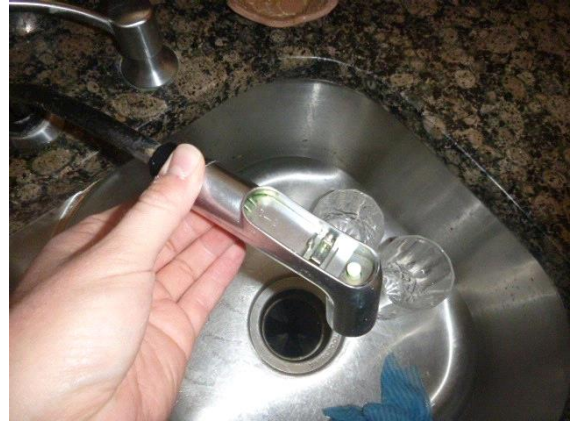
Kitchen: View of hand sprayer missing control button

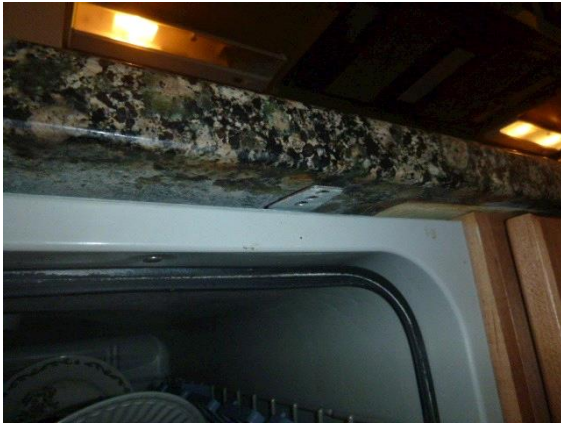
Kitchen: View showing the dishwasher tab not secured to the countertop

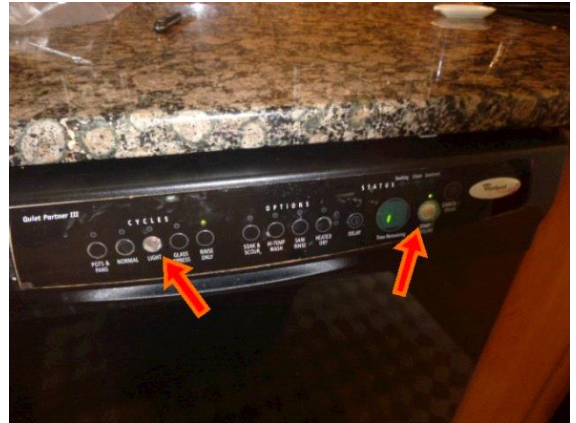
Kitchen: View of damaged dishwasher control buttons

****Recommend a qualified appliance contractor evaluate items 3 and 4 and make the necessary repairs.**

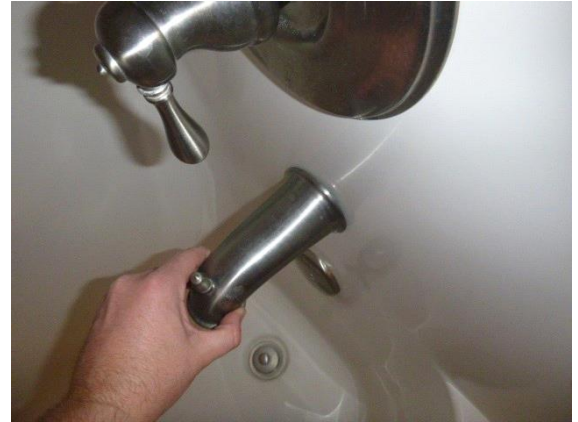
The bathtub faucet is loose from the tub enclosure. See photo. Evidence suggests this condition creates an avenue for water intrusion behind the tub enclosure. Recommend a licensed plumber evaluate and make the necessary repairs or replacements.

Bathroom #1 - Guest - Right Side : View of loose bath tub faucet

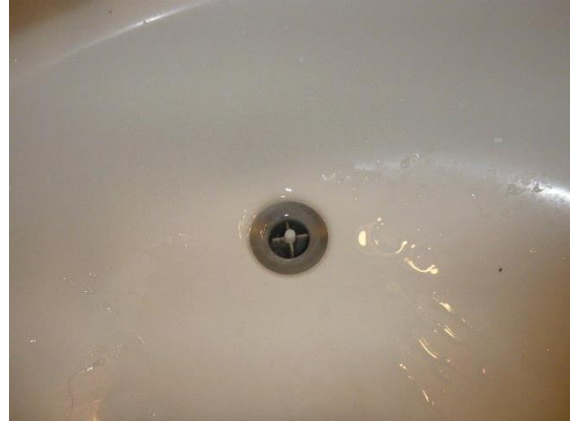
2. The bathtub cold water faucet handle hits the tile wall when operating. See Photo. Evidence suggests the faucet does not operate as intended.
3. The left side bathroom sink is missing the drain stopper. See photo. The stopper is needed to use the sink in the soak-mode and to prevent items from accidentally going down the drain.

Bathroom #2 - Master: View of missing drain stopper in left side sink

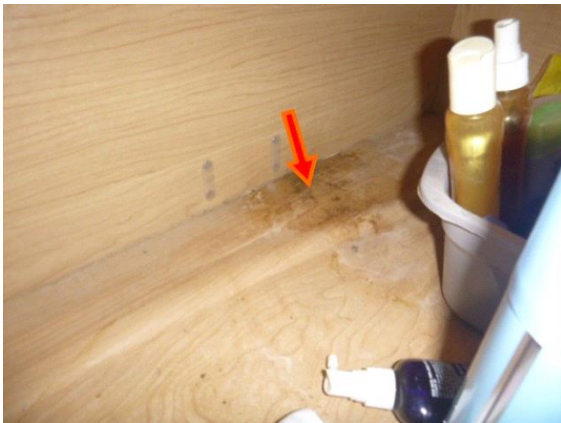
**Recommend a licensed plumber evaluate items 2 and 3 and make the necessary repairs.
4. The particle board located inside the master bathroom vanity is swollen in several areas. See photo. Evidence suggests the particle board has had contact with water which has damaged the wood shelf. Recommend a qualified contractor to evaluate the cause of the water damage and cabinet and make the necessary repairs.

Bathroom #2 - Master: View of water damage to particle board located under the bathroom sink

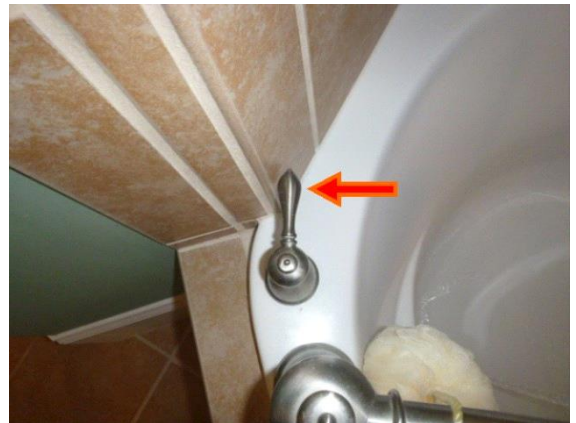
Bathroom #2 - Master: View of bathtub faucet handle hitting wall when operating

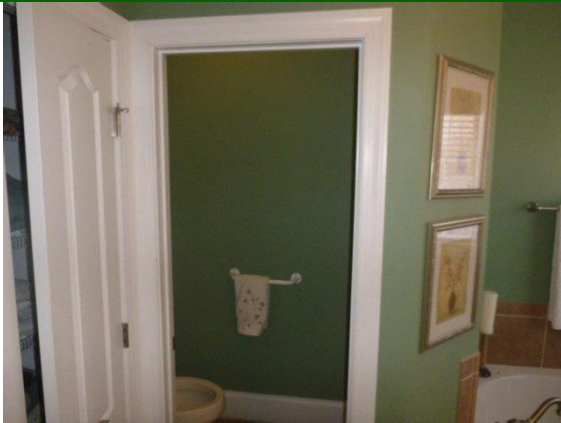
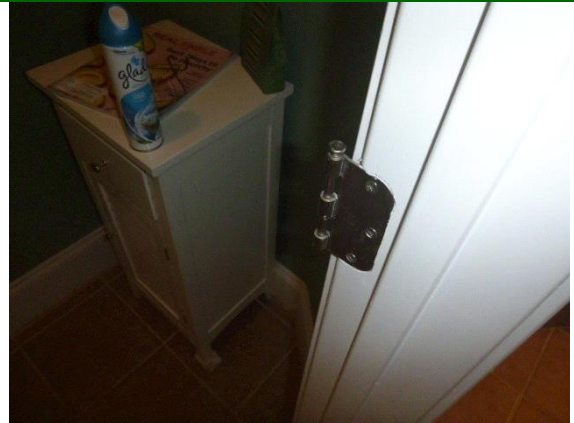
1. The bathroom toilet closet entry door is missing from the door frame and hinges. See photo. Evidence suggests the door does not operate as intended. Recommend a qualified contractor evaluate and make the necessary repairs.

Bathroom #2 - Master: View of missing toilet closet door

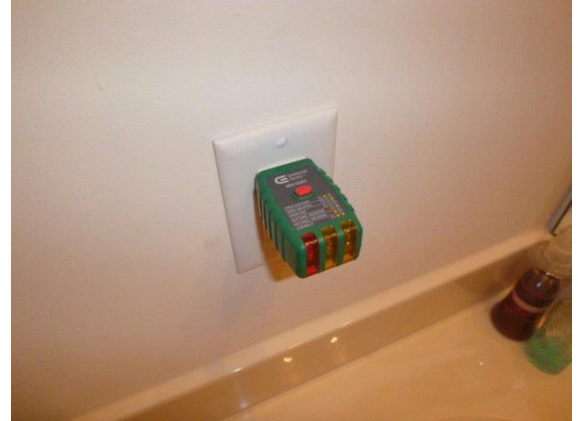
1. There was no power present at the GFCI receptacle located next to the bathroom sink. See photo. Evidence suggests the receptacle does not function as intended.
 2. One bulb in the light fixture, located over the bathroom sink, did not light when the wall switch was turned on. See photo. Recommend changing the light bulbs first.
- **Recommend a licensed electrician evaluate items 1 and 2 and make the necessary repairs.

Bathroom #3 - Guest - 2nd Floor : View of no power present at GFCI receptacle in bathroom

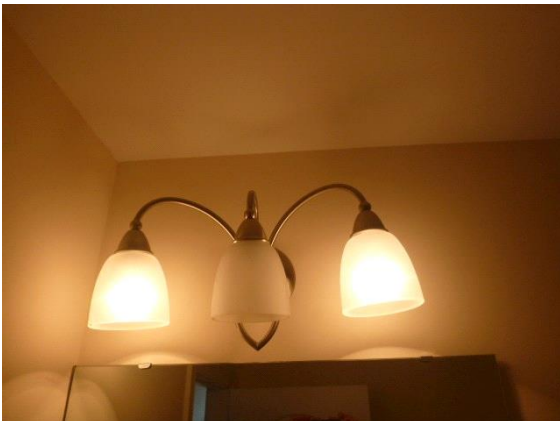
Bathroom #3 - Guest - 2nd Floor : View showing defective light in fixture located above the sink

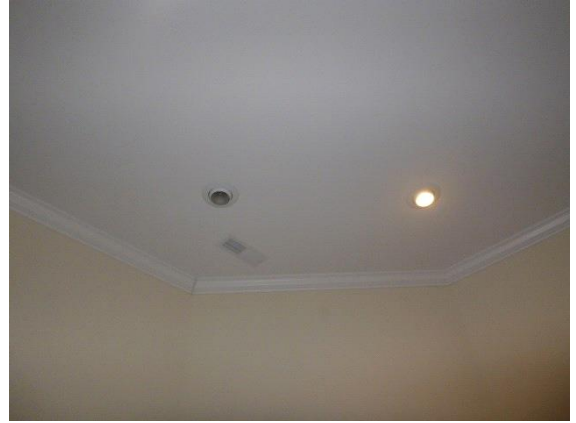
One of the recessed ceiling lights, located above the fireplace, did not light when the wall switch was turned on. See photo. Recommend changing the light bulb first, and if the light still does not work, have a licensed electrician evaluate and make the necessary repairs.

Living Room: View of defective light on living room ceiling

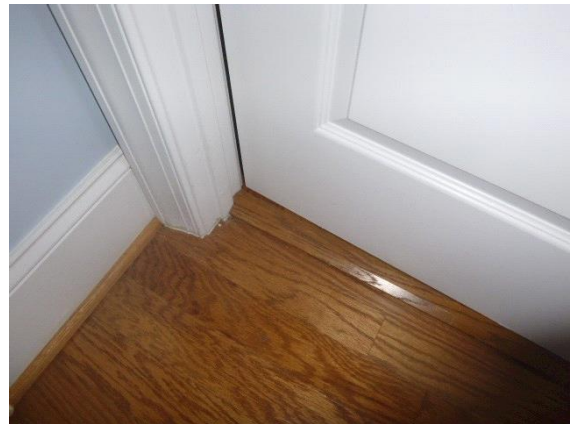
The bedroom entry door is hitting the threshold when closing. See photo. Evidence suggests the door is not operating as designed. Recommend a qualified contractor evaluate and make the necessary repairs.

Bedroom #2 - Guest - Right Side - Front : View of entry door hitting threshold

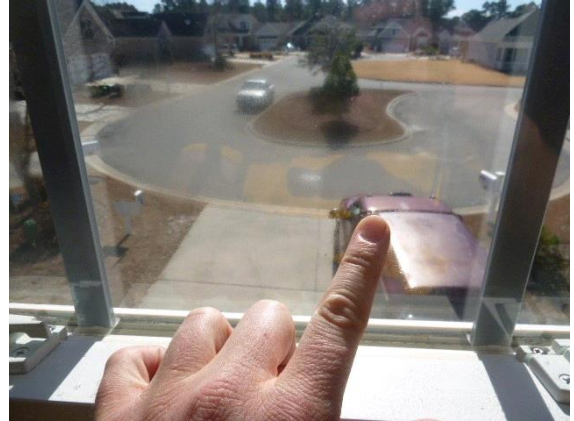
There is condensation present inside the window panes of the double-pane glass window. See photo. Evidence suggests this indicates the desiccant strip designed to absorb moisture from the space between the panes has become saturated, and will no longer prevent condensation from forming. In some situations repair is possible, but if irreparable damage has occurred, the window pane assembly will need to be replaced. Recommend a qualified contractor evaluate the window and make the necessary repairs or replacements

Finished Room Over Garage: View of fogged window
