# Building Inspection Report

Commercial Property

Property Address 1234 anywhere  
City Kenosha State Wisconsin

Others Present Seller, Buyer Property Occupied Occupied  
Estimated Age 15-17 years old Entrance Faces South  
Inspection Date 1-15-2008  
Start Time 9 am End Time 12:30 pm  
Electric On ☒ Yes ☐ No ☐ Not Applicable  
Gas/Oil On ☒ Yes ☐ No ☐ Not Applicable  
Water On ☒ Yes ☐ No ☐ Not Applicable  
Temperature 20  
Weather Partly sunny Soil Conditions Frozen, Snow covered  
Space Below Grade None  
Building Type Commercial Garage Detached  
Sewage Disposal City How Verified Seller  
Water Source City How Verified Visual Inspection

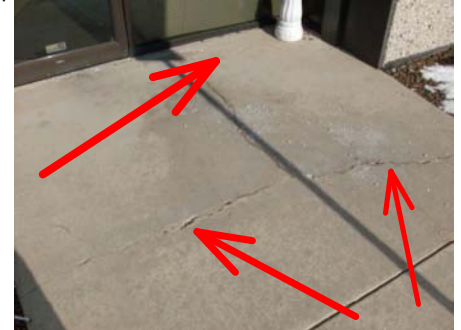
1. ☐ ☐ ☒ ☐ ☐ Walks: Concrete Due to snow cover, the side walks were not inspected.  
2. ☐ ☐ ☐ ☒ ☐ Steps/Stoops: Concrete The front stoop at the South door has some cracks - monitor at this time.

1. Steps/Stoops: Concrete      The front stoop at the South door has some cracks - monitor at this time.
2. Grading: Flat      The West side is flat - recommend re grade. The grading along the West side of the driveway has been damaged with snow plows this winter - recommend re grade.
3. Retaining Walls: Stone, Concrete      The concrete retaining wall at the South East corner of the building has a bent/ loose metal cap that should be fastened down to the wall for protection.

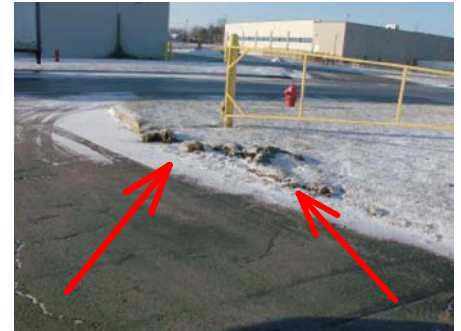
3. ☐ ☐ ☒ ☐ ☐ Patio: Concrete Due to snow cover, the patio was not inspected.  
4. ☐ ☐ ☐ ☒ ☐ Grading: Flat The West side is flat - recommend re grade. The grading along the West side of the driveway has been damaged with snow plows this winter - recommend re grade.

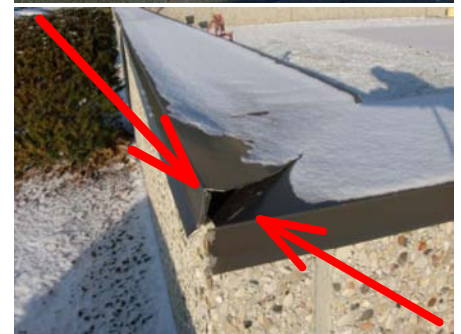
5. ☐ ☐ ☐ ☒ ☐ Retaining Walls: Stone, Concrete The concrete retaining wall at the South East corner of the building has a bent/ loose metal cap that should be fastened down to the wall for protection.

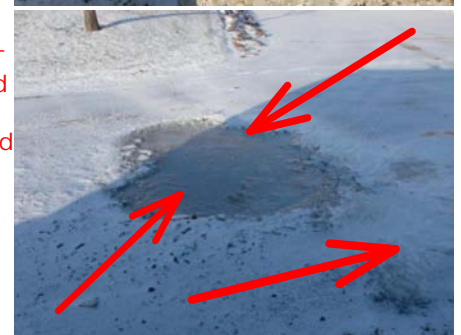
6. ☐ ☐ ☐ ☐ ☒ Parking Lot: Asphalt, Concrete The main South asphalt lot has just some cracking - these should be sealed. There is broken asphalt near the East end of the loading dock area from heavy traffic - this area should be repaired.  
Note: most of the Eastern end of the parking lot was snow covered - could not fully inspect.

1. Parking Lot: Asphalt, Concrete      The main South asphalt lot has just some cracking - these should be sealed. There is broken asphalt near the East end of the loading dock area from heavy traffic - this area should be repaired.  
Note: most of the Eastern end of the parking lot was snow covered - could not fully inspect.

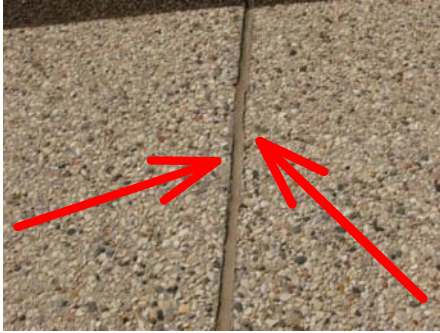
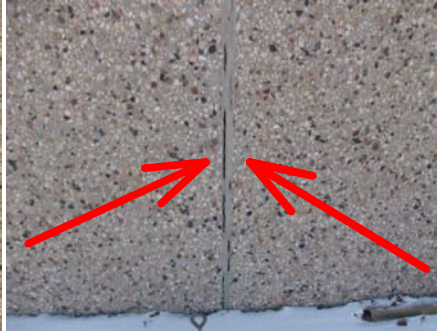
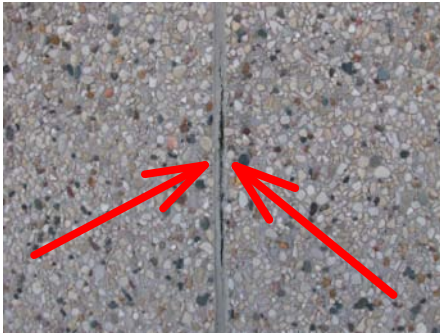
1. ☐☐☐☒☐ Type: Concrete tilt-up panels  
the vertical joints.

There are several locations around the building that need re caulking at

4. Entire Exterior Surface Type: Concrete tilt-up panels      There are several locations around the building that need re caulking at the vertical joints.

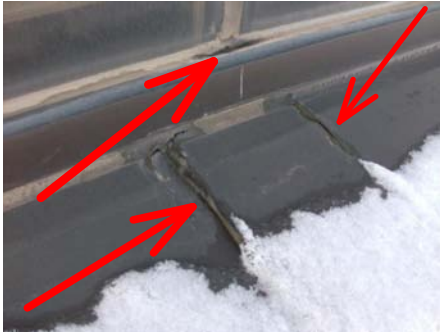
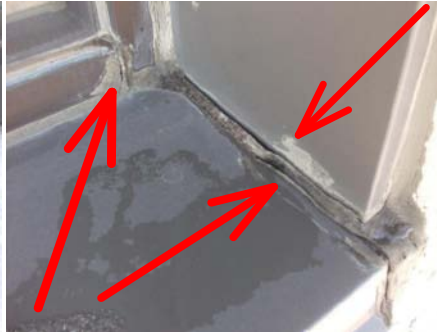
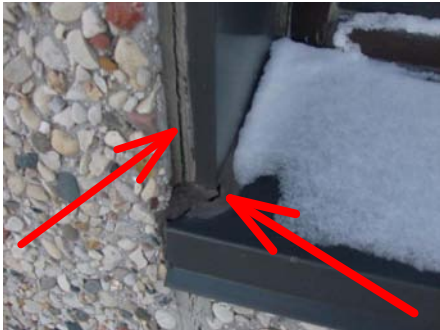
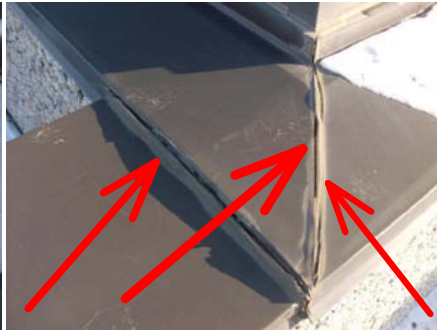
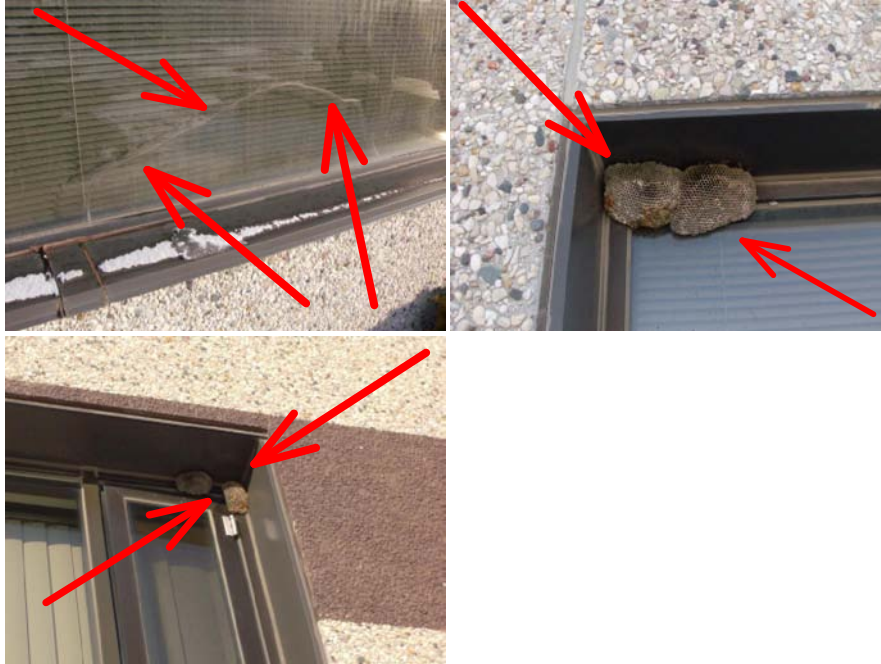
There is one broken/ cracked glass on the South side in the Conference room. There are several windows through-out the building that need re caulking outside. There is hornet nests on office windows on the West and East sides.

2. Windows: Fixed, Aluminum Hopper      There is one broken/ cracked glass on the South side in the Conference room.  
There are several windows through-out the building that need re caulking outside. There is hornet nests on office windows on the West and East sides.

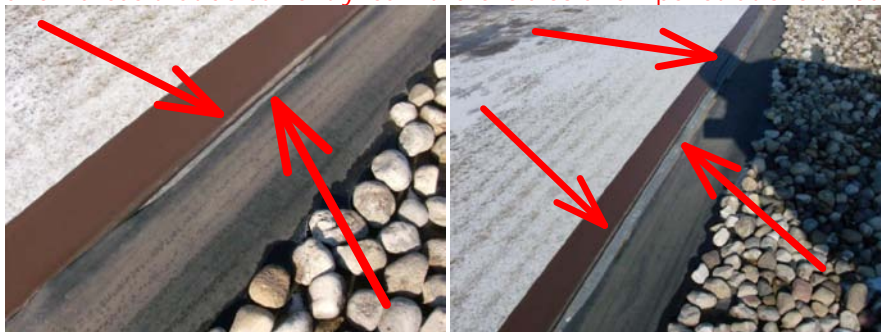
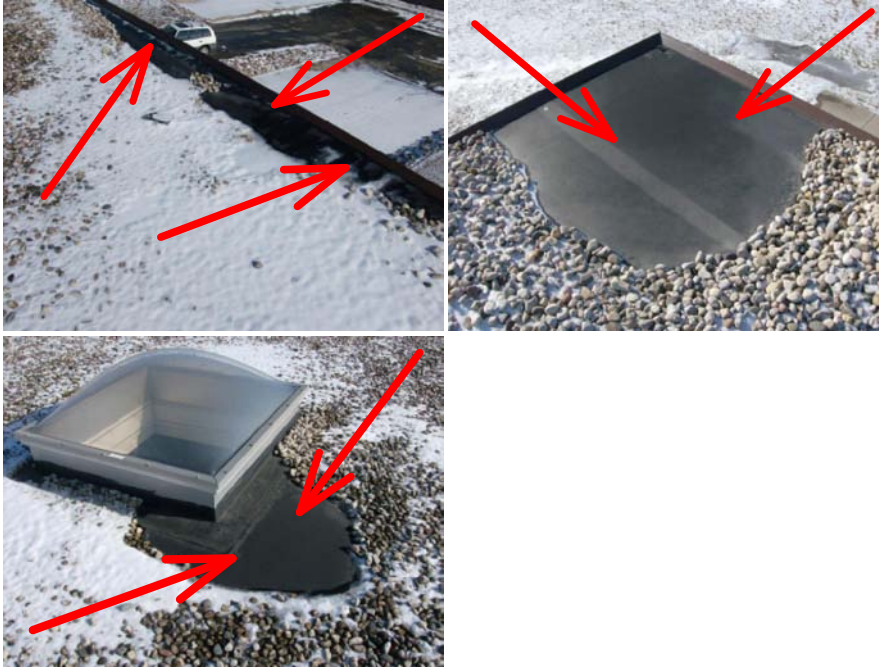
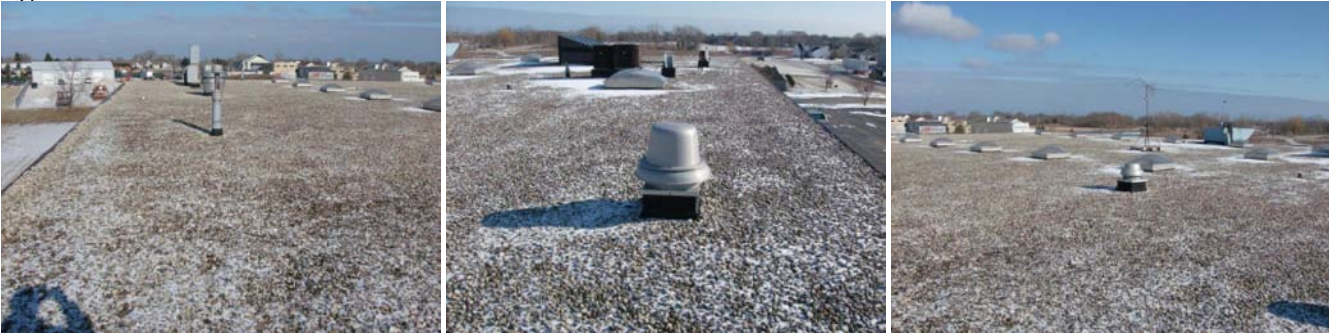
There was a few areas that the stones were not covering the rubber. There are several areas around the perimeter that the rubber has shrunk and need repairs - there are a few areas that do currently leak. there is also a few penetrations through the rubber that need repairs.

3. Main Roof Surface Material: Rubber with stone ballast      There was a few areas that the stones were not covering the rubber. There are several areas around the perimeter that the rubber has shrunk and need repairs - there are a few areas that do currently leak. there is also a few penetrations through the rubber that need repairs.
4. Plumbing Vents: PVC      Repair the boot around the North vent.

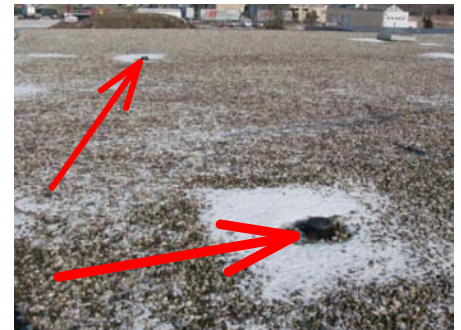
The drains appear to be working, there was not water on top of the roof.

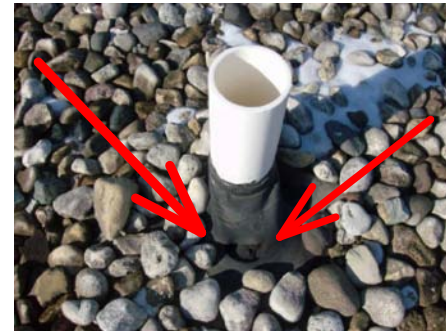
Repair the boot around the North vent.

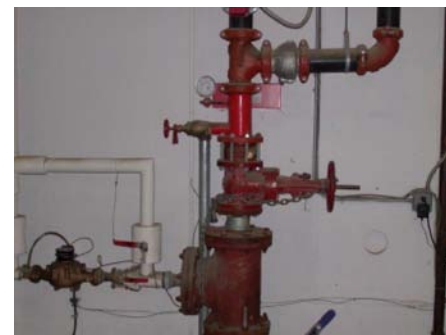
The sprinkler system was not

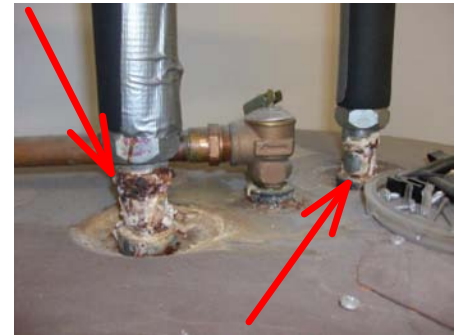
17. ☐☐☐☐☒ Water lines: Copper  
The copper hot and cold lines are corroded and leak at the top of the tank.

5. Second Floor - Office Water Heater Water lines: Copper      The copper hot and cold lines are corroded and leak at the top of the tank.

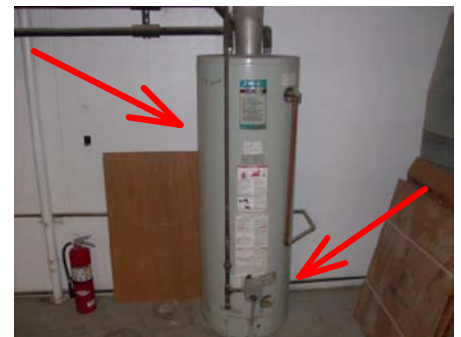
19. ☐☐☒☐☐ Water Heater Operation: Inadequate  
OFF at the time of the inspection.

The water heater is turned

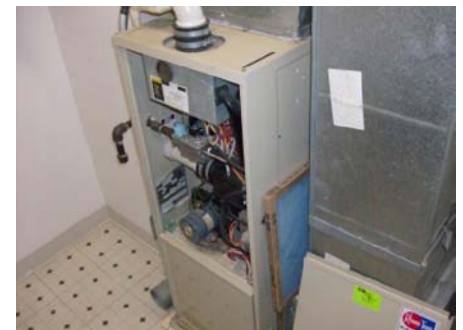
1. ☐ ☐ ☐ ☒ ☐ Heating System Operation: Adequate  
due to condition and age.

Cleaning recommended

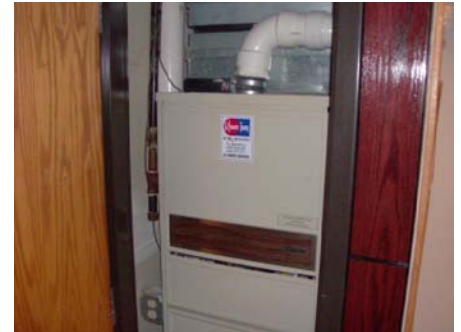
18. ☐☐☐☒☐ Heating System Operation: Adequate  
due to condition and age.

Cleaning recommended

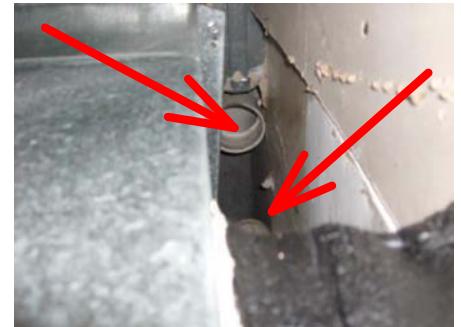
The intake pipe has fallen apart at a joint near  
the ceiling inside the closet.

6. First Floor - South East Offices Heating System Flue Pipe: PVC      The intake pipe has fallen apart at a joint near the ceiling inside the closet.

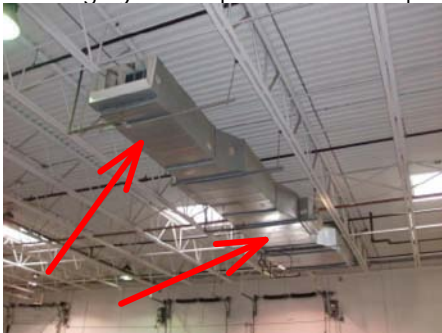
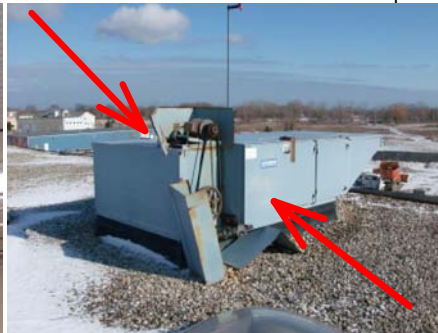
The unit was not inspected, utilities are turned OFF.

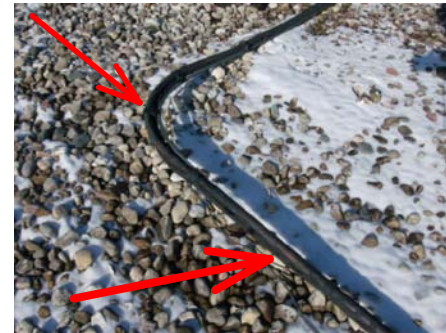
1. ☐☐☒☐☐ A/C System Operation: Not inspected Due to the season, the Air Conditioning was not tested
2. Manufacturer: Carrier
3. Area Served: Office Approximate Age: 1 - 15-17 years old and 1 - 5-8 years old
4. ☐☐☐☐☒ Refrigerant Lines: Only visual Torn and missing insulation

7. Two Roof Top Units AC System Refrigerant Lines: Only visual      Torn and missing insulation

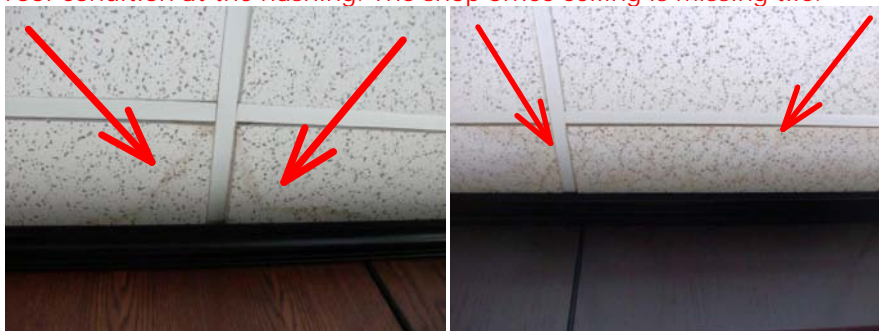
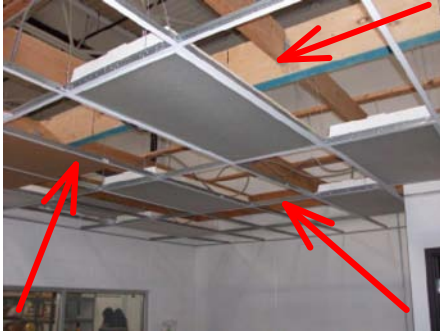
1. ☒ ☐ ☐ ☐ ☐ Closet: Few  
 2. ☐ ☐ ☐ ☒ ☐ Ceiling: Drop ceiling **The East side office and conference room has stained ceiling tile from the poor roof condition at the flashing. The shop office ceiling is missing tile.**

10. First Floor Living Space Ceiling: Drop ceiling      The East side office and conference room has stained ceiling tile from the poor roof condition at the flashing. The shop office ceiling is missing tile.

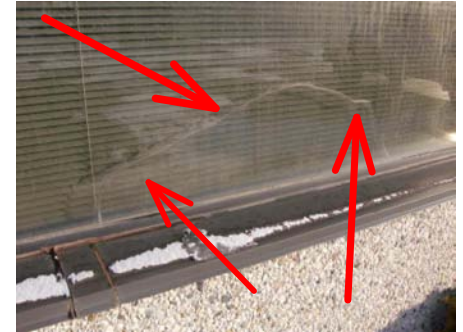
The conference room South side has a cracked

11. First Floor Living Space Windows: Fixed      The conference room South side has a cracked window pane.
12. First Floor Living Space HVAC Source: Forced air      The West office at the sink should have GFCI outlets and one cover plate is missing on an outlet.

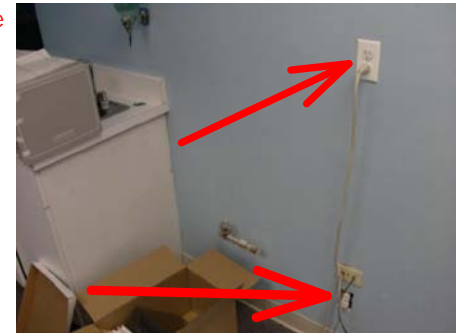
The West office at the sink should have GFCI outlets and one cover plate is missing on an outlet.

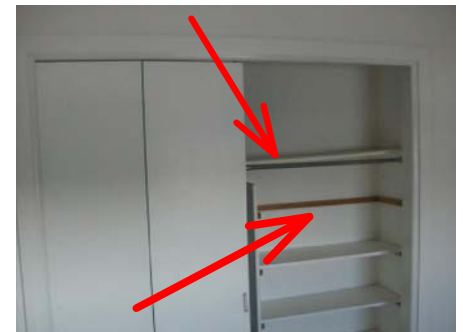
One office is missing a door and has a bowed shelf.

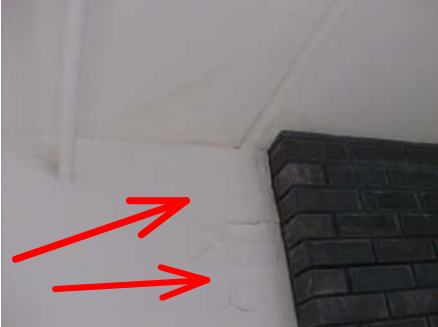
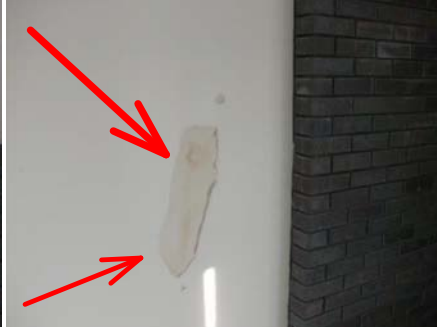
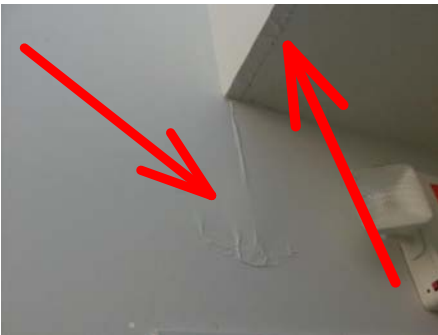
Near the old fireplace location there is a roof leak and there is stains on the walls and ceiling. There is also stains near the large skylight at the walls and loose drywall corner in same area.

13. Second Floor Living Space Closet: Few      One office is missing a door and has a bowed shelf.
14. Second Floor Living Space Walls: Paint      Near the old fireplace location there is a roof leak and there is stains on the walls and ceiling. There is also stains near the large skylight at the walls and loose drywall corner in same area.

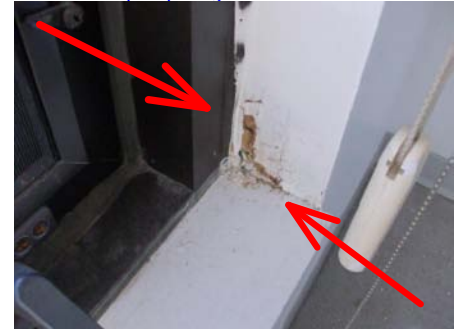
15. ☐☐☐☐☒ Windows: Aluminum Hopper  
has a window leak.

The South East room - East window

15. Second Floor Living Space Windows: Aluminum Hopper      The South East room - East window has a window leak.
16. Shop And Mezzanine Living Space Ceiling: Paint      There is a roof leak at the South East corner of the shop.

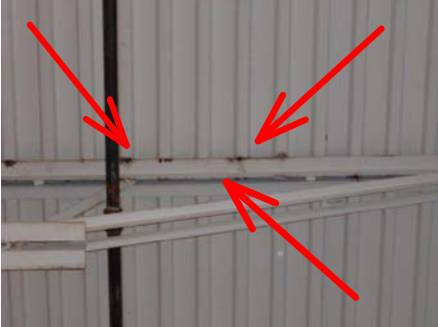
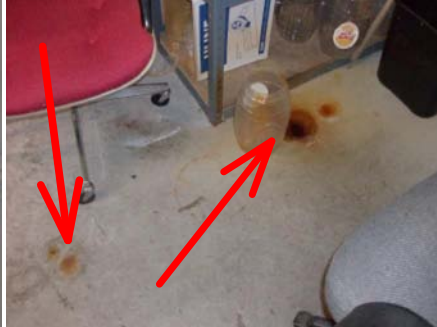
There is a roof leak at the South East corner of the shop.

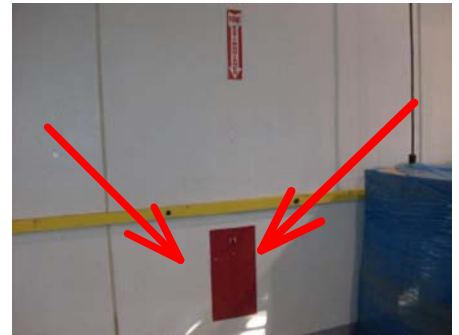
22. ☐☐☐☐☒ Fire Extinguisher: **Missing at the North wall.**

17. Shop And Mezzanine Living Space Fire Extinguisher: Missing at the North wall.
