National Property Inspections  
2053 Quincy Ave.  
Racine, WI 53403

# Building Inspection Report

Residential Property

Property Address 1234 Anywhere  
City Racine State Wisconsin

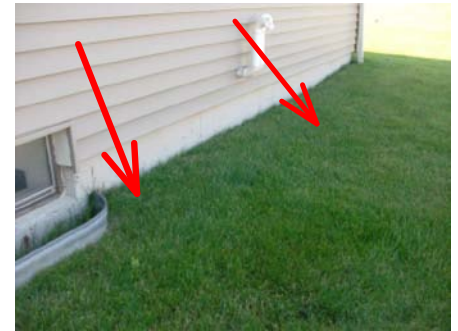
5.      Grading: Flat Recommend add more fill where needed to create positive drainage around the building

- 1. Driveway: Concrete Few typical cracks
- 2. Deck: Stained wood There are some boards that are cracking - typical
- 3. Grading: Flat Recommend add more fill where needed to create positive drainage around the building

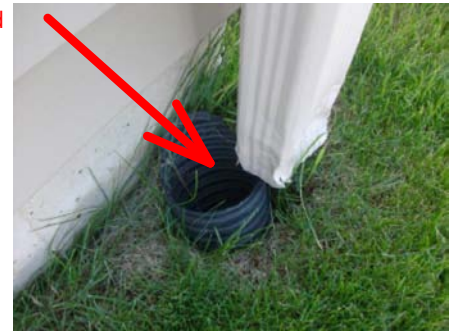
11.  Leader/Extension: Underground, Aluminum The extensions should be further away from building, the drain tile at South West corner are not aligned properly

2. Leader/Extension: Underground, Aluminum      The extensions should be further away from building, the drain tile at South West corner are not aligned properly

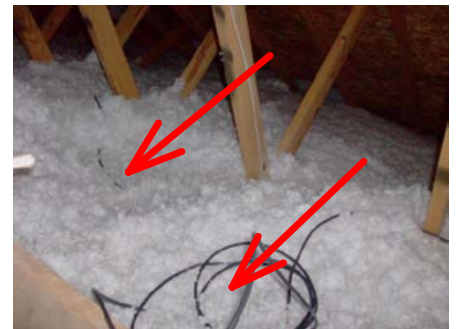
1. Method of Inspection: From the attic access  
 2.  Roof Framing: Truss  
 3.  Sheathing: Oriented Strand Board  
 4.  Ventilation: Ridge and soffit vents  
 5.  Insulation: Loose The upper roof has uneven insulation, the garage does not have insulation for your information only ( not needed )

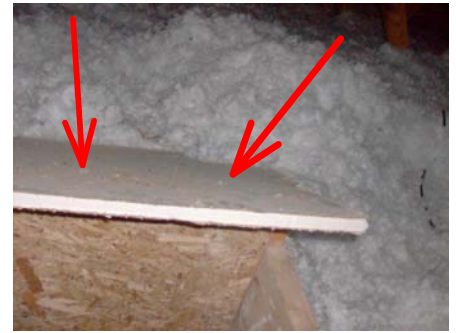
7.      Access Panel Drywall      Both doors do not have insulation, recommend add to the second floor access door

- 6. Upper and garage Attic Insulation: Loose The upper roof has uneven insulation, the garage does not have insulation for your information only ( not needed )
- 7. Upper and garage Attic Access Panel Drywall Both doors do not have insulation, recommend add to the second floor access door

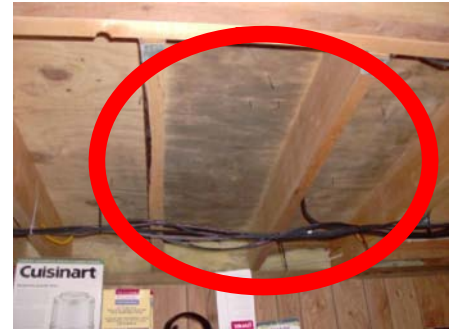
- There is some mildew on some sub-floor under the fireplace, recommend testing and cleaning properly

3. Subfloor: Plywood where visible      There is some mildew on some sub-floor under the fireplace, recommend testing and cleaning properly

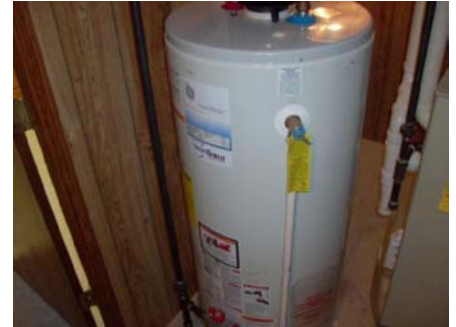
- 8.      Water Heater Operation: Adequate

- 9. Manufacturer: General Electric
- 10. Type: Natural gas Capacity: 40 Gal.
- 11. Approximate Age: 1-2 years old Area Served: Whole building
- 12.      Flue Pipe: Single wall
- 13.      TPRV and Drain Tube: PVC

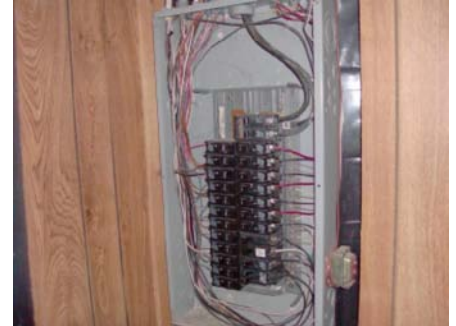
Basement Electric Panel

6.      Manufacturer: Siemens

7. Maximum Capacity: 100 amp
8.      Main Breaker Size: 100 amp
9.      Breakers: Copper
10. Is the panel bonded?  Yes  No

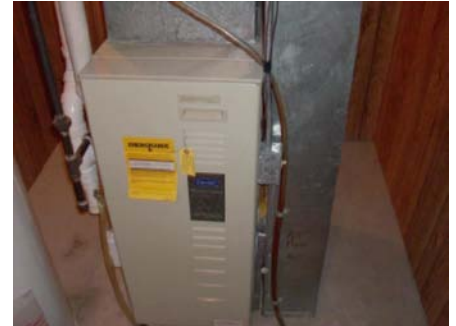
Basement Heating System

1.      Heating System Operation: Adequate

2. Manufacturer: Carrier
3. Type: Forced air Capacity: 74,000 btu
4. Area Served: Whole building Approximate Age: 8 - 10 years old
5. Fuel Type: Natural gas
6.      Heat Exchanger: 4 Burner
7.      Blower Fan/Filter:
8.      Distribution: Metal duct
9.      Flue Pipe: PVC
10.      Thermostats: Non-programable
