Commercial Inspection Report

Sample - Union Grove, WI

Prepared for: **Sample**

Prepared by: **National Property Inspections
2053 Quincy Ave.
Racine, WI 53403
Inspection Date: 11/16/2017**

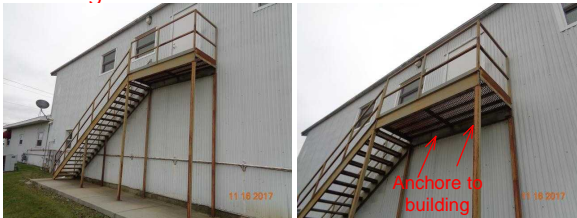
2. Repair or Replace **Balcony:** Metal
building.

The East steps and platform need painting as well as securing to the

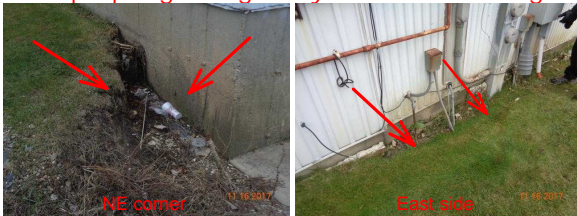
3. Repair or Replace **Grading:** Flat, Negative slope
need proper grading away from the building.

The NE corner has eroded away. The East and South sides

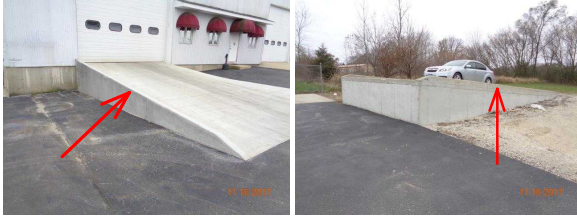
6. Repair or Replace **Retaining Walls:** Concrete
should have safety rails on sides.

The stand alone dock ramp as well as the ramp at NW corner

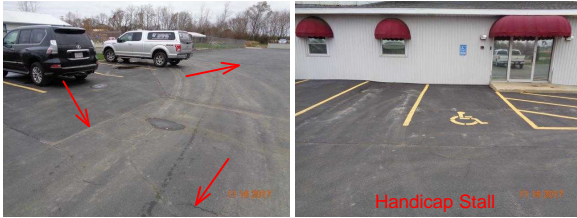
Parking Lot: Asphalt, Concrete coated.

There is some typical cracks present, keep parking lot seal coated.

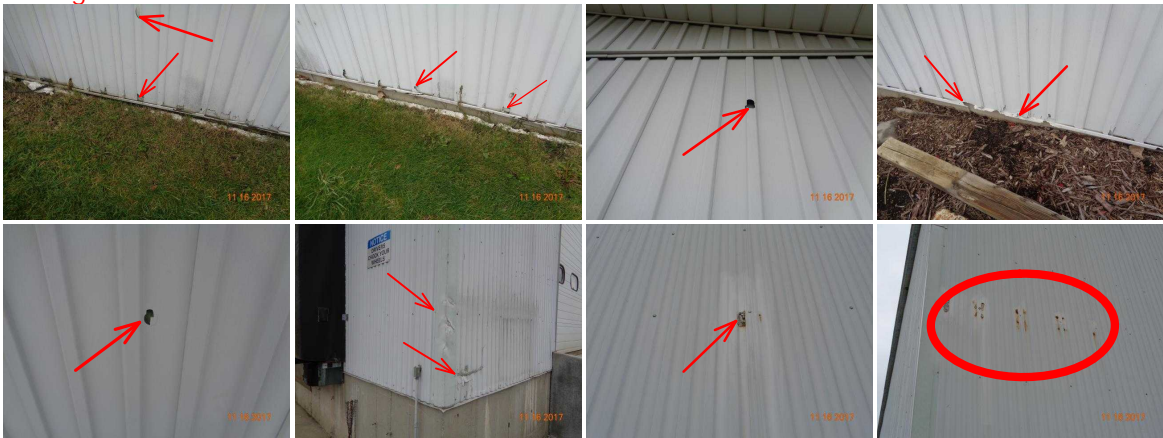
1. Repair or Replace Type: Vinyl siding, Metal

The vinyl siding has a few holes present as well as damaged trim and siding at grade on East and South sides. The metal siding has a few holes present as well as a damaged NW corner.

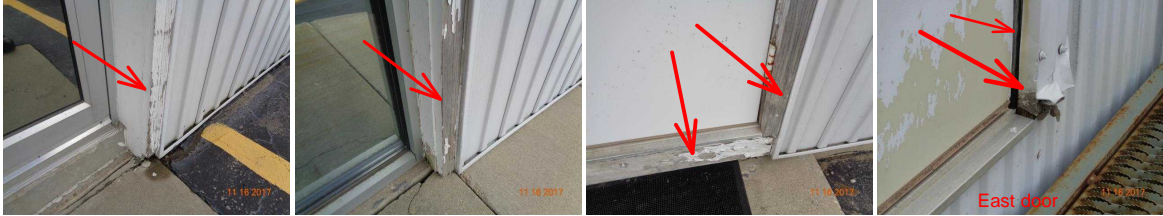
4. Repair or Replace Entry Doors: Aluminum Glass, Metal also East door trim repair.

The doors on exterior need caulking and painting and

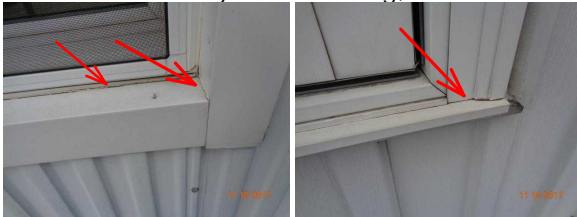
5. Repair or Replace Windows: Vinyl double hung, Wood casement

Few windows need caulking on exterior.

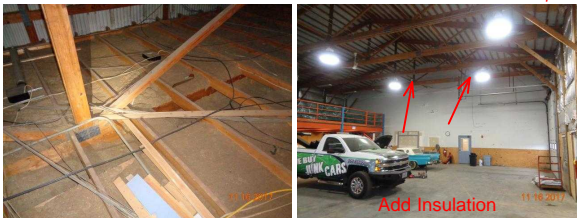
- 3. Acceptable Sheathing: Metal
- 4. Repair or Replace Ventilation: None
- 5. Repair or Replace Insulation: Blown in

Recommend add proper ventilation.

Approx 3-4" present. Recommend add more insulation on the ceiling.

The wall to the warehouse has no insulation, recommend add to complete heating envelope.

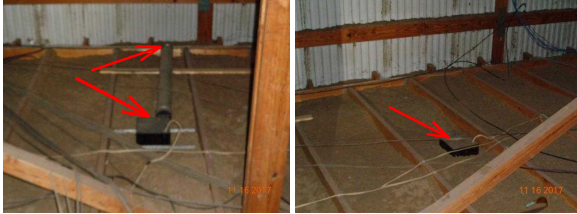
8. Repair or Replace Bathroom Fan Venting: Electric fan

Recommend vent to the exterior.

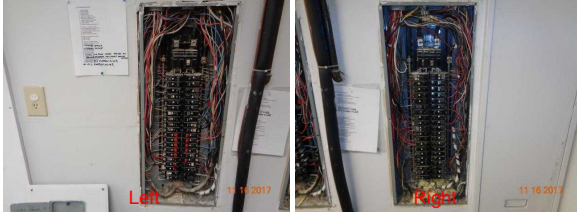
11. Repair or Replace Manufacturer: Unknown The panel covers have some wood screws which are improper, recommend add proper screws and some missing and or stripped out.

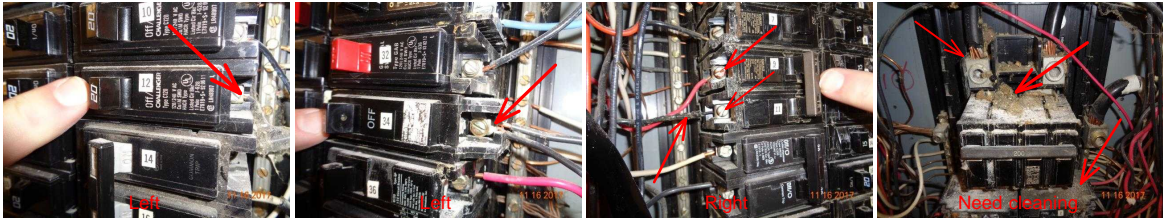
14. Repair or Replace Breakers: Copper The left panel breaker #12 is oversized and should be 15 amp, breaker #34 is double tapped. The right panel breaker #9 and #11 have melted wires and should be replaced. Both panels should be cleaned on the inside. Recommend a qualified electrician inspect and repair as needed.

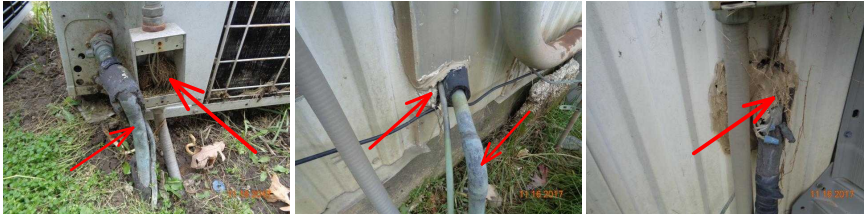
- 2. Acceptable Condensate Removal: Plastic tubing
- 3. Repair or Replace Exterior Unit: Pad mounted The North unit is not level. The electrical junction box is missing a cover and grass is inside. Caulk lines going through the siding. Some missing insulation on the lines.

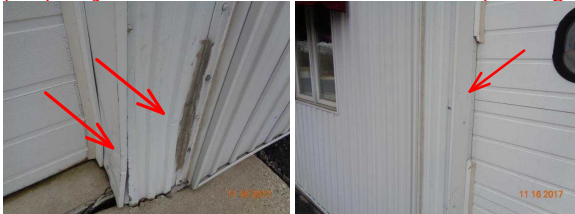
- 22. Acceptable Doors: Metal
- 23. Repair or Replace Overhead Doors: Aluminum Insulated The West wall South door opener does not work properly and lift the door. South door opening on West wall has some damaged trim.
