Inspection Report

Sample Report

Property Address:
123 Home Sweet Home
Nice City OH 45312

National Property Inspections

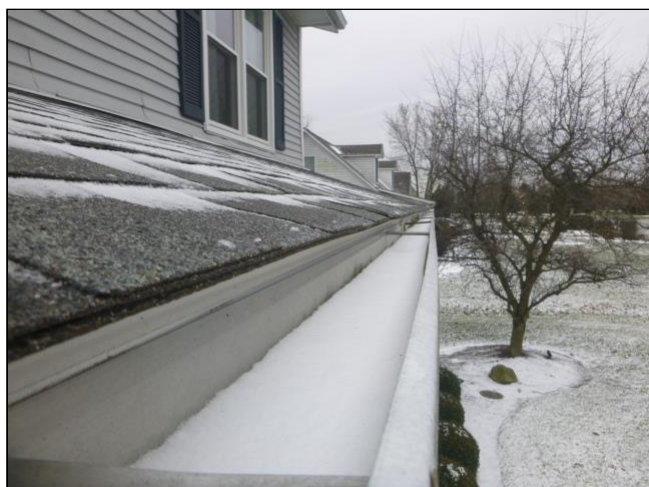
1.1 Item 1(Picture)

Metal flashing visible along the perimeter of the roof line or eaves. Surface found in good repair at the time of the inspection. Vent pipe seals and exhaust vent flashing found in good repair the day of the inspection.

Side wall flashing not visible due to tight clearance with the shingles and siding. Roof was not walked due to snow and ice.

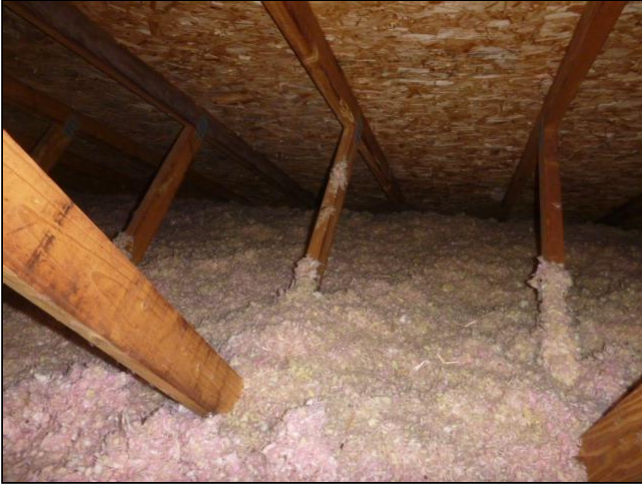
1.5 Item 1(Picture)

Roof structure is configured with truss support system 2" x 4" - 24" inches on center with OSB roof decking. Area was found in good repair. Limited visibility in some areas due to insulation and/or stored items.

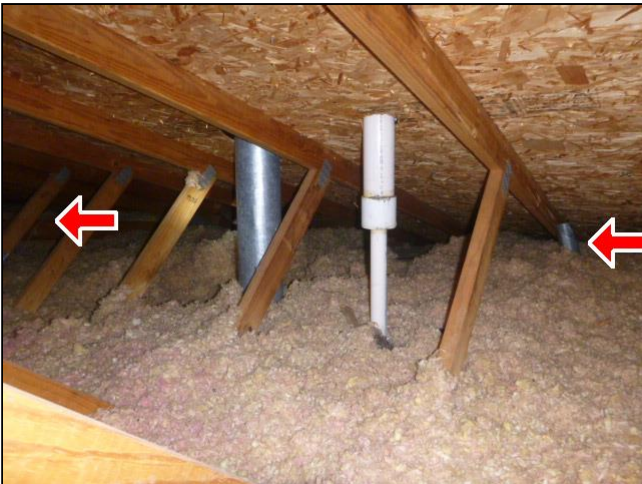
1.6 Item 1(Picture)

Bathroom fan is exhausting into the attic area. Because of the age of the home the vents have been like this since the house was built or when the fans were installed. No visible defects at the time of the inspection.

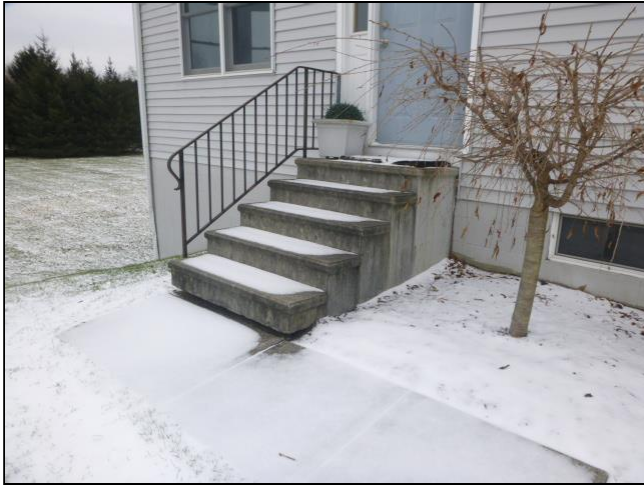
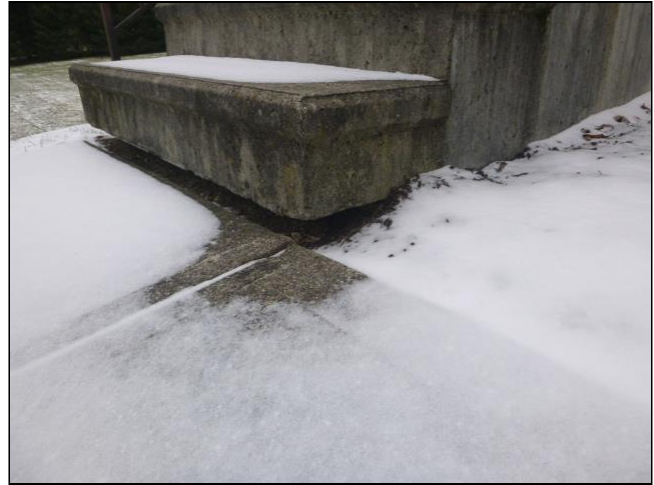
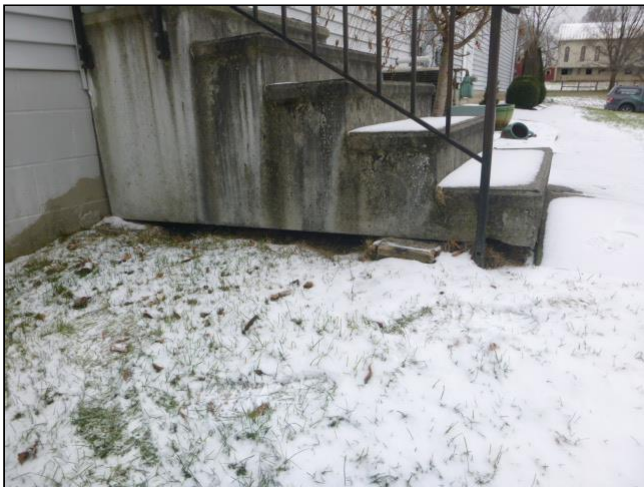
(1) Side entry to the in-law-suite was found with settlement and erosion. The pre-cast concrete steps was found sloping towards the home and with 2-3 inch gap below the first step and side. We recommend having the steps adjusted and repaired. Recommend additional railing on the right side for safety due to the height.

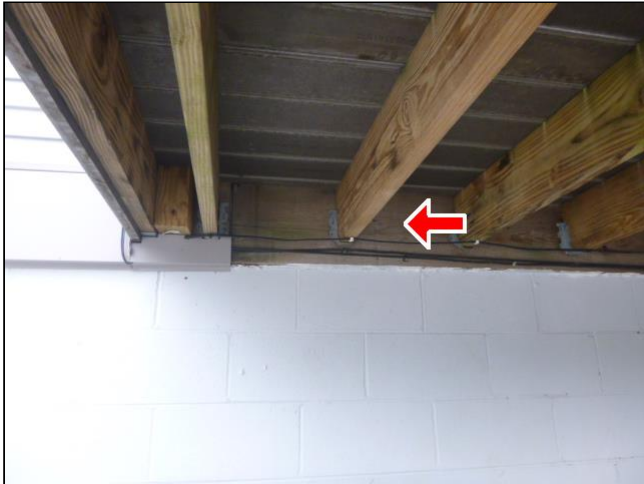
2.1 Item 4(Picture)

(2) Wooden deck marked for repair because of undersized or missing fasteners (lag bolts) in the ledger board below the south side doors. The undersized or missing fasteners can allow the ledger board to pulling away from the exterior of the house.

Exterior flashing missing or not visible along the ledger and behind the siding.

We recommend having the fasteners and flashing evaluated by a qualified deck contractor for safety.

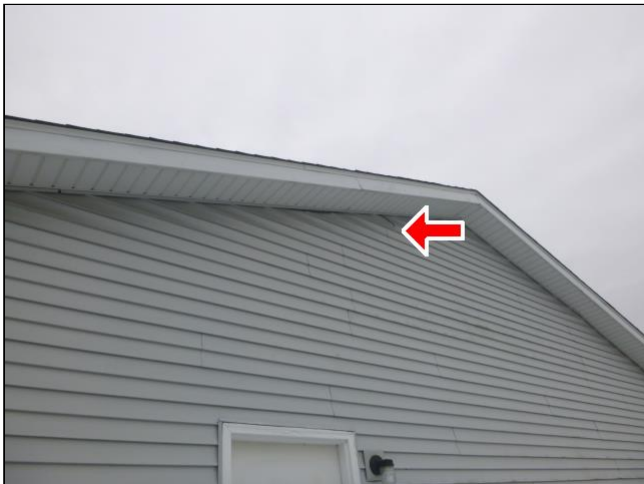
2.2 Item 1(Picture)

Vinyl siding found loose and moving out of position at the gable end at the garage and over the double doors at the walkout basement. Recommend having the siding secured to prevent damage or insects nesting behind the siding.

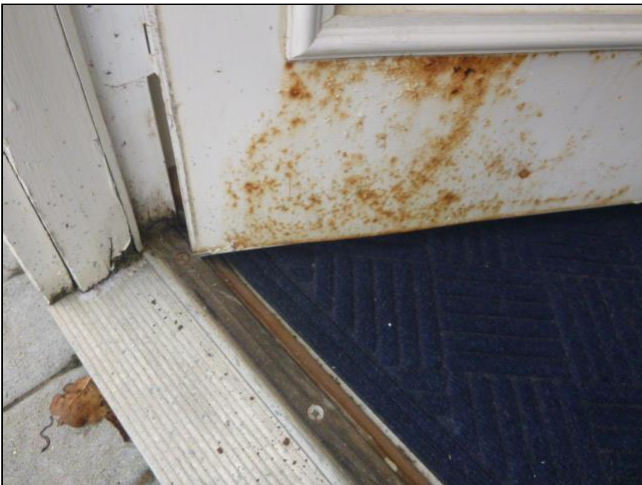
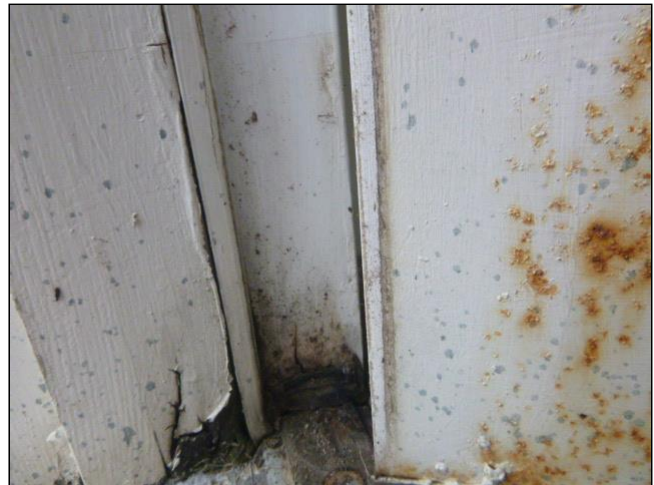
Double doors at the walkout section of the basement marked for repair or replacement. Doors are not flashed correctly on the exterior and suspect past and future leaks on the interior.

Secondary door is badly rusted at the base, wood rotted frame and primary door has loose hinge screws. Thermal glass in the two doors were noted with fogging.

We recommend evaluation and repairs or replacement by qualified contractor.

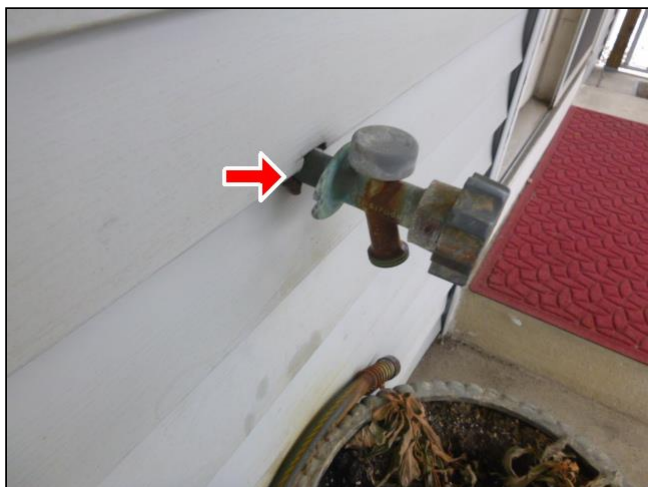
2.6 Item 1(Picture)

Exterior hose spigot(s) were tested the day of inspection and operated correctly. Spigots were pressure tested by capping the end and turning the valve on to identify leaks. No leaks detected the day of inspection.

Recommend having the outside valves secured to the exterior siding to prevent twisting on the pipe connections and joints.

Recommend always removing garden hoses or attachments during winter months.

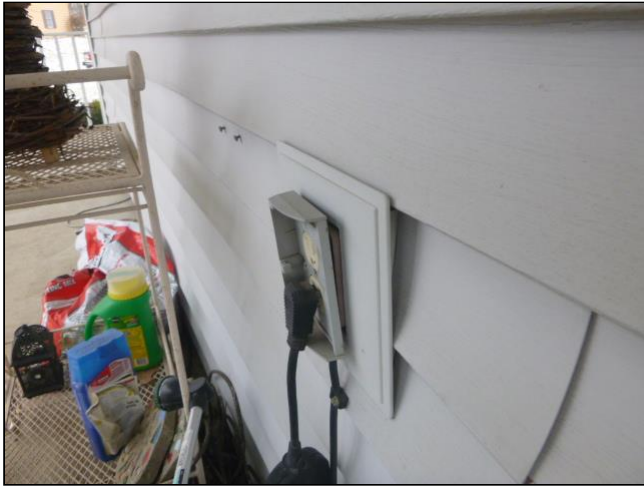
2.7 Item 1(Picture)

Exterior plug at the rear of the home tested good for ground circuit and correct polarity. No GFCI protection. GFCI protection should be present due to age of the build. Recommend evaluation by qualified electrical contractor as needed.

Porch plug was found loose and missing protective cover. Recommend having the plug or electrical box secured for safety.

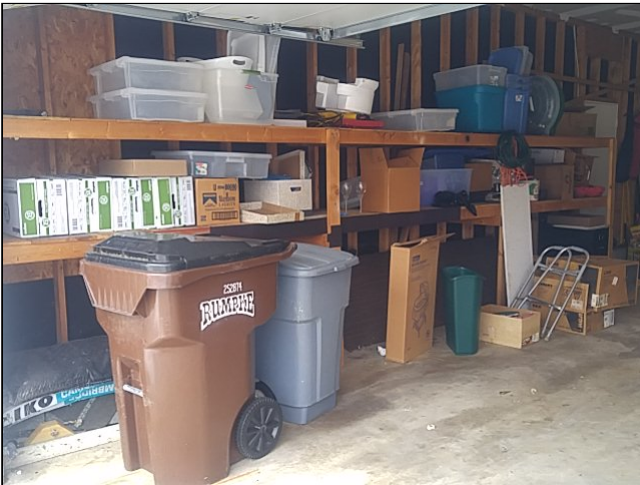
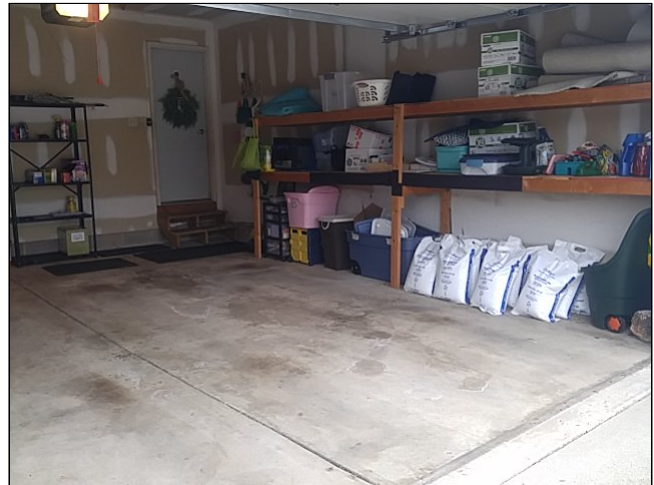
Walls found in overall good repair. General deterioration consistent with use and age; typical cracks and marks due to normal wear. Limited visibility due to home owner personal possessions.

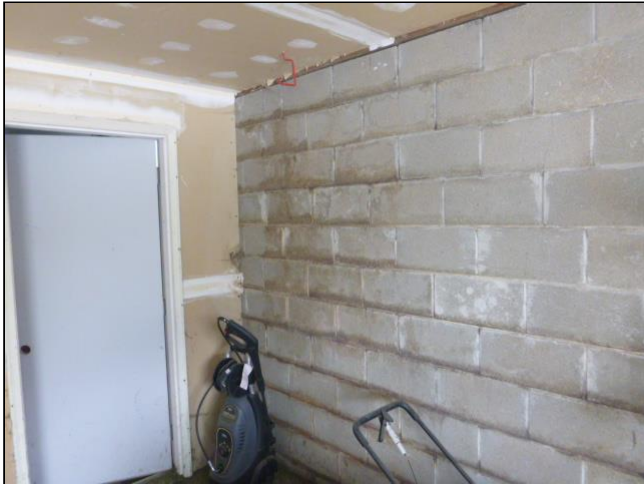
Water entry into the basement workshop below the in-law suite because of staining noted on the block. We would recommend monitoring and keep gutters and down spouts in good working order to manage moisture around the structure.

Foundation is marked for further evaluation and repair due to visible moisture entry and/or efflorescence on walls in the (LOCATION) of the basement/crawlspace. Recommend further evaluation and repairs by a qualified foundation waterproofing contractor.

4.0 Item 1(Picture) area behind exterior stoop

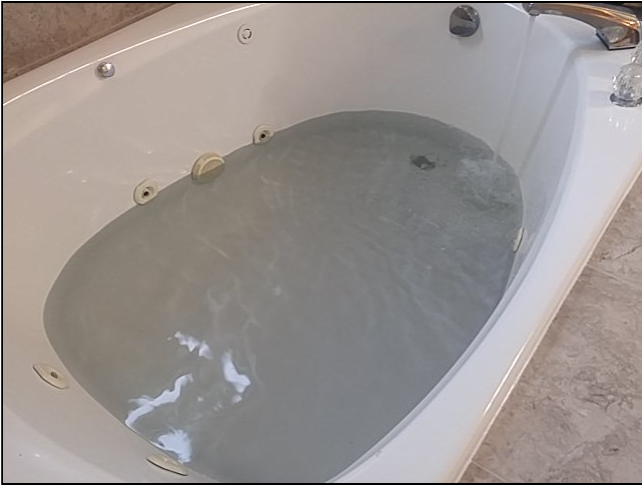
5.1 Item 1(Picture)

(1) Metals or debris in the water making it cloudy and dark. Recommend a whole house filter and softener check-up.

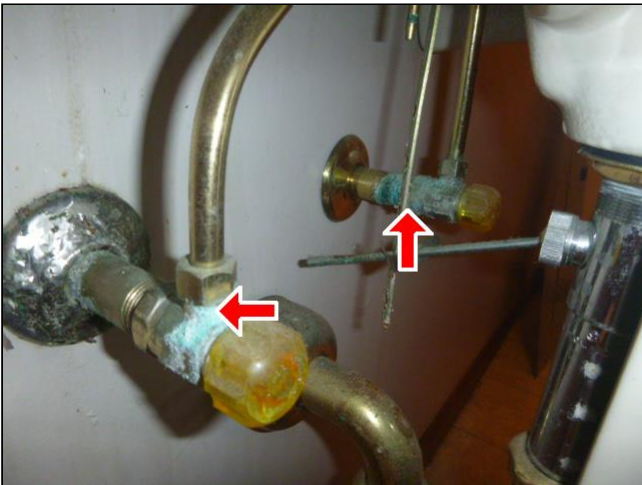
5.1 Item 2(Picture)

(4) Water supply line leaks noted at the basement pedestal sink. Recommend having the supply valves & nipples repaired by qualified plumbing contractor.

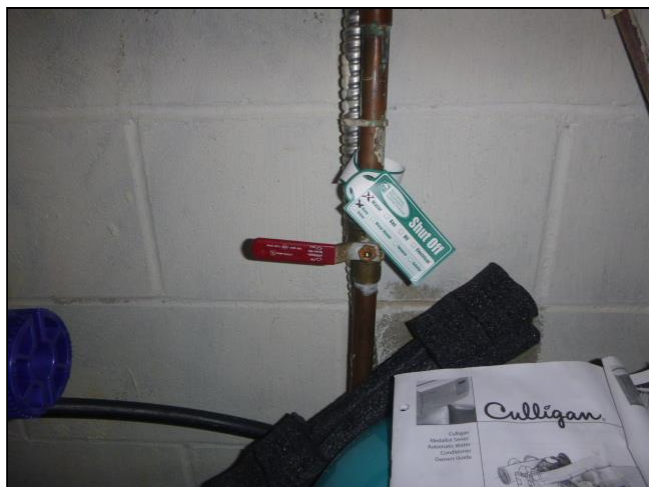
5.3 Item 1(Picture)

Main water shut off is located in the basement above the bladder tank.

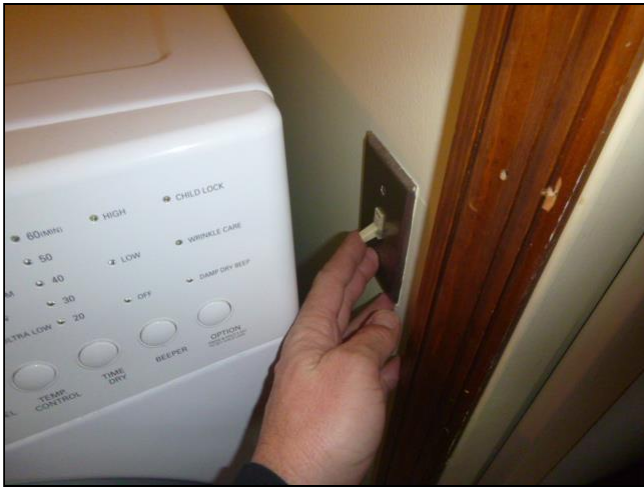
6.3 Item 3(Picture)

(2) Wall switch next to the washer/dryer had no function. Switch should control ceiling light as you exit or enter the room. Recommend repairs as needed.

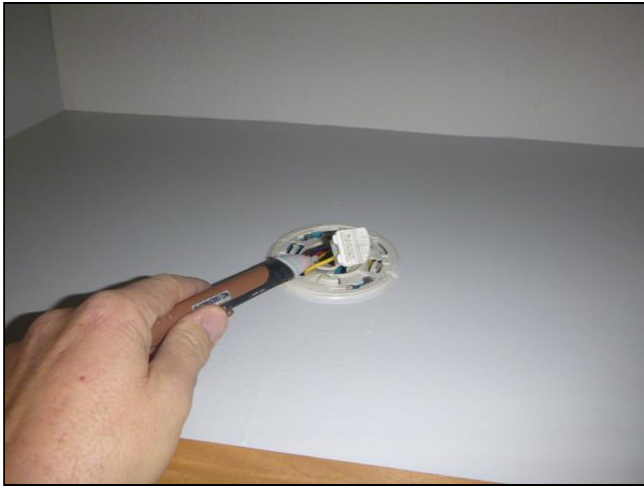
6.8 Item 1(Picture)

(1) Smoke detector has been removed from the In-Law suite. Recommend replacing for safety.

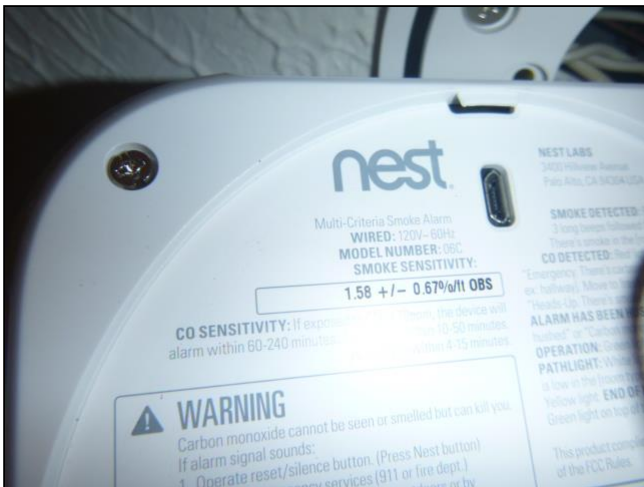
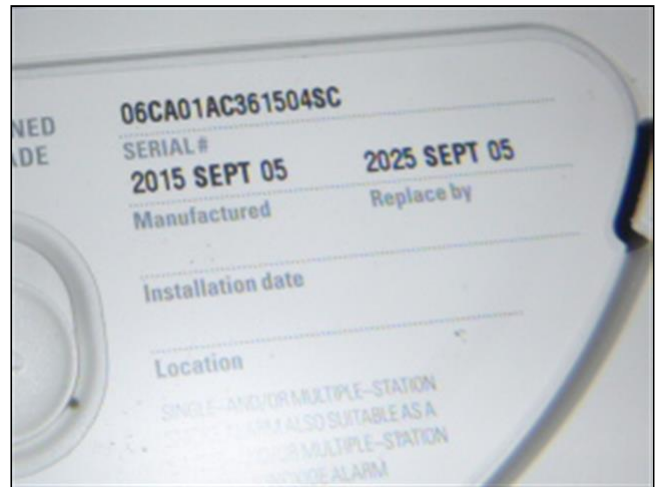
(2) Smoke detectors found on each level of the home and outside the sleeping rooms on the second floor. Detectors are connected to the electrical system of the the home and have a battery back-up in the case of power failure. Recommend replacing the batteries once a year to assure reliable operation in the event of power outage.

Smoke detectors have a 10 year operational life expectancy and manufactures recommend home owner test them monthly to assure operation.

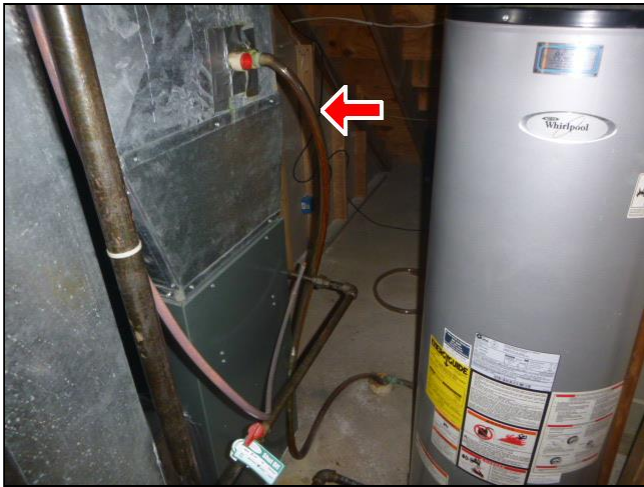
7.3 Item 1(Picture)

Condensate line uses gravity to control the moisture from the ventilation system to the floor drain. Lines require general maintenance to assure reliable operation.

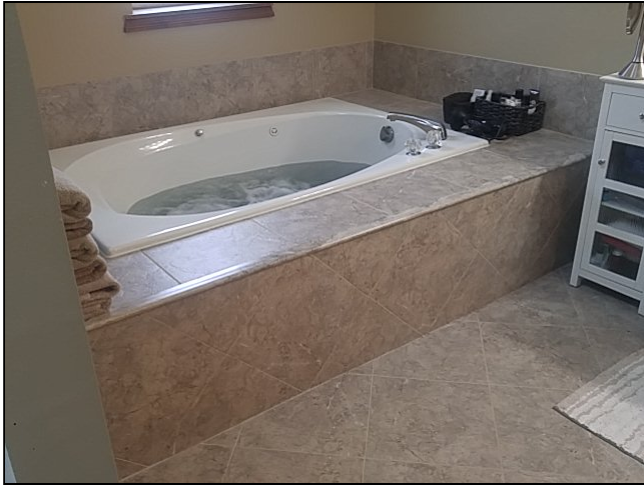
9.6 Item 1(Picture)

Jetted Tub was tested and appeared to operate correctly at the time of inspection. Tub had no accessible service access panel present. Inspector was not able to inspect the plumbing supply lines, plumbing drain lines or the electric source to the motor. Recommend adding an access panel to allow for future inspection or future service if necessary. Recommend repairs by qualified contractor.

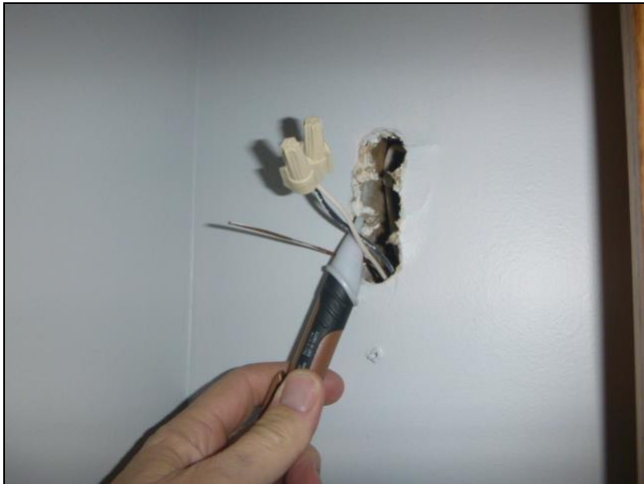
9.7 Item 1(Picture)

Vanity light missing and exposed electrical leads. Recommend repairs.

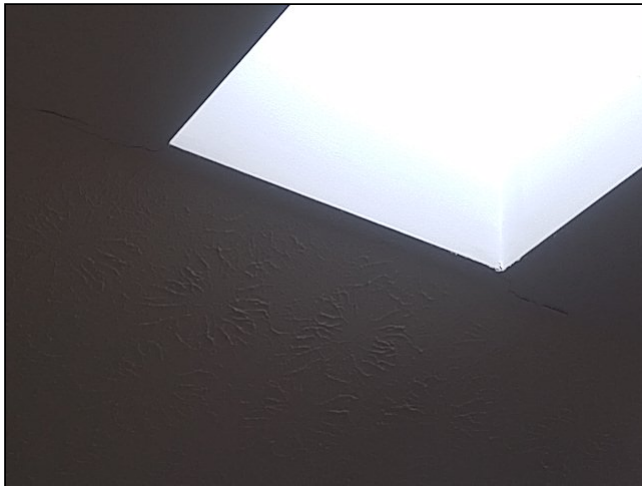
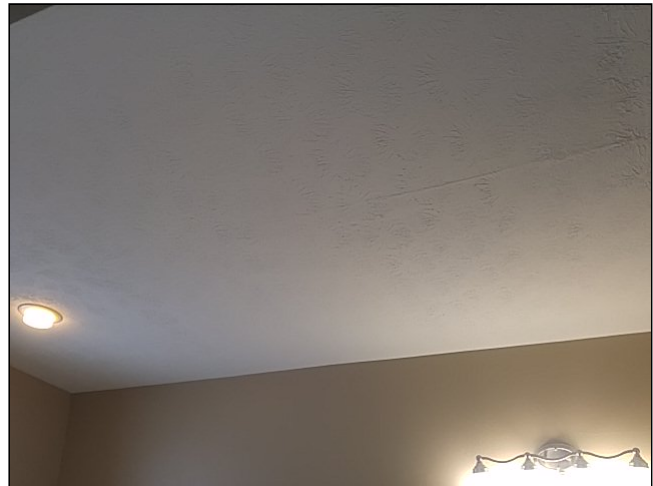
Previous repair noted on the basement ceiling.

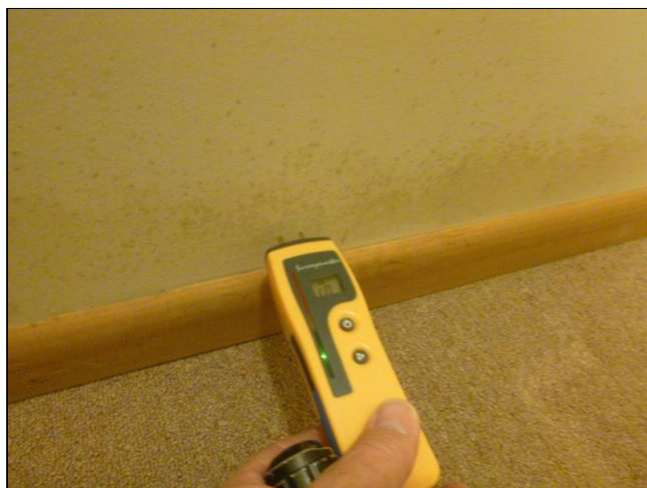
10.1 Item 1(Picture)

Basement closet wall in the southeast corner was found with surface residue. Area measured dry but maybe splatter or past fungal growth. Recommend evaluation by qualified handyman or contractor.

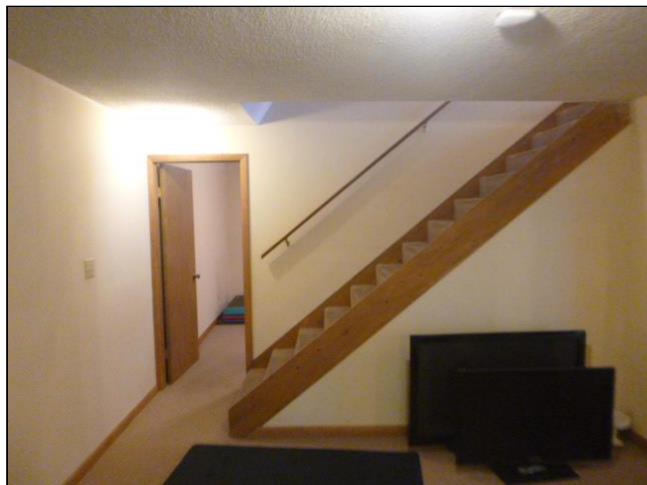
10.3 Item 1(Picture)

Handrail at the basement stairs is loose at the wall. Recommend replacing the support to prevent injury.

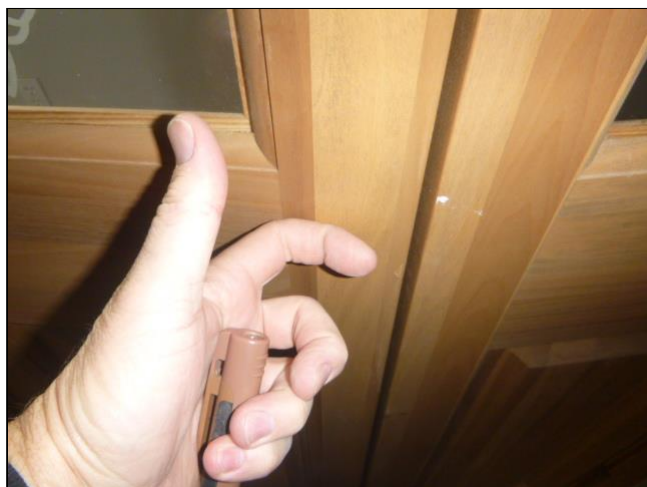
10.4 Item 1(Picture)

Double bedroom doors at the in-law suite are missing handles. No way to open the doors after closing. Recommend adding handles.

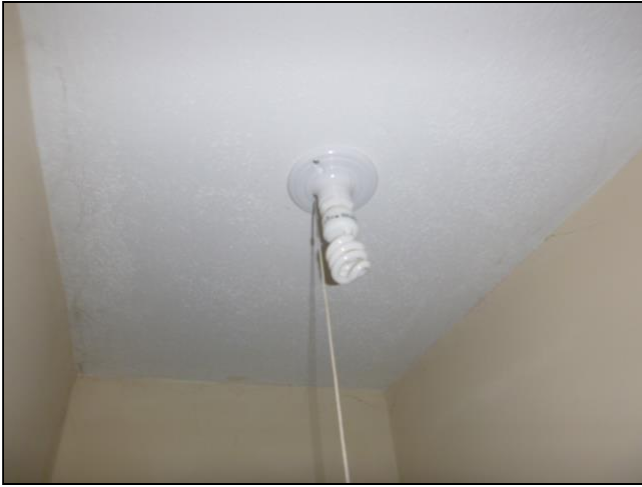
10.6 Item 1(Picture)

(2) Closets were found with open/surface mounted light fixtures. Recommend having replacement fixtures installed that have a globe or cover over the light because of fire hazard.
