JDeeEn Inc. DBA
National Property Inspections

Website Sample Report

Inspection Date:
06/20/2018

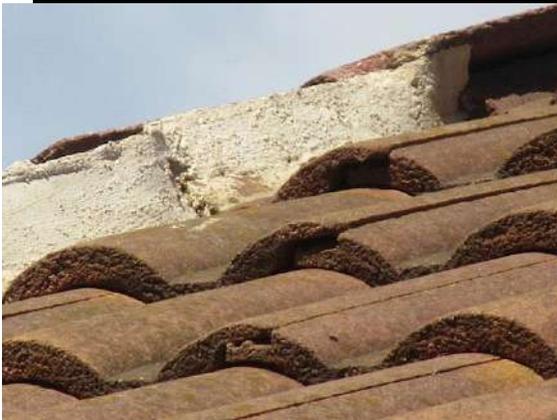
ROOFING: Unconventional roof patch at location of previous leak.

I'd strongly recommend a qualified, licensed roofing contractor inspect the roofs and make a determination if they are water-tight, if the current patches will last, and if further repairs are needed or the entire roof structure should be removed and replaced.

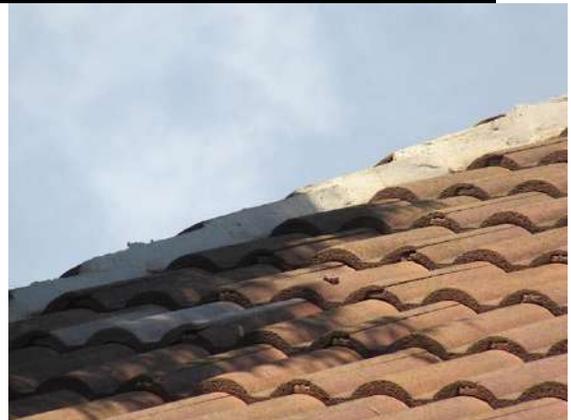
ROOFING: Unconventional roof patch at location of previous leak.

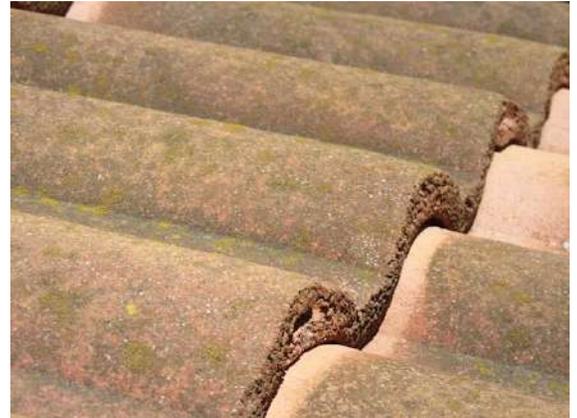
ROOFING (CONT): Lighter coloration of tile indicates areas where tiles have come loose.

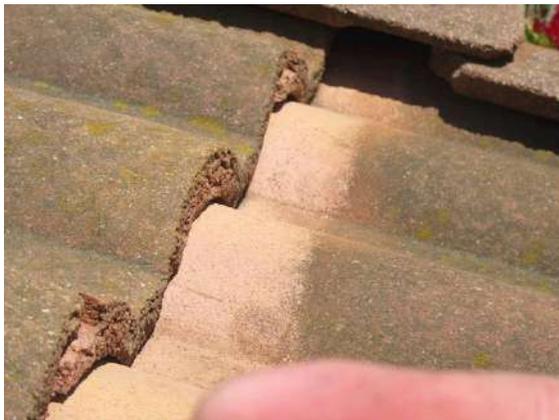
ROOFING (CONT): Lighter coloration of tile indicates areas where tiles have come loose.

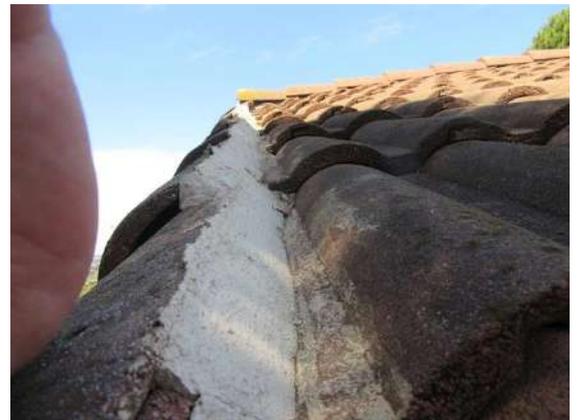
ROOFING (CONT): Unconventional repairs at location of previously suspected leak.

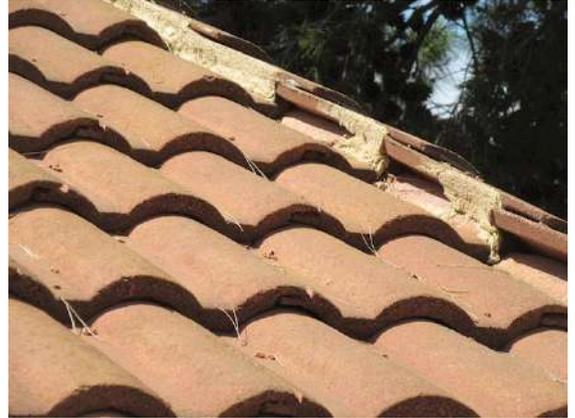
ROOFING (CONT 2): Unconventional repairs at location of previously suspected leak.

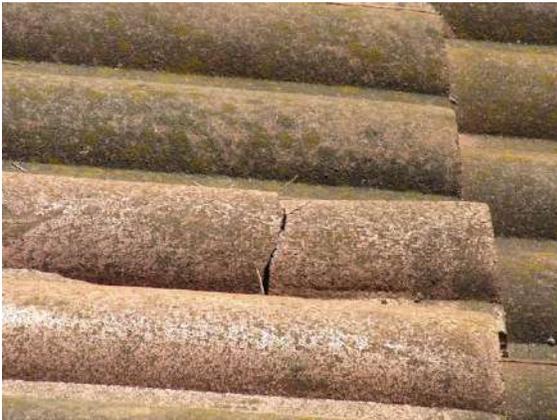
ROOFING (CONT 2): Some cracked tiles observed.

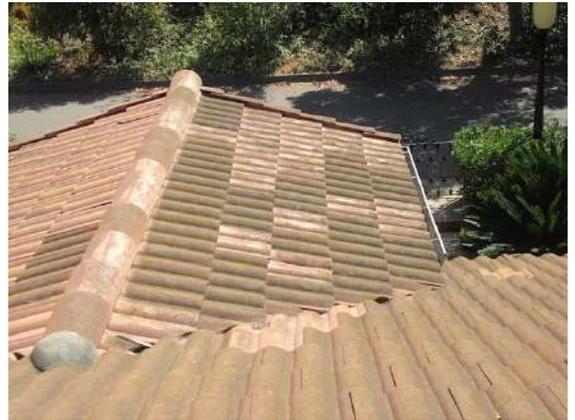
ROOFING (CONT 2): Locations of previous repairs.

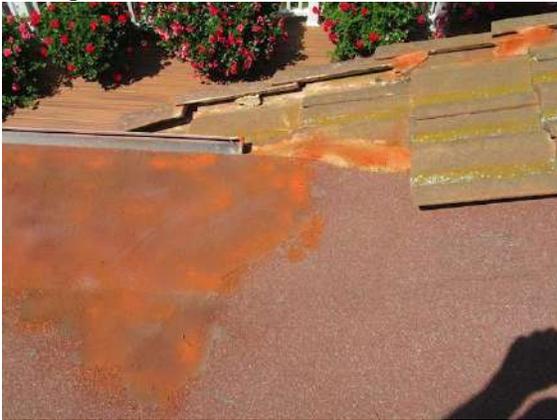
The flat roof over the sunroom appears to have been repaired for leaks at least once. Roof may be at or near its useful life. I'd recommend a qualified, licensed roofing professional inspect the roof and make a determination on possible repairs or replacement.

FLAT ROOF OVER SUNROOM: Evidence of unconventional repair methods with unknown materials indicates previous leaks.

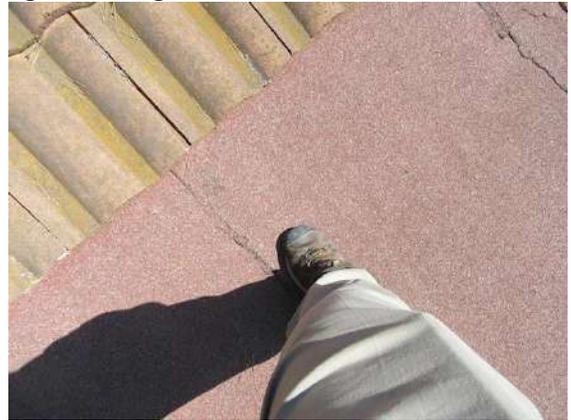
FLAT ROOF OVER SUNROOM: Soft spots and air pockets observed under rolled roofing indicating no adhesion or the adhesion has failed.

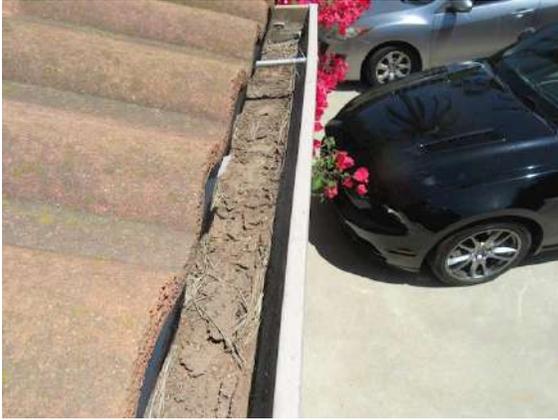
Gutters full of debris, which will inhibit water movement and may cause water ponding and gutters being ineffective. Recommend cleaning.

GUTTERS/DOWN SPOUTS: Some area had caked on mud in gutters which affects operation.

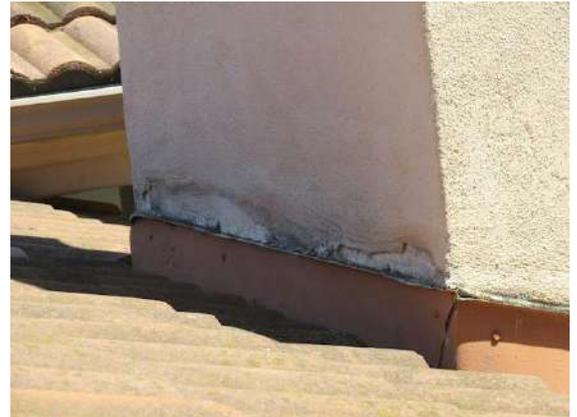
Chimney is 30 inches or wider and is missing cricket or saddle flashing at roof intersection. Water damage at flashing/stucco intersection indicates the lack of a cricket is causing issues. I recommend installing cricket/saddle flashing by a qualified roofing contractor to divert water away from the back side of the chimney.

CHIMNEY: Water damage at base of chimney at flashing.

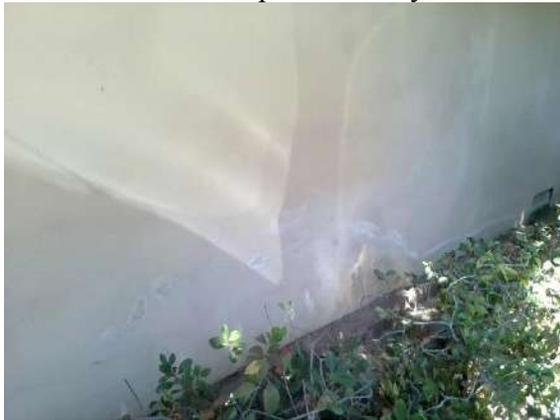
EXTERIOR SURFACE: Evidence of water staining and/or patching, potentially caused by irrigation. May warrant further investigation to resolve issue.

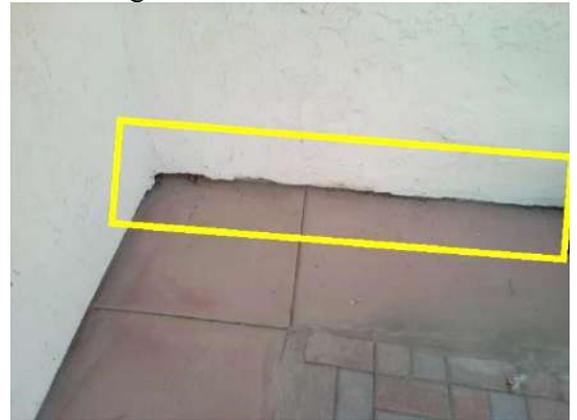
EXTERIOR SURFACE: Water damage and rusty drip screed.

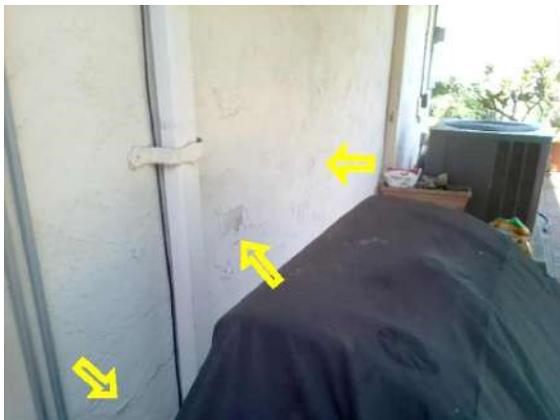
EXTERIOR SURFACE: Peeling paint in various locations.

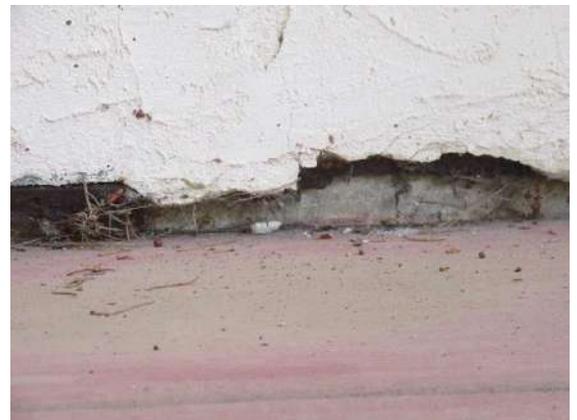
EXTERIOR SURFACE: Water damage and rusty drip screed.

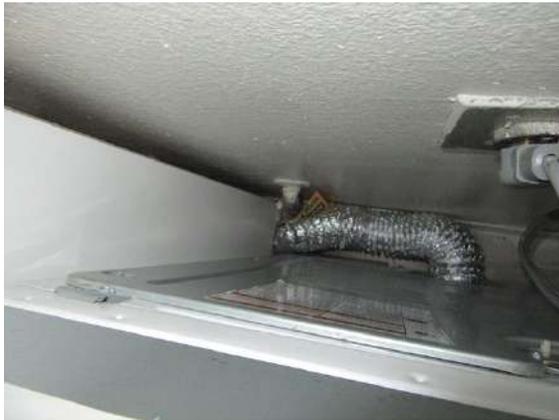
Dryer vent hose is made of a plastic fabric wrapped around a wire spiral and is not intended to be used for this purpose. Recommend installation of the proper type of metal flex pipe as recommended by dryer manufacturer by a licensed, qualified plumber.

LAUNDRY FACILITIES: Dryer vent snakes through back wall into cabinet, then garage, then under water heater to the outside.

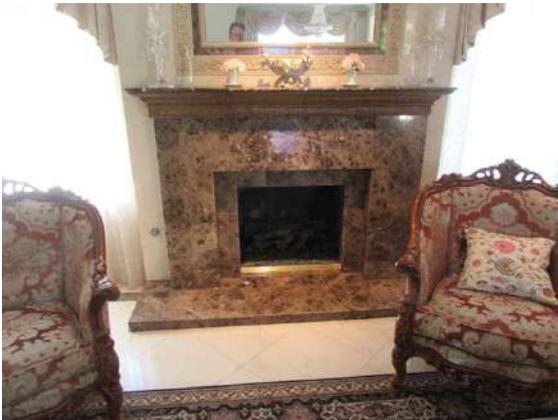
FIREPLACE/STOVE: No fireplace doors or spark arrestor screen installed.

No fireplace doors or spark arrestor screen installed. Recommend review by a fireplace expert.

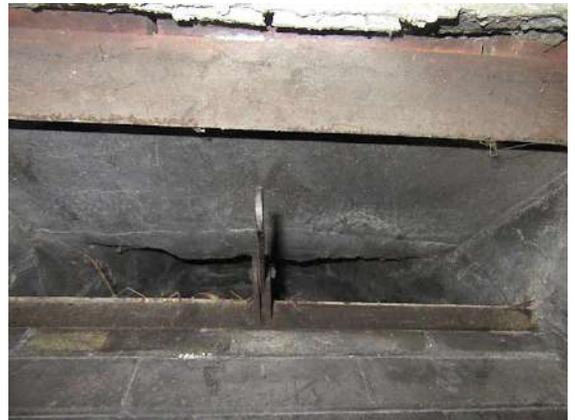
FIREPLACE/STOVE: Vent appeared to be missing damper stopper clamp

Vent appeared to be missing damper stopper clamp which when installed does not permit damper to be closed all the way. Completely closing the vent damper or forgetting the damper is all the way closed, while operating/starting the wood-burning fireplace will cause smoke/carbon monoxide to enter the living space. Recommend a damper stopper be installed.

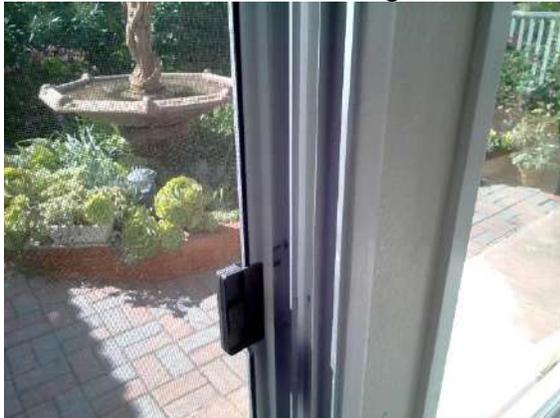
Screen latches/locks missing on both doors.

SUNROOM: Screen latches/locks missing.

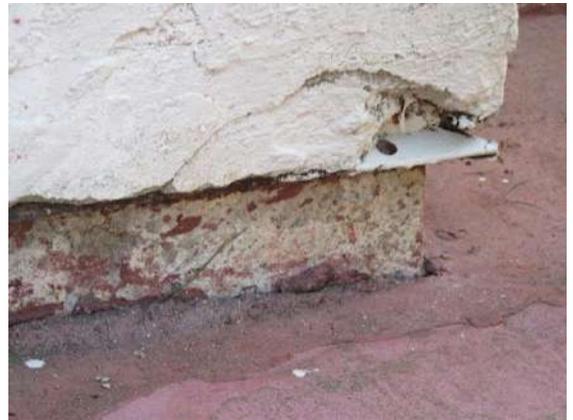
Foundation Apron: Evidence of water damage at footing and stucco intersection with damaged & rusted drip screed. Also observed patching of flatwork next to house.

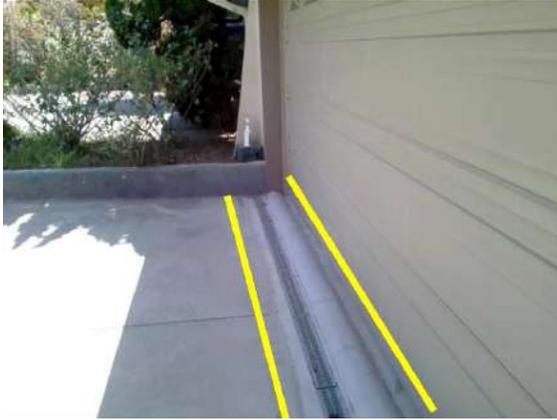
Foundation Apron: Installation of concrete berm & trench drain indicate possible past water intrusion issues.

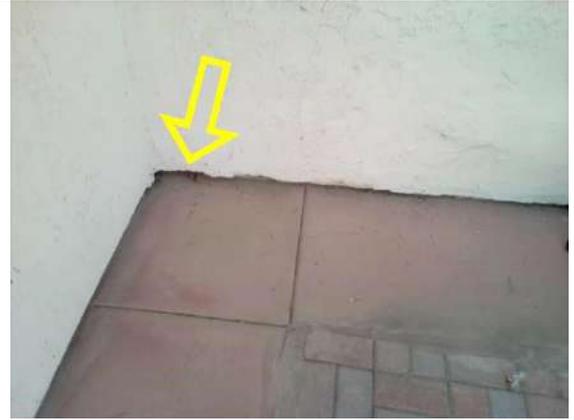
Foundation Apron: Observation of concrete apron around structure. Arrow indicates potential past water damage.

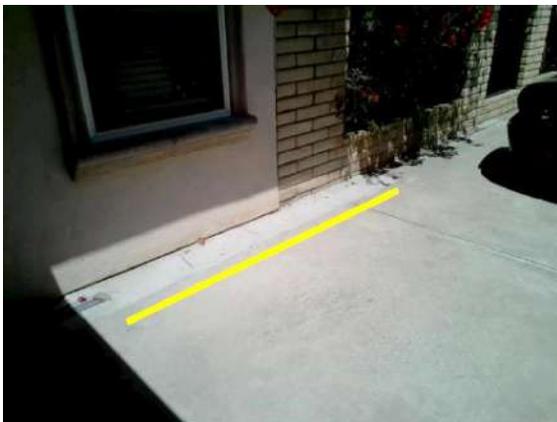
Driveway: Concrete repair potentially in conjunction with installation of driveway trench drain.

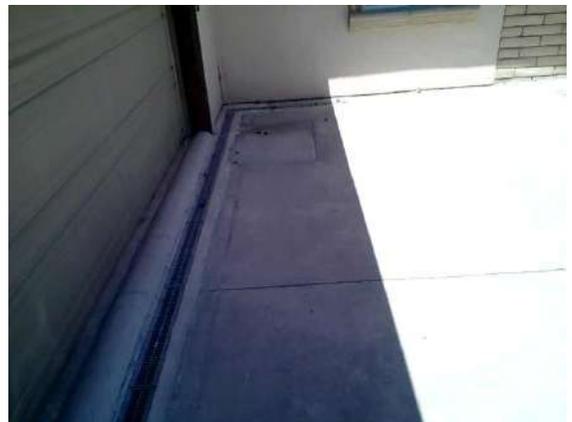
Driveway: Driveway berm/trench drain installation.

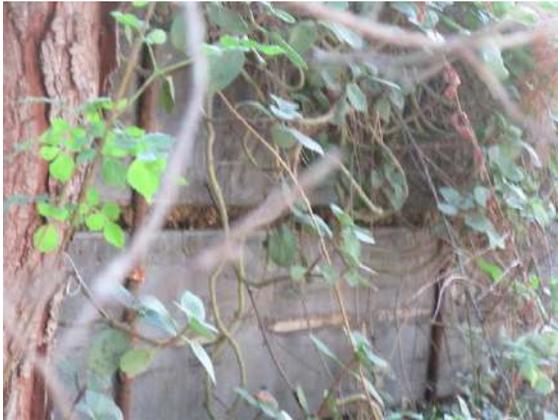
Retaining Walls (cont): Rebar outside of wall used to stabilize wall.

I strongly urge a licensed structural/geotechnical engineer inspect the walls and make recommendations for stabilization.

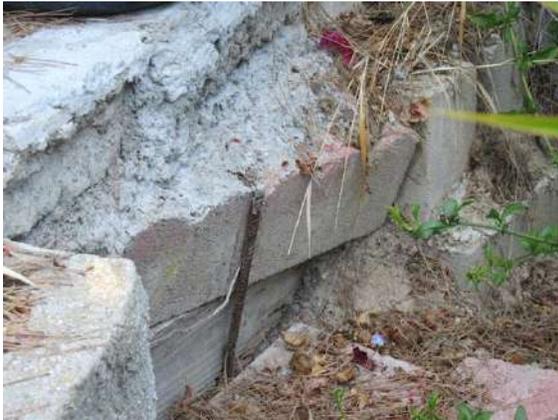
The fact that various block laying methods were used, rebar was used to hold up the wall from the outside rather than the conventional inside of the wall, mortar beds are uneven, partially missing, or filled with bit of floor tile and not struck clean, Block laid crooked and kittywampus throughout, places the entire integrity of the wall as suspect.

Retaining Walls (cont 2): Example of poor and unconventional workmanship encompassing the entire retaining wall structure.

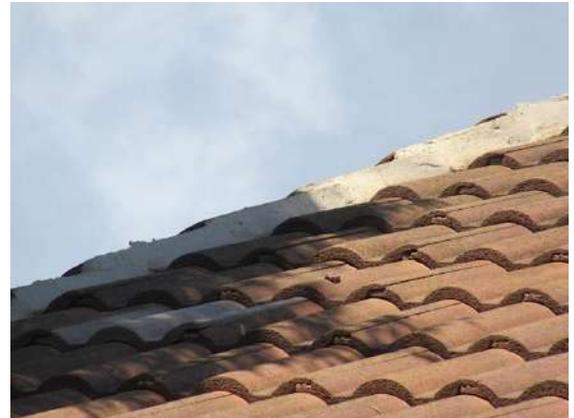
Roofing: Unconventional roof patch at location of previous leak.

I'd strongly recommend a qualified, licensed roofing contractor inspect the roofs and make a determination if they are water-tight, if the current patches will last, and if further repairs are needed or the entire roof structure should be removed and replaced.

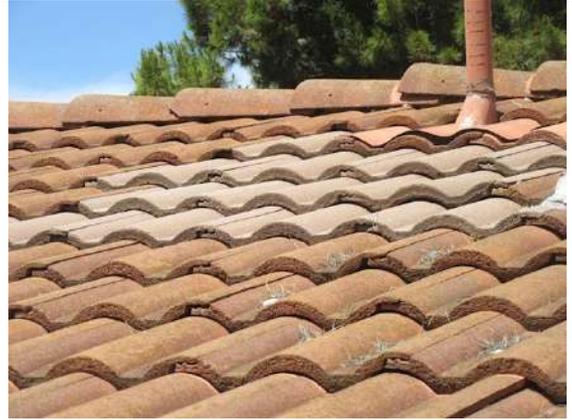
Roofing: Lighter tile indicate past repairs.

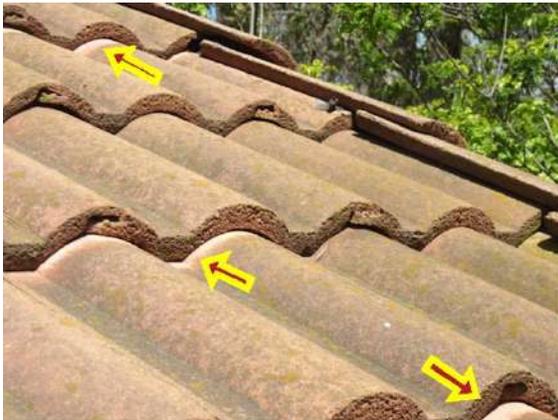
Roofing (cont): Lighter coloration of tile indicates areas where tiles have come loose.

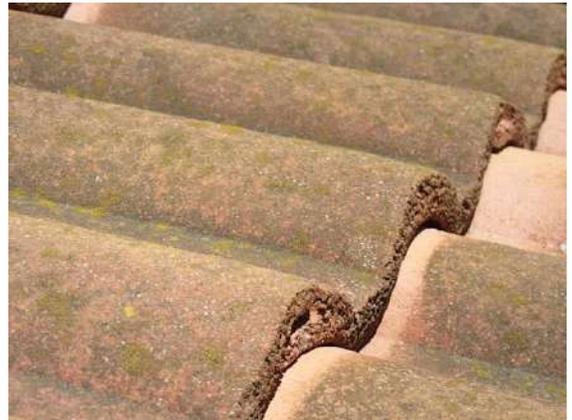
Roofing (cont): Lighter coloration of tile indicates areas where tiles have come loose.

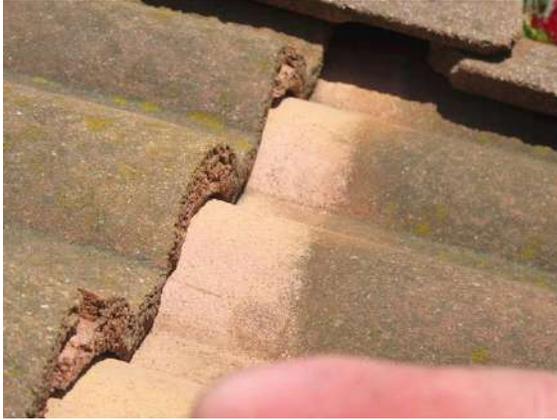
Roofing (cont): Lighter coloration of tile indicates areas where tiles have come loose.

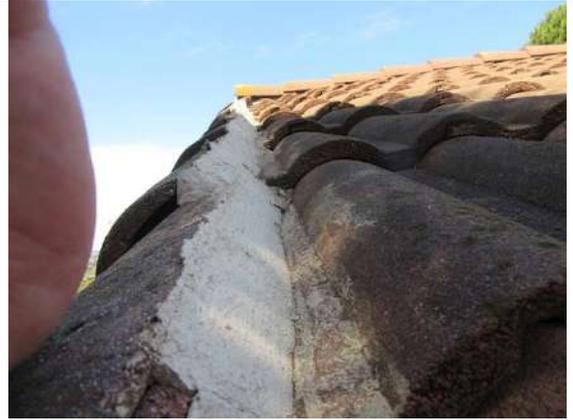
Roofing (cont): Unconventional repairs at location of previously suspected leak.

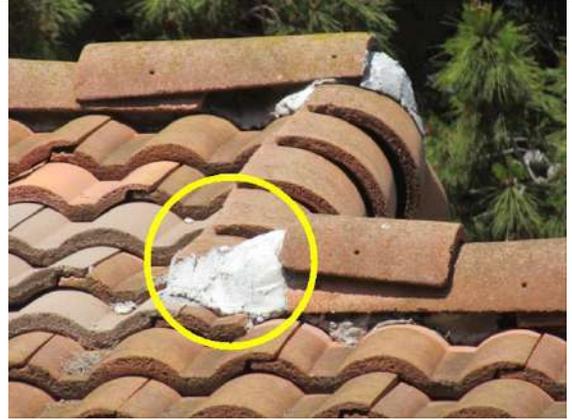
Roofing (cont): Unconventional repairs at location of previously suspected leak.

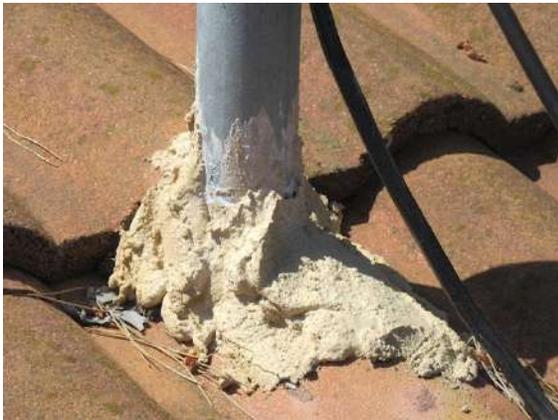
Roofing (cont 2): Unconventional repairs at location of previously suspected leak.

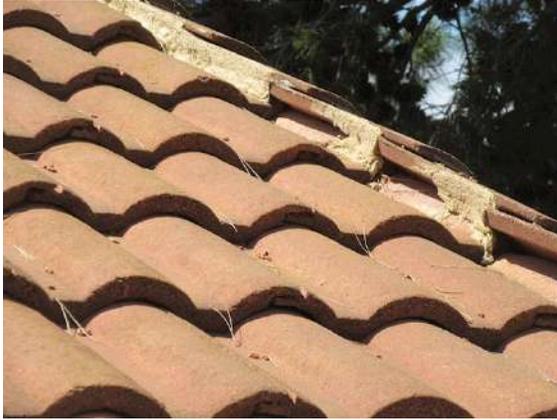
Roofing (cont 2): Unconventional repairs at location of previously suspected leak.

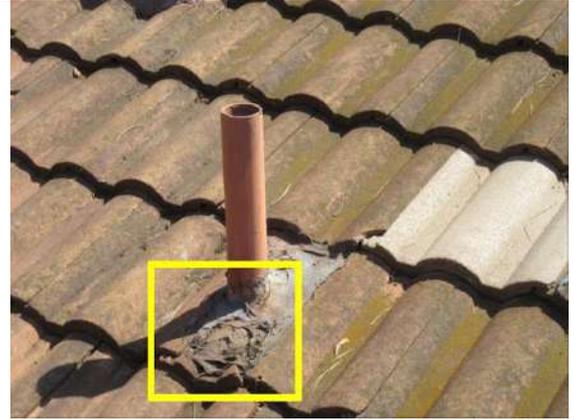
Roofing (cont 2): Unconventional repairs at location of previously suspected leak.

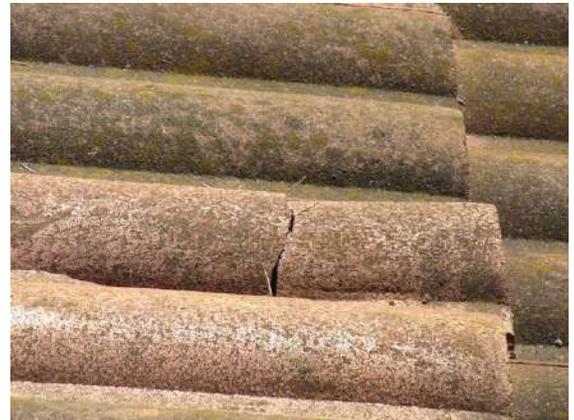
Roofing (cont 2): Some cracked tiles observed.

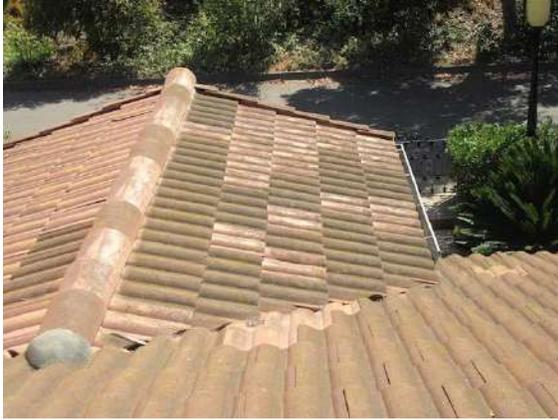
Roofing (cont 2): Locations of previous repairs.

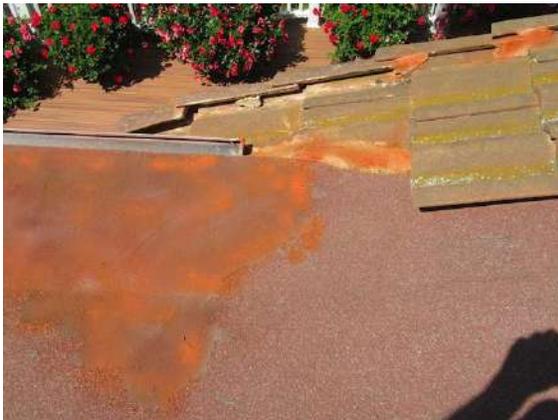
The flat roof over the sunroom appears to have been repaired for leaks at least once. Roof may be at or near its useful life. I'd recommend a qualified, licensed roofing professional inspect the roof and make a determination on possible repairs or replacement.

Flat Roof over Sunroom: Evidence of unconventional repair methods with unknown materials indicates previous leaks.

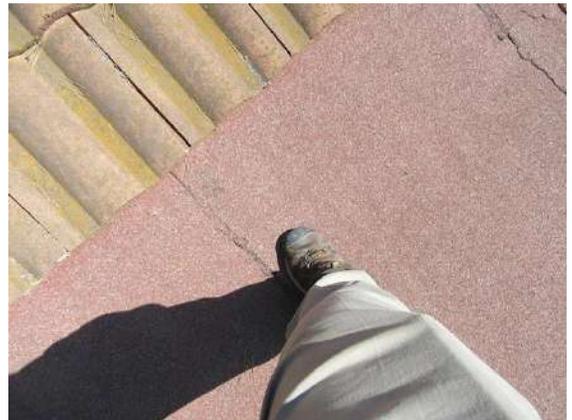
Flat Roof over Sunroom: Soft spots and air pockets observed under rolled roofing indicating no adhesion or the adhesion has failed.

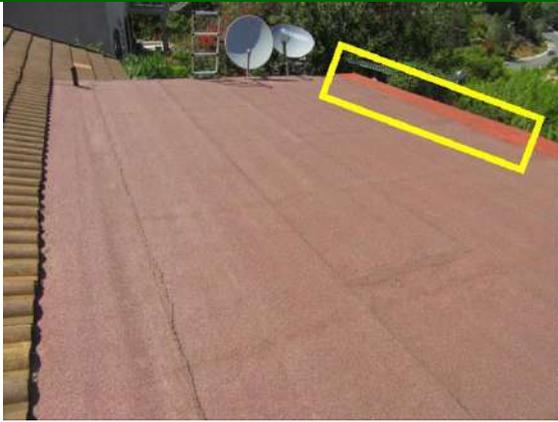
Flat Roof over Sunroom: Location of previous roof repairs at location of suspected leaks.

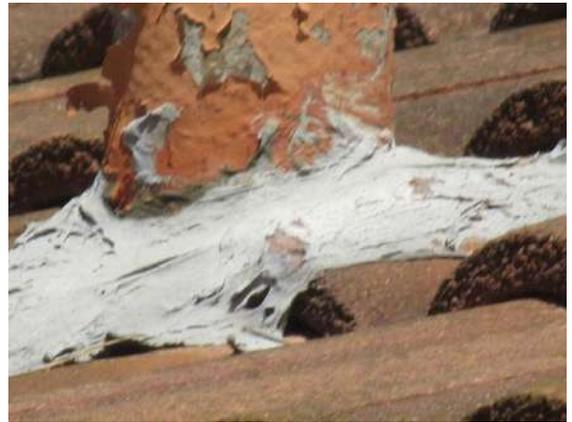
Flashing/Valleys: Temporary, non-professional repair.

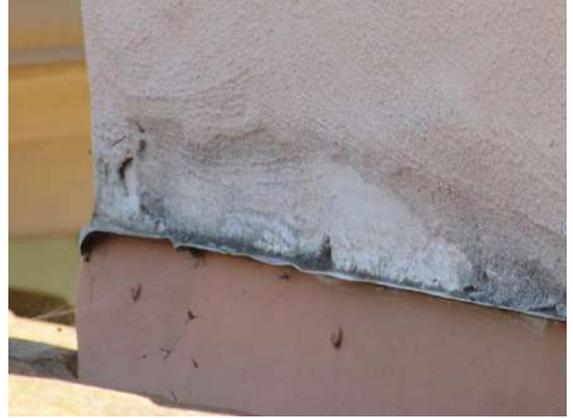
Chimney: Water damage at base of chimney at flashing.

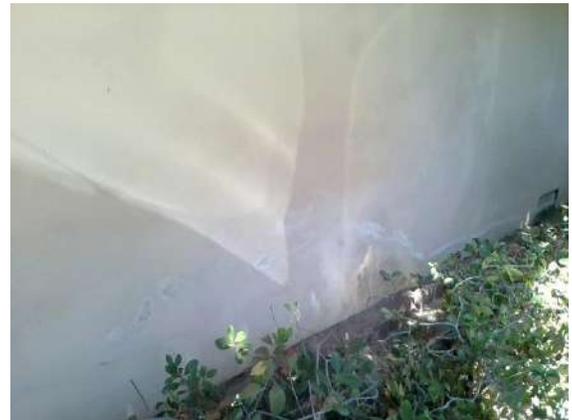
Exterior Surface: Evidence of water staining and/or patching, potentially caused by irrigation. May warrant further investigation to resolve issue.

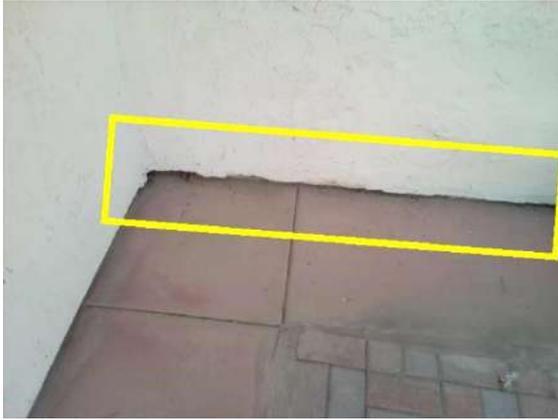
Exterior Surface: Water damage and rusty drip screed.

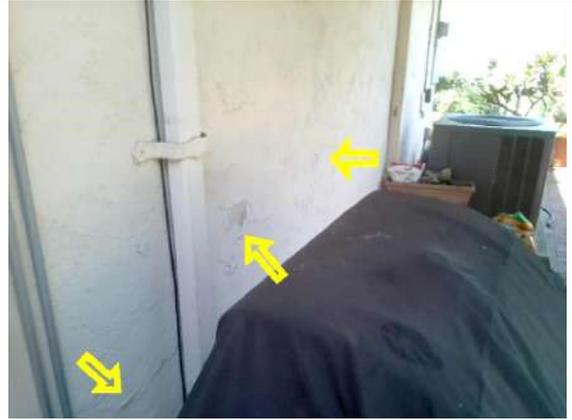
Exterior Surface: Peeling paint in various locations.

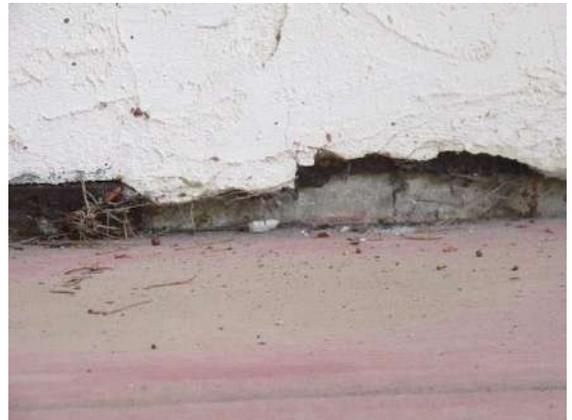
Exterior Surface: Water damage and rusty drip screed.

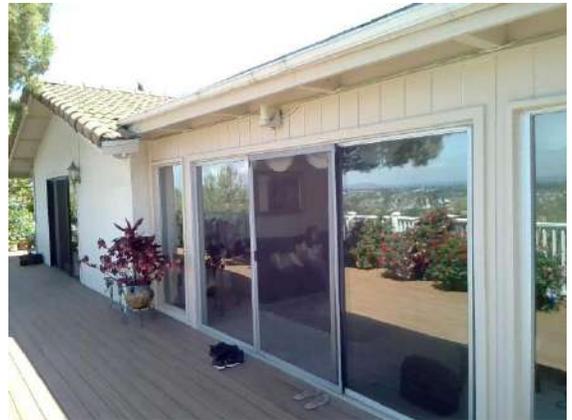
Exterior Doors: Sliding doors off sunroom are missing the door lock mechanisms on both sets of doors.

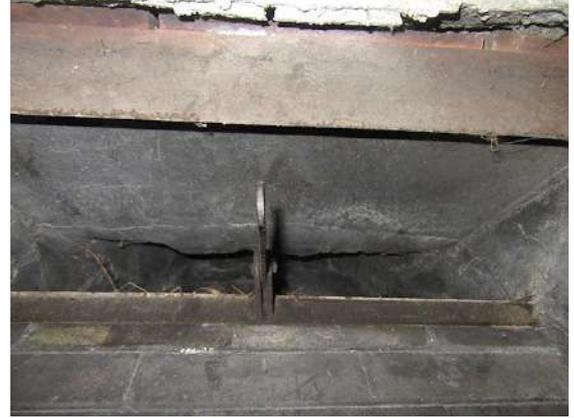
Fireplace/Stove: Vent appeared to be missing damper stopper clamp

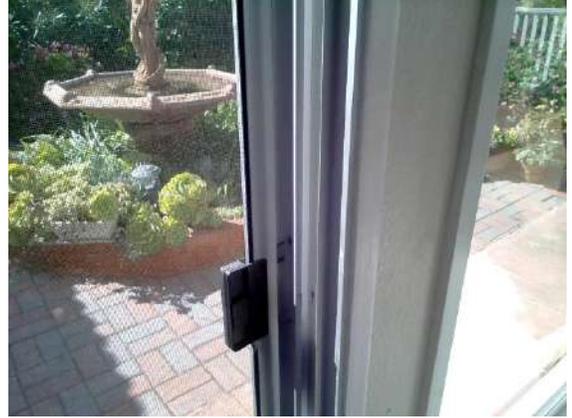
Sunroom: Screen latches/locks missing.

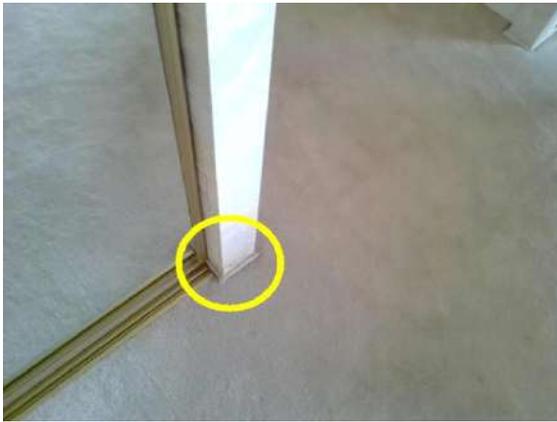
Water damage observed next to closet door near floor. Ceiling looks as if it has been recently repainted, with paint making its way onto the wallpaper in several locations. Though this is cosmetic in nature and typically not part of a home inspection, it warrants pointing out as evidence of potential or past water leaks based on what was observed around perimeter of the house flatwork and the roof disrepair.

East Master Bedroom: Previous water damage observed.
