Southwest Virginia Property Inspections, LLC DBA  
National Property Inspections

My Client, 123 Any Street, Southwest, VA, 99999

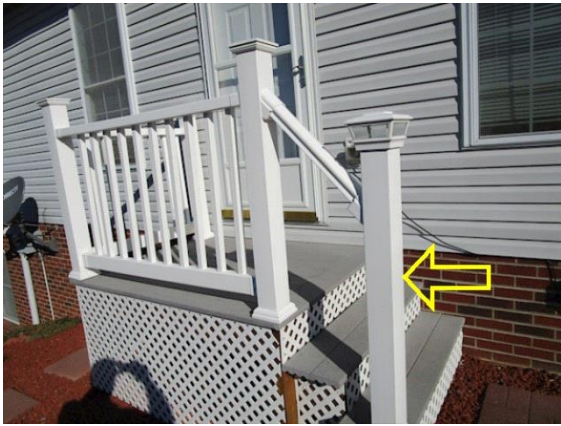
Porches / Stoops:

The handrail is loose on the side porch.

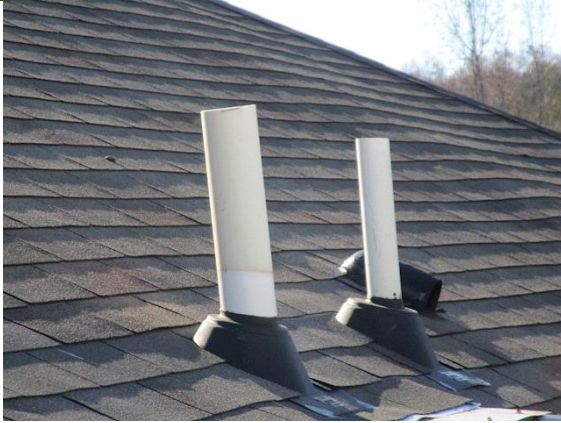
Roofing:

Leaks not always detectable.

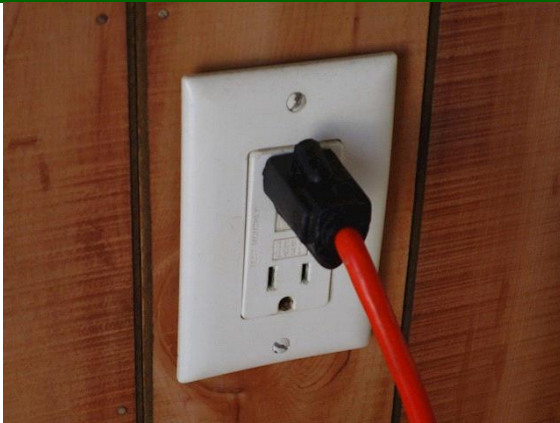
Garage/Carport:

The GFCI outlet on the left wall is defective. GFCI (Ground Fault Circuit Interrupter) outlets help reduce the risk of electrical shock. GFCIs detect a change in current between the "hot" and "neutral" wires and trip the circuit, shutting off power to the circuit.

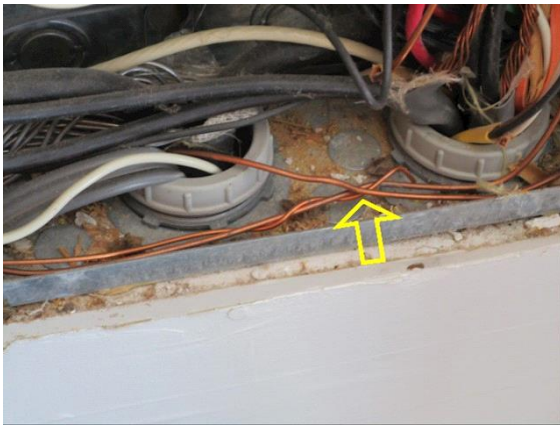
Electrical:

\* There is an improperly grounded circuit at the bottom of the panel (ground wire wrapped not bonded with clamp).  
 \* The CSST (yellow) piping in the basement that leads to the propane tank needs to be grounded.  
 "Manufacturers believe that this product is safer if properly bonded as required by the manufacturer's installation instructions. Proper bonding and grounding of the product should be determined by a contractor licensed to perform the work in the Commonwealth of Virginia."

- \* There is an improperly grounded circuit at the bottom of the panel (ground wire wrapped not bonded with clamp).
- \* The CSST (yellow) piping in the basement that leads to the propane tank needs to be grounded. "Manufacturers believe that this product is safer if properly bonded as required by the manufacturer's installation instructions. Proper bonding and grounding of the product should be determined by a contractor licensed to perform the work in the Commonwealth of Virginia."

Recommend a licensed, certified, professional electrician be consulted.
