INSPECTION REPORT

Address
Sarasota FL 34234

Client Name
NOVEMBER 9, 2020

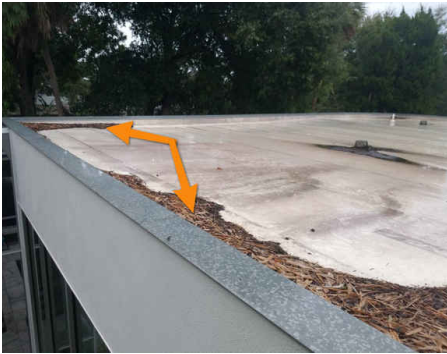
Debris needs to be removed for proper draining.

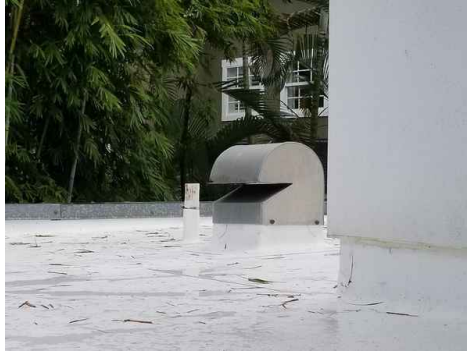
Plumbing vent and exhaust fan vent from bathroom

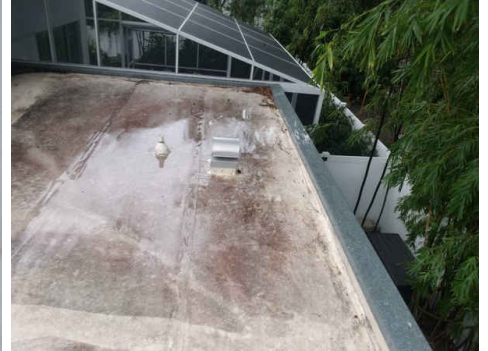
Plumbing vent and exhaust fan vent from master bathroom

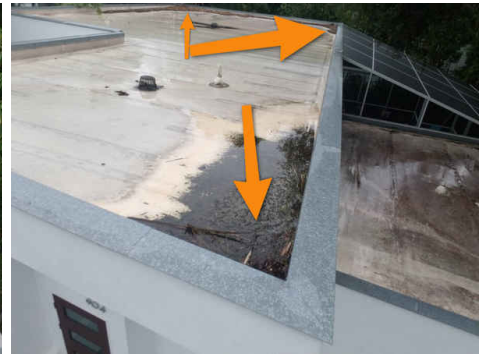
Debris needs to be removed for proper draining.

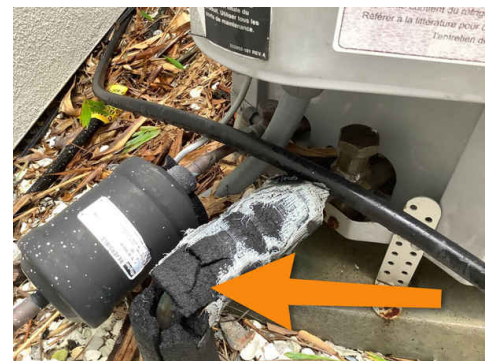
EAST

REFRIGERANT LINE INSULATION

Insulation was damaged/deteriorated/missing on the refrigerant lines. Recommend licensed HVAC technician repair or replace insulation.

Contact a qualified heating and cooling contractor

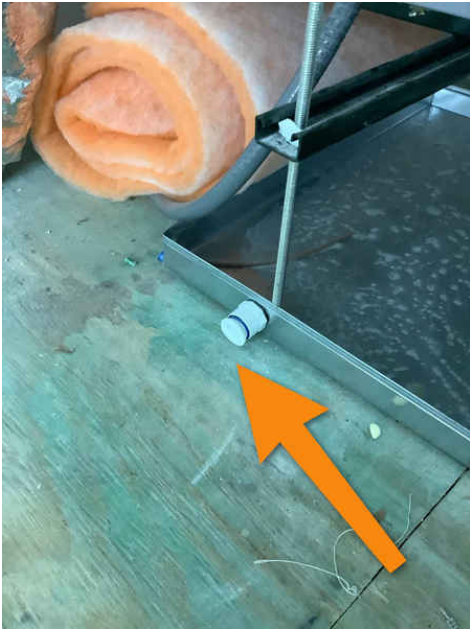
NO DRAIN LINE

A high-efficiency furnace or air conditioning equipment was installed. A catch pan was installed to prevent damage to finished spaces below from leaking condensate water. However, no auxiliary drain line was installed at the catch pan. Recommend that a qualified HVAC contractor install an auxiliary drain line per standard building practices.

Contact a qualified heating and cooling contractor

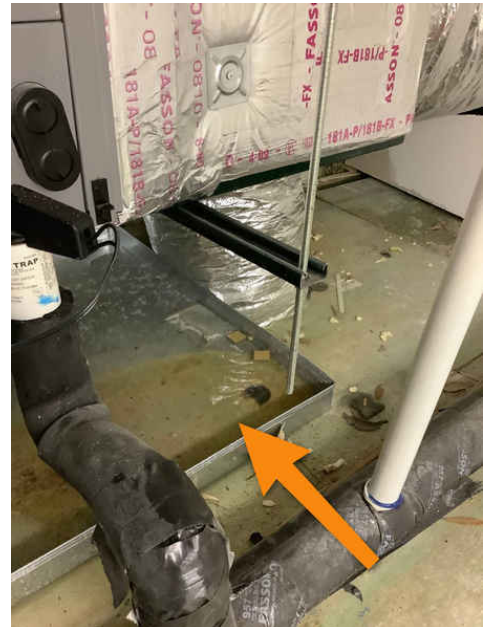
WATER IN CATCH PAN

Standing water in catch pan. A licensed HVAC technician should complete a more invasive inspection.

Contact a qualified heating and cooling contractor
