Upper Chesapeake Inspections, LLC DBA
National Property Inspections

ABC Warehousing, Inc, 123 Commercial Drive, Building 321, Anytown, MD, 12345

Monday, July 18, 2022

GENERAL INFORMATION

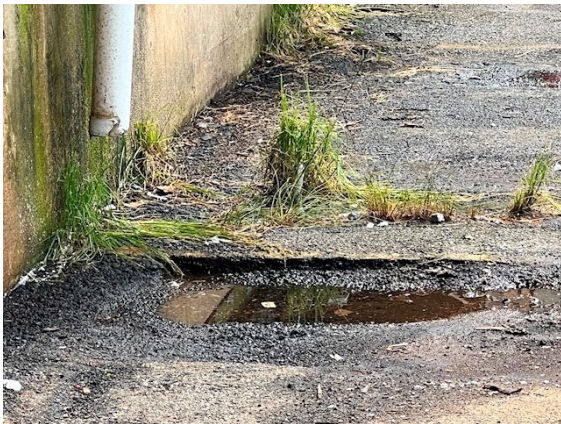
Grading was found to be mostly level with some areas of positive slope away from the building foundation. Some evidence of ponding was observed around the property, primarily in the parking lot and loading dock area. This will be covered in more detail later in the report.

Grading / Drainage: Ponding observed in some low lying areas in the dock/loading area

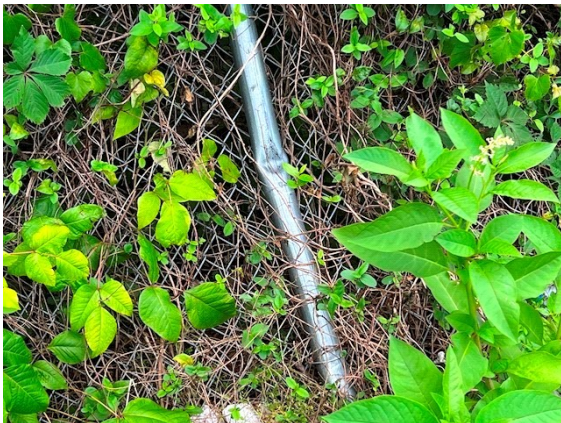
Fencing on the east side of the yard was over grown with vegetation and appeared to have been hit by a vehicle, as it is leaning. Wiring conduit at the base of the gate entry keypad needs to be replaced.

Fences / Enclosures: Fence pole on east side of yard bent and fence leaning in this area

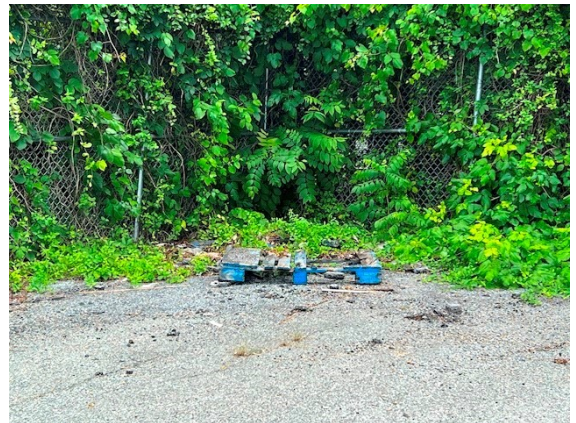
Fences / Enclosures: Vegetation growth should be removed from fencing

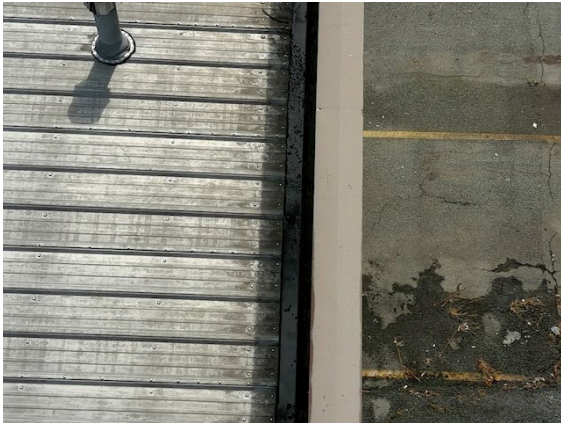
Overall the roof drainage system is in fair to poor condition due to multiple defects observed during the inspection. Age and lack of regular upkeep is the probable cause of these issues. There are some holes in the gutter system (some visible and some not). Also of note were the lack of splash blocks being installed at the bottom of downspouts or downspouts not being directed away from the foundation. At the southwestern side of the building the gutters and downspouts are directed underground at first and then through a larger pipe that empties in front of the loading dock area. This allows water run off to pool even more in this area, especially during heavy rains. Recommend further evaluation by a professional contractor.

Roof Drainage System: Water observed sitting in gutters on south side of building

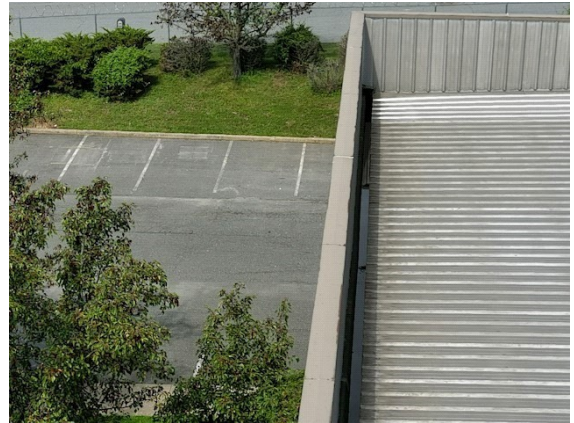
Roof Drainage System: More water not completely draining from gutters on south side

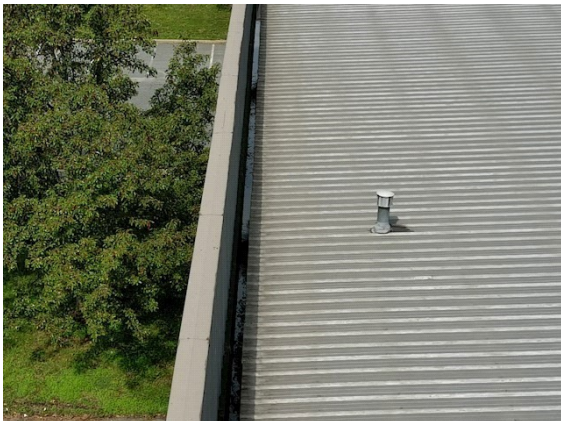
Roof Drainage System: Water not draining, possibly due to debris in the gutters

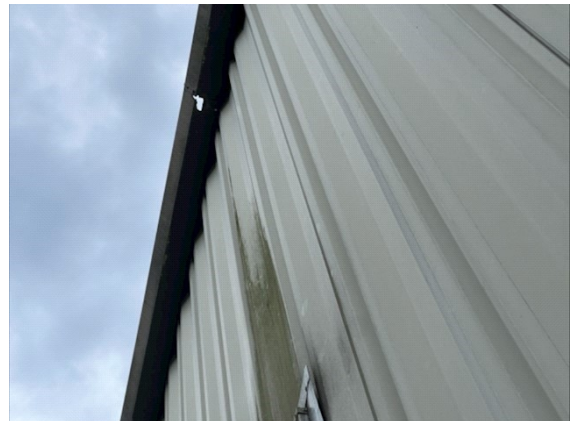
Roof Drainage System: Large hole in gutter on north side of building

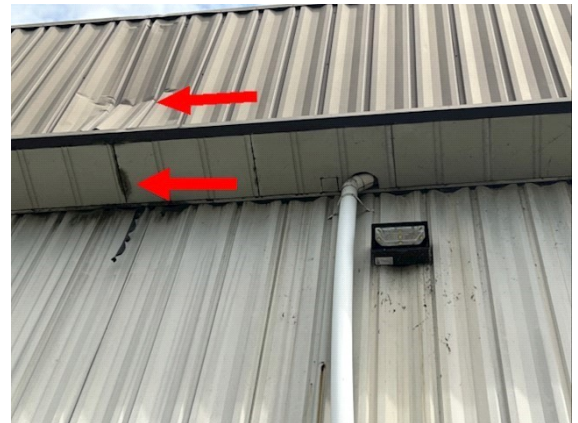
There appear to be multiple leaks in the gutter system along the southern parapet wall. Weather seals are hanging in some areas along this wall and water staining is present on the wall covering underneath the parapet. Infrared imaging appears to show evidence of the gutter leaks as well. This is not a failure of the parapet wall, but more so the gutter system contained by it. There was also some damage to the southern wall as well, above freight door #5.

Parapet Wall System: Damage to parapet wall and evidence of gutter leaks

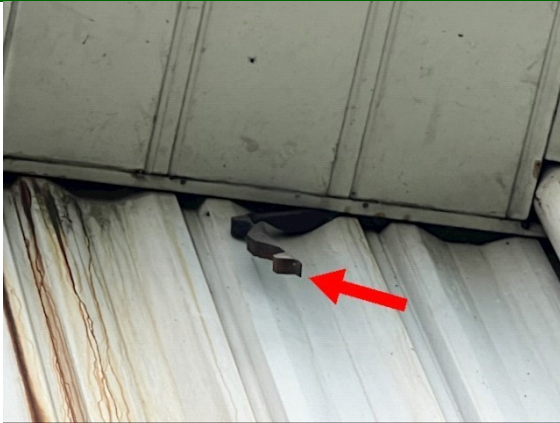
Parapet Wall System: Weather seals hanging down in some locations

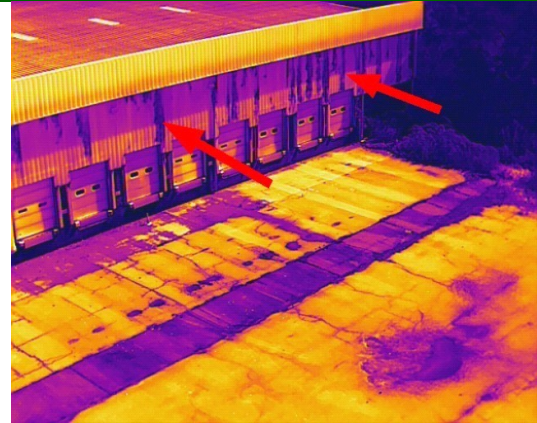
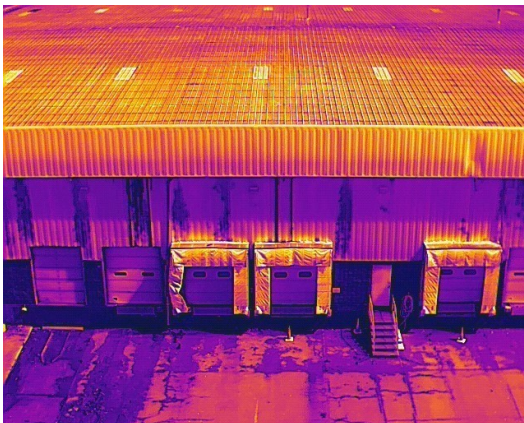
Parapet Wall System: Infrared image of south side showing evidence of gutter leaks

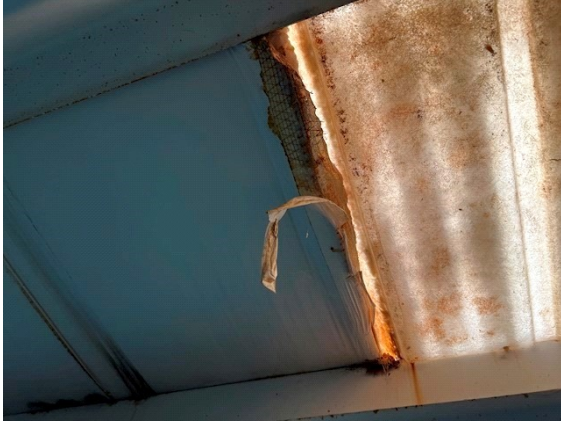
Evidence of leaking was found around a fiberglass roof panel on the northeastern section of the roof. There were also a few other suspected leaks that will be covered in the insulation section of this report. During the inspection there were also vent pipes observed that are no longer connected to an appliance inside the building. Recommend these be removed and penetration capped and sealed in these locations. Dented center steel column near eastern wall of building.

Roof & Interior Structure: Insulation tape peeling away from water intrusion

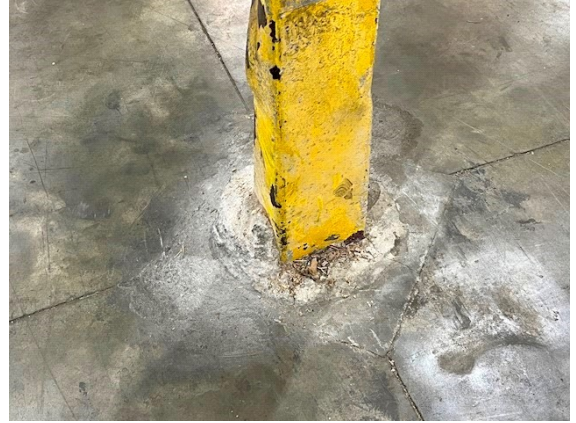
Roof & Interior Structure: Dented steel column with concrete repair evident

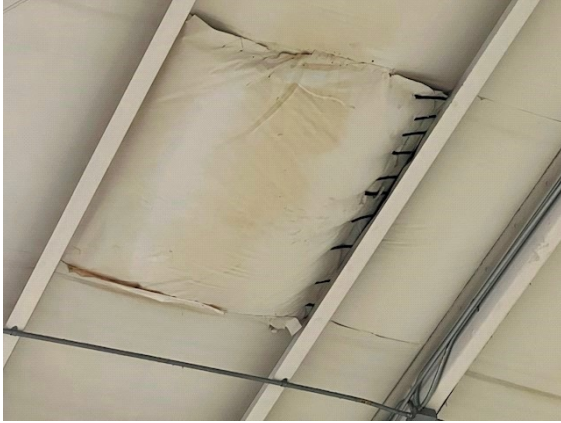
Roof Insulation: Evidence of past leak

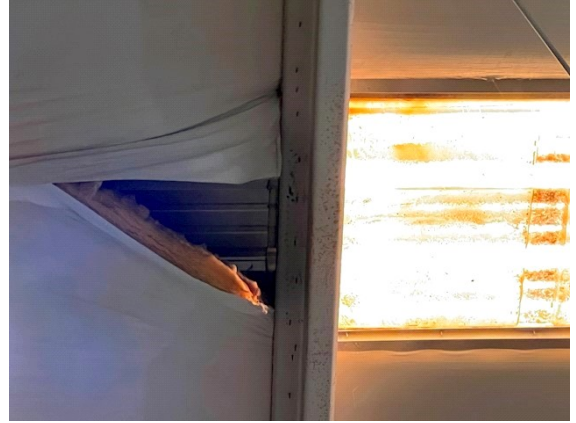
Roof Insulation: Evidence of past leak, dry on the day of inspection

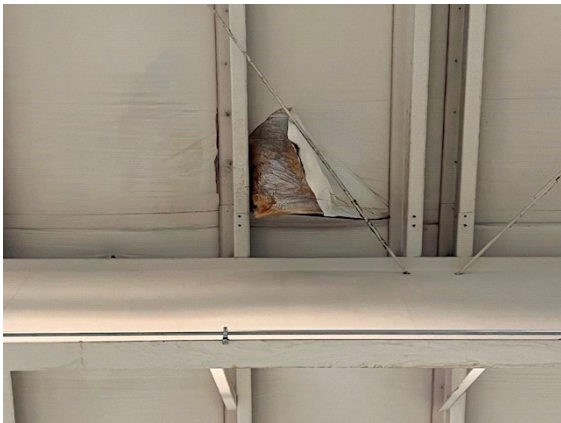
Evidence of past and present leaks were observed during the inspection. See photos below for details. Recommend further evaluation by a roofing professional.

Roof Insulation: Evidence of active leak (northeastern quadrant of roof)

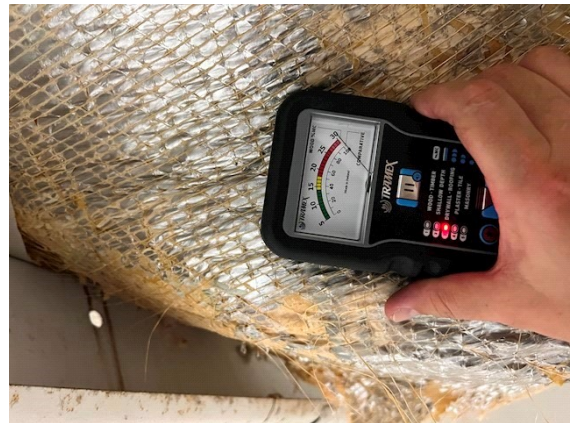
Roof Insulation: Moisture meter reading of this drooping section of insulation (meter off scale)

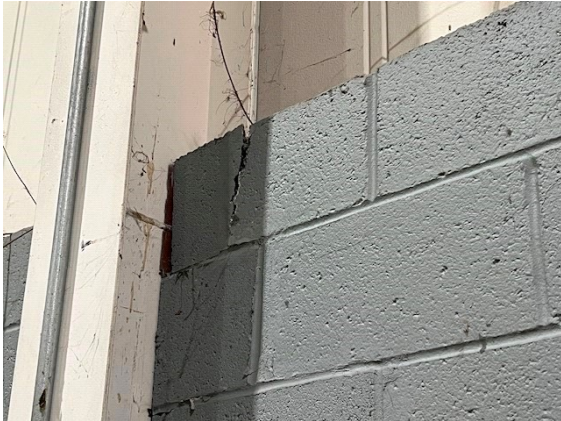
Interior Foundation: Top edge block cracked near northeastern corner of building along back (east) wall

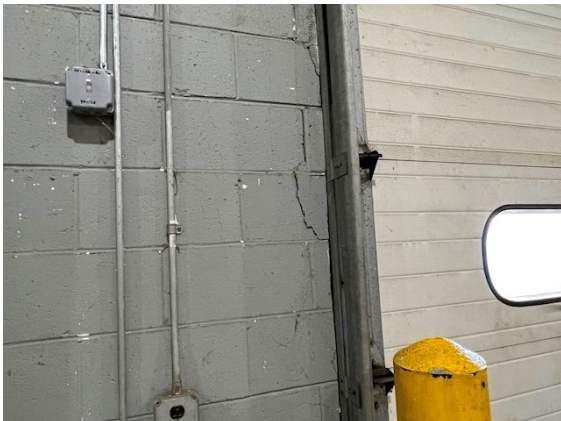
Interior Foundation: Vertical cracking observed to the left of freight door #3

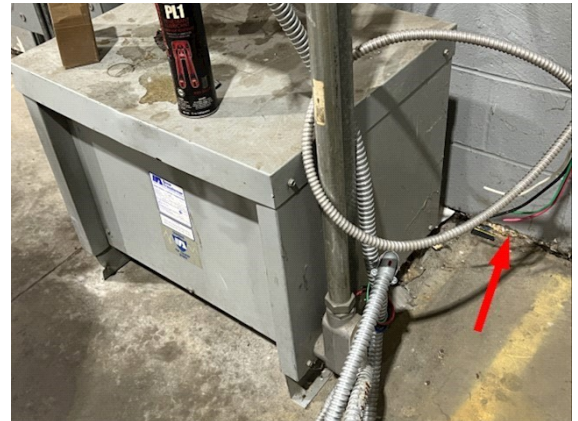
There appears to be vacated electrical panels or gutter boxes on the exterior of the western and northern walls. Recommend removal if no longer in use. There is a transformer located to the right of the western drive in door that appears to have been possibly a charging station. There are exposed wires in this area that should be removed or made safe by capping and placing in an enclosure. Another transformer is located in the ceiling of the warehouse that is wired to a panel in the center line of the warehouse floor. The breakers in this panel were all in the off position and there was exposed wiring below this panel as well. Exposed wiring was observed in other areas of the building during the inspection. Recommend the whole electrical system be evaluated further by a commercial electrician.

Electrical: Transformer to the right of drive in door on west side (note exposed wiring)

Recommend further evaluation by a certified commercial electrician

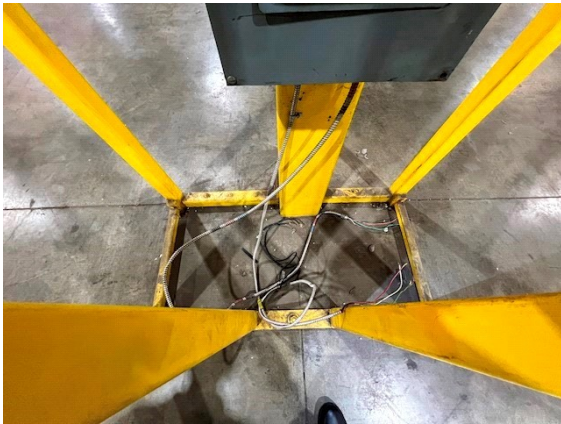
Branch circuits were marked as poor due to exposed wiring observed on the property.

Electrical: Exposed wiring

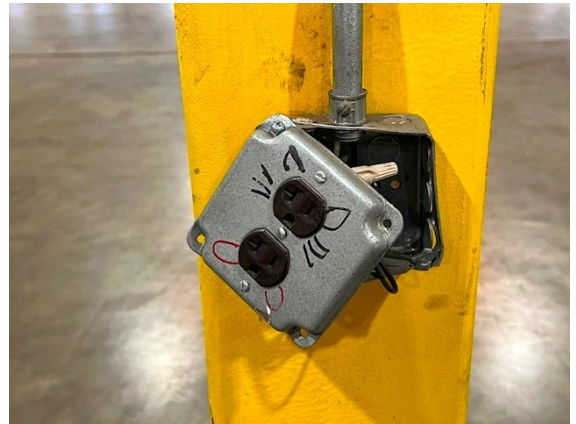
Electrical: Outlet cover not secure

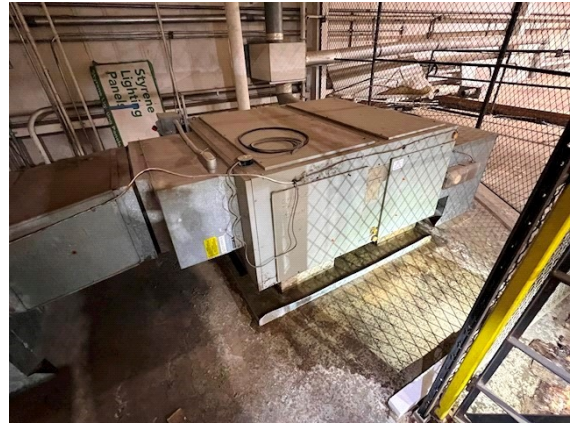
System was not operated during the inspection due to suspected blockages in the condensate lines and or clogged secondary drain pan. This unit is beyond its design life and it is recommended that the entire system be evaluated by an HVAC professional. The leaking condensate has caused damage to the walls and ceiling tiles below.

HVAC: Secondary condensate drain pan was full at time of inspection

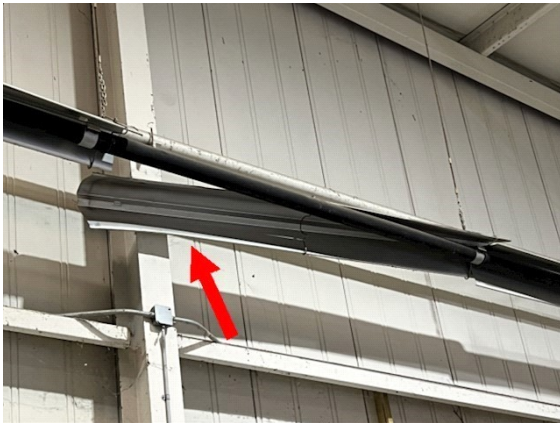
The warehouse appears to have been heated primarily with gas powered radiant heaters. Many of these heaters were in various states of disrepair and will need to be further evaluated prior to operation. These heaters were unable to be tested during the inspection.

Warehouse Heating: Displaced heat shield

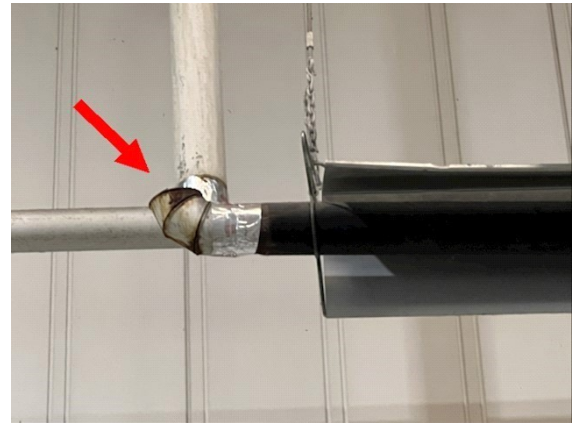
Warehouse Heating: Disconnected exhaust stack

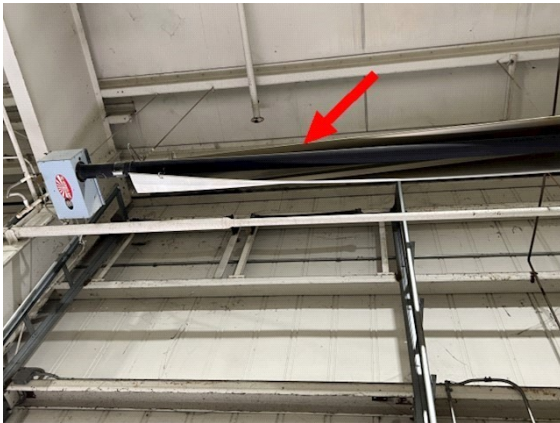
Warehouse Heating: Twisted heat shield

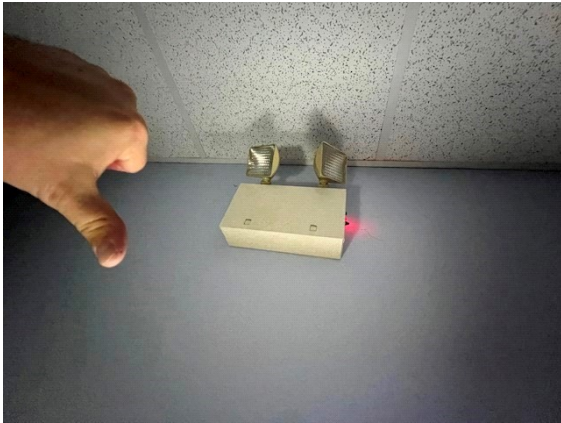
- Emergency exit signs appear not functional and unable to test
- Emergency exit lighting appear not functional and unable to test
- Southern stairwell from second floor has no functional lighting

Life Safety: Emergency exit lights did not test properly

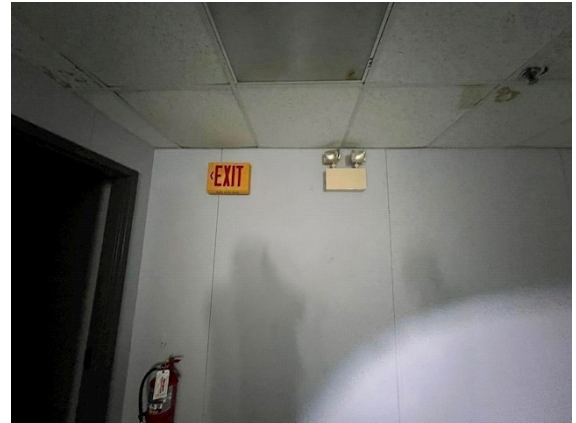
Life Safety: Exit signs did not work or test properly

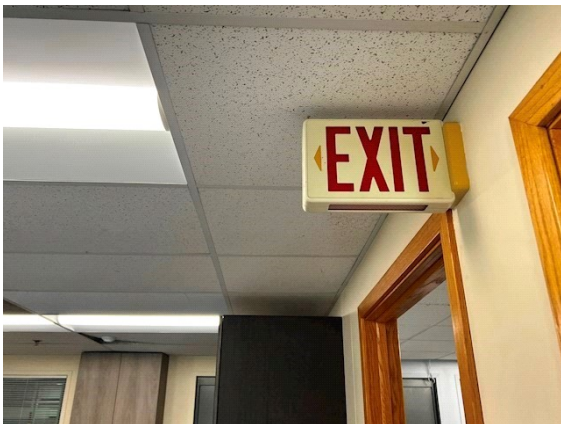
Life Safety: Exit sign not working
