Upper Chesapeake Inspections, LLC DBA
National Property Inspections

Jane Doe, 123 Any Street, Anytown, MM, 12345

Monday, July 18, 2022

Inspection Date:
07/18/2022

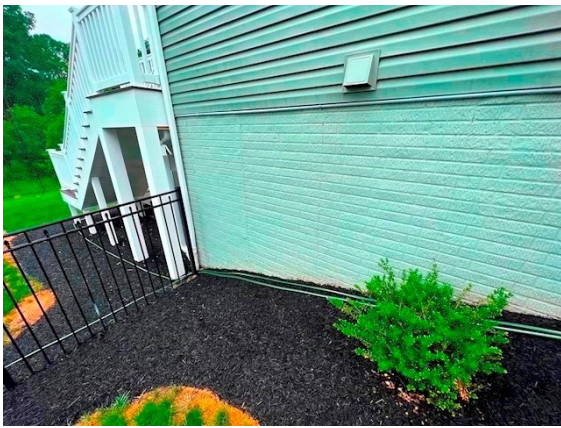
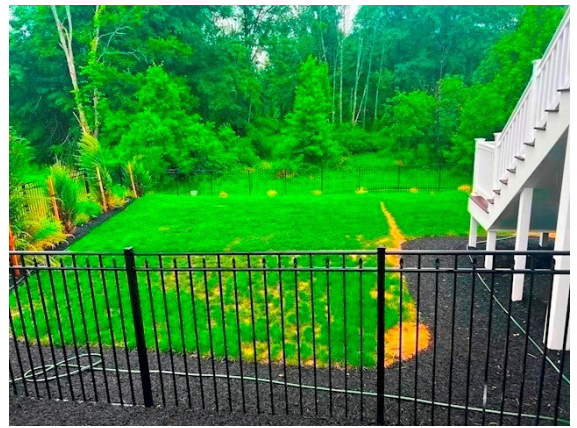
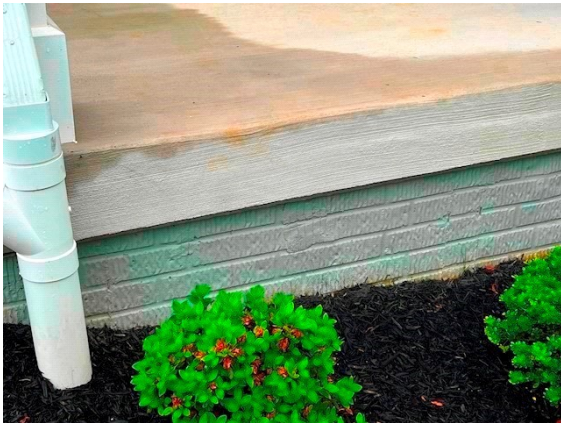
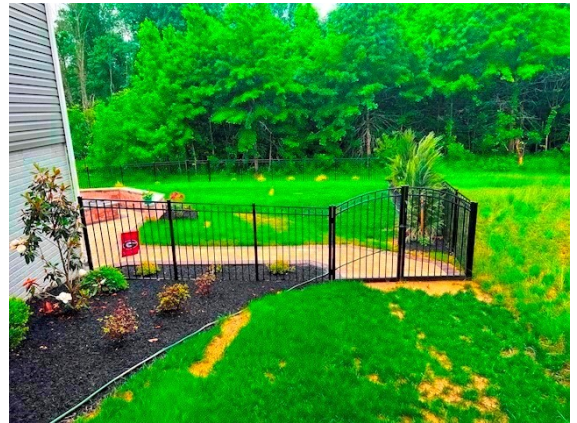
Today's standards indicate final grade should slope away from dwelling and foundation a minimum of 6 inches within the first 10 feet. There appeared to be a positive slope around all sides of the home at the time of the inspection.

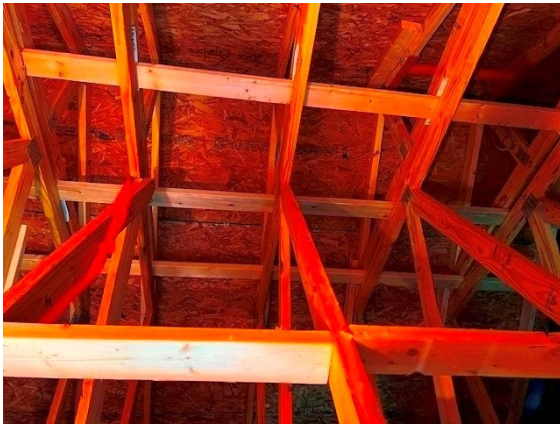
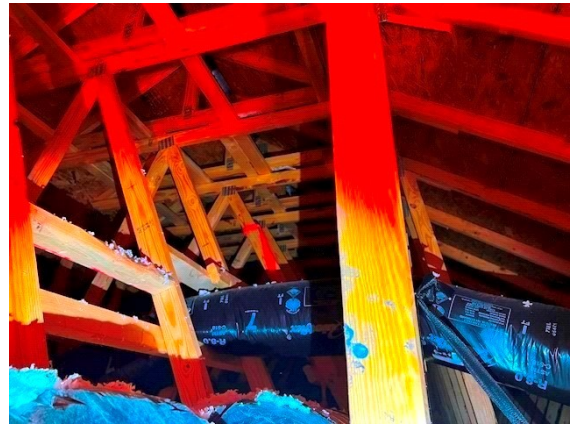
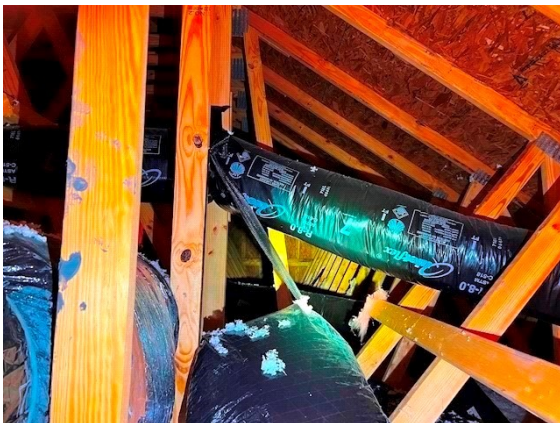
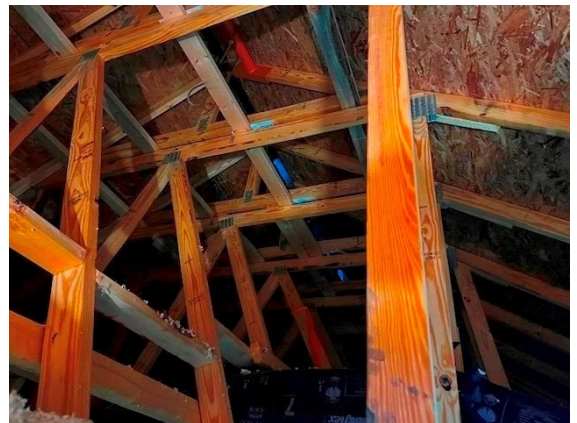
The attic interior was visually examined for leaks and/or water stains. No cracked trusses or rafters, stains, or leaks were observed at time of inspection.

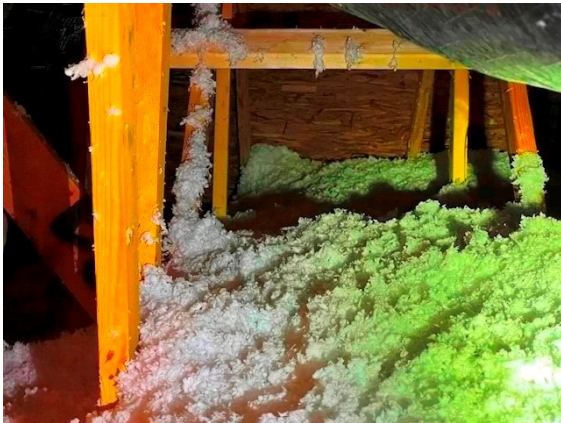
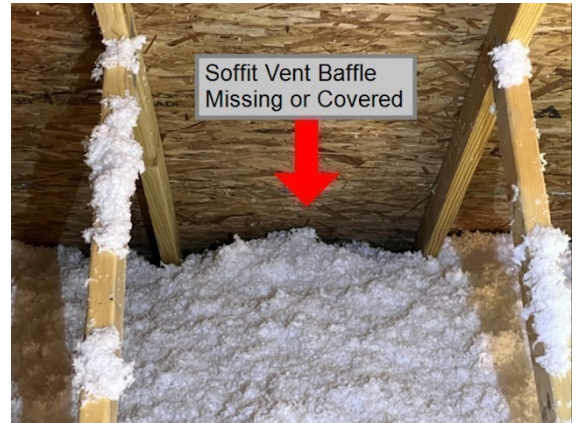
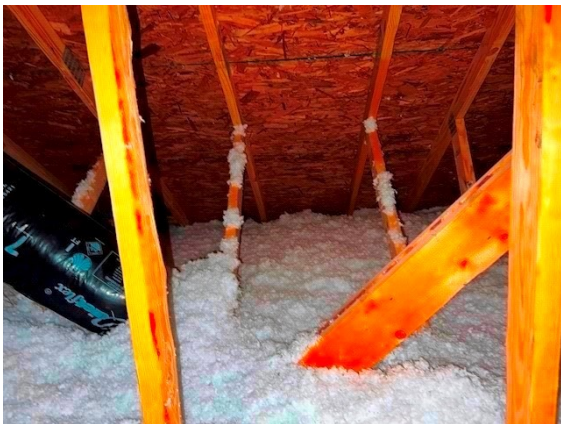
Proper soffit vent baffles did not appear to be present or were unable to be seen due to large amount of insulation. Recommend further investigation to ensure proper air flow (no insulation blocking baffles, proper venting at the base of the baffles, etc.). A number of soffit vents appeared to be blocked with insulation. Recommend clearing insulation away from soffit vents to help provide proper ventilation in attic.

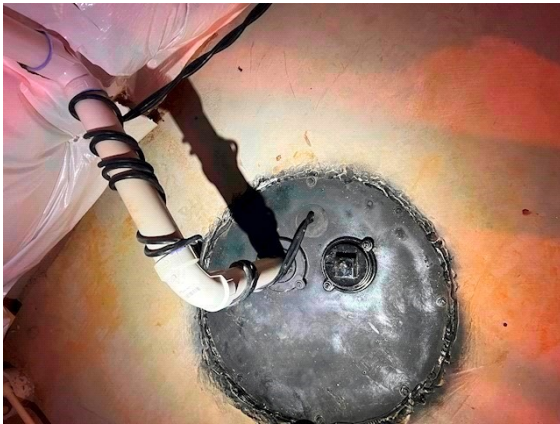
Sump pump was located in a covered sump that was unable to be accessed at the time of inspection. Battery back up pump is installed and was tested by triggering the GFCI, listening for the audible alarm and then resetting the GFCI.

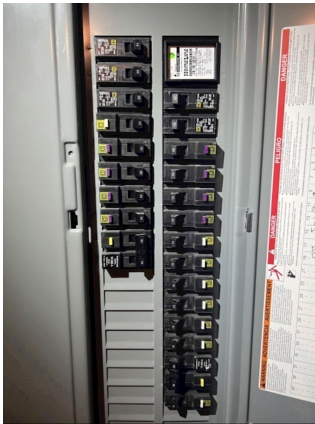
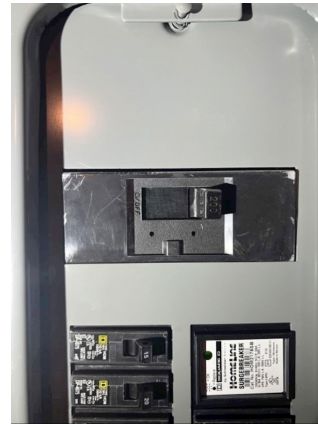
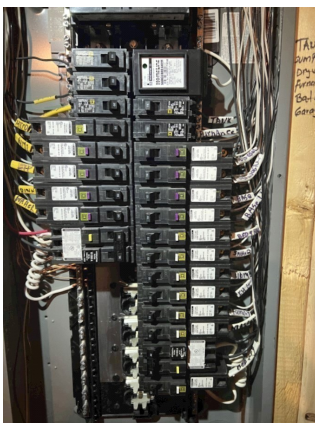
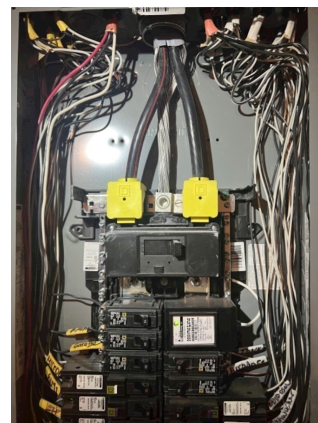
Electrical main service panel is located in the basement utility above the water main. Main service cut off is located in the service panel. All panel wiring was installed correctly and most breakers were AFCI or GFCI protected at the panel. The panel was also properly grounded.

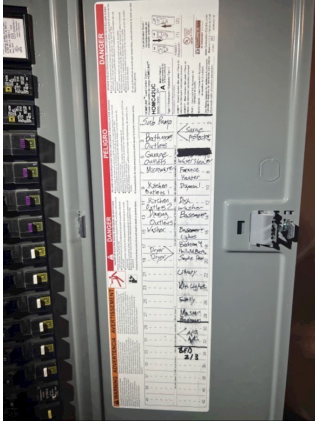
Electrical: All circuits properly labeled inside panel door

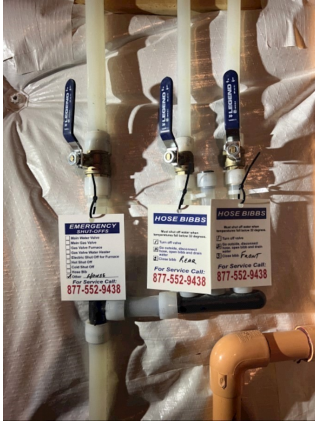
Plumbing: Main house, front and rear hose bib shut offs

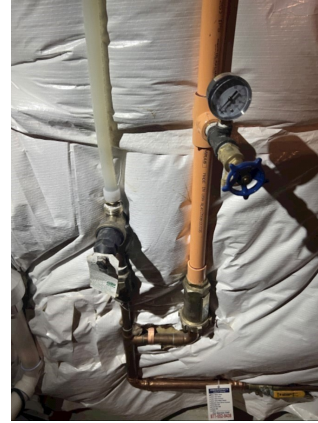
Plumbing: Water service main and sprinkler system drain valve

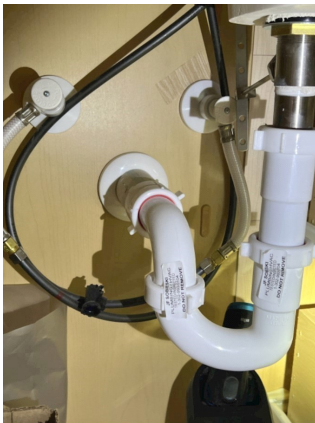
Plumbing: All fixtures have shut offs located near the fixture

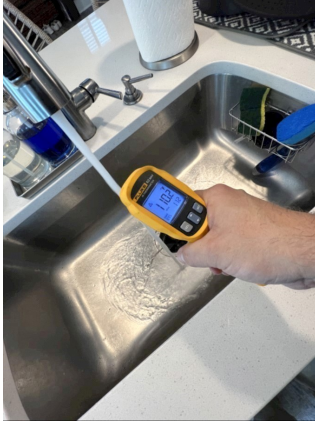
Water Heater: Average temperature at fixtures was 110° F.
