National Property Inspections

Sample Residential Report, , Riverside, Ca, 92508

Tuesday, June 07, 2011

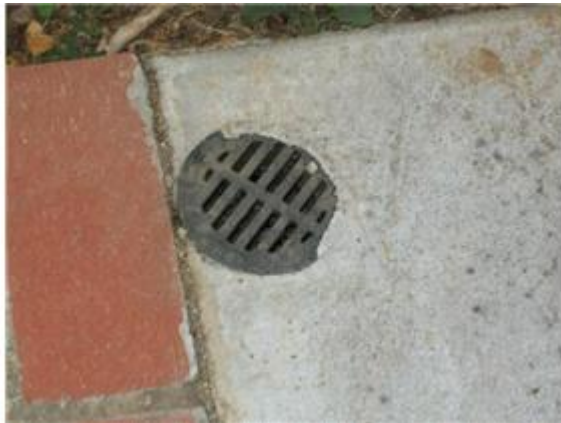
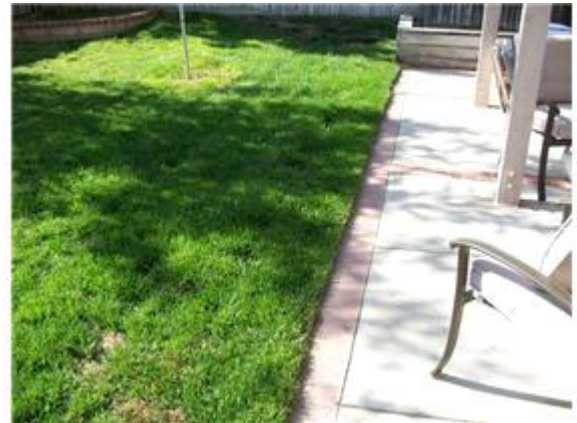
There does not appear to be proper drainage in front of the rear patio. Recommend monitoring for swampy conditions and/or water run off onto the patio surface. If so, contact a licensed contractor to further evaluate and present drain options.

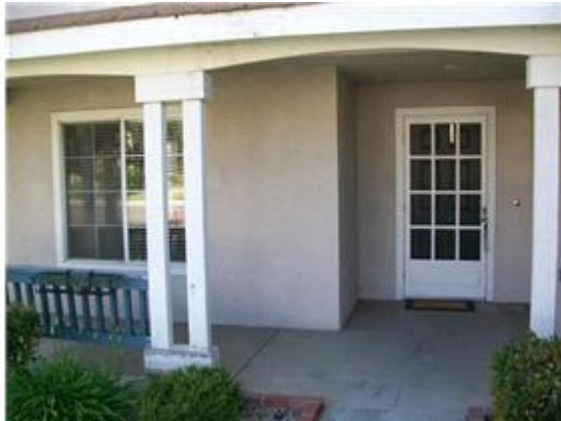
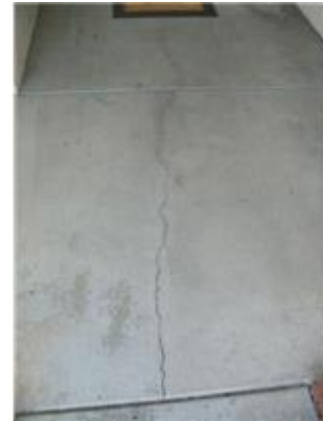
Comments : **Some cracking is present on the surface on the concrete. Recommend filling in cracks with a concrete base caulk to prevent further damage.**

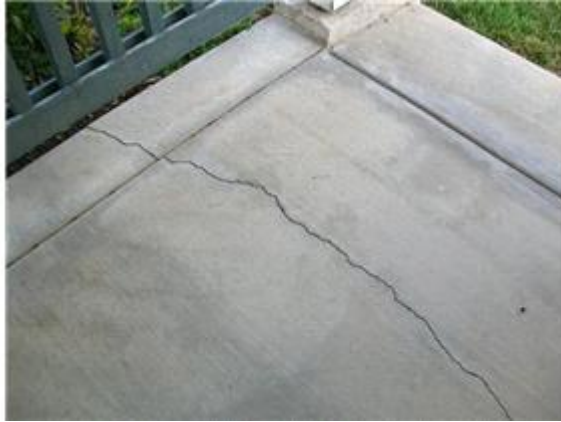
REAR PATIO

- Concrete
- Flagstone
- Brick
- General Deterioration
- Cracks
- Settlement
- Slopes Toward House

Comments : The surface of the patio and related components show typical conditions indicative to the age of the home. Recommend monitoring for any further developments.

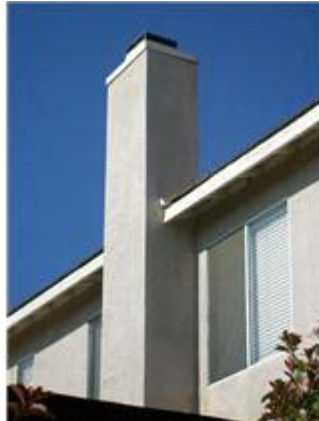
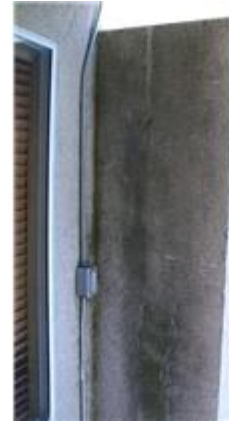
The kick-out flashing on both sides of the chimney is causing moisture stains on the sides of the chimney base. Once repairs have been completed above, recommend power washing stains and possibly applying touch up paint to blend.

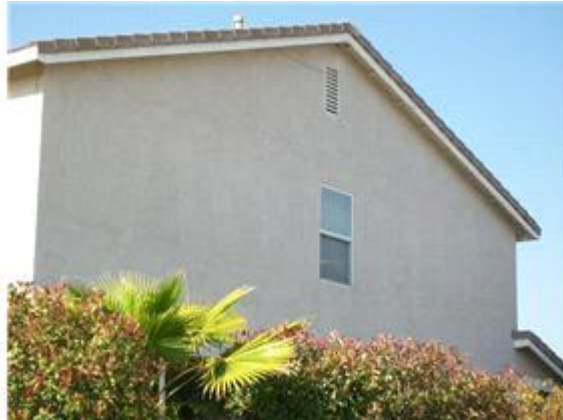
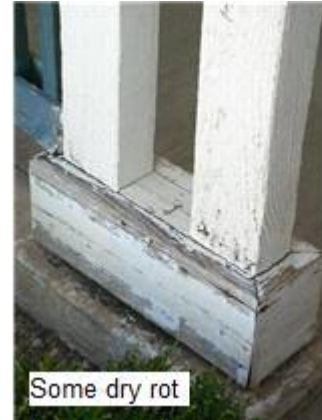
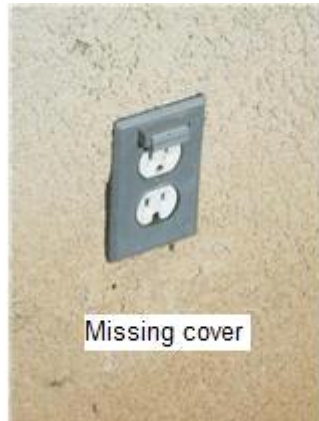
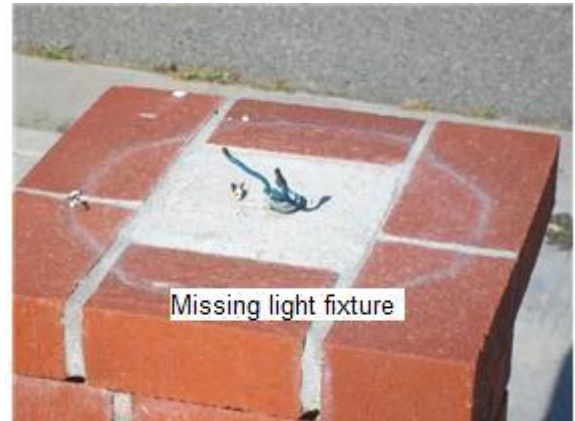
There appears to be dry rot on some of the exterior wood components. Please review the termite report for recommendations concerning the exterior wooden components of the home.

The receptacle in the backyard is exposed. All exterior outlets need to have covers placed over them to protect the circuitry from moisture

An exterior light fixture is missing from the top of the column by the driveway. Recommend the installation of a light fixture.

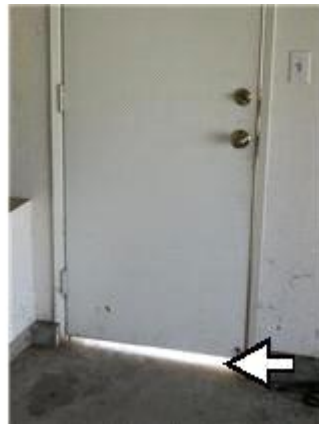
Comments : **There is gap at the bottom of the exterior door in the garage. Recommend installing or adjusting the existing door sweep to prevent insect intrusion.**

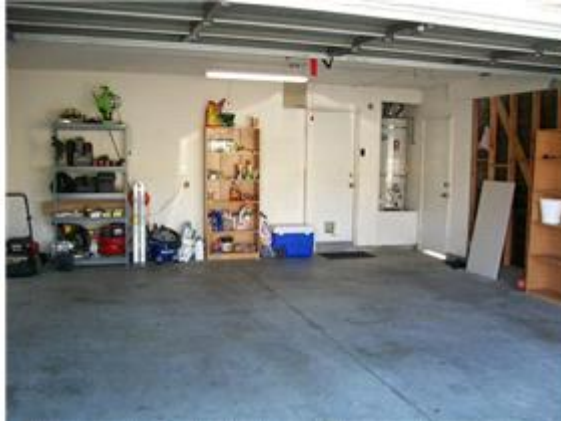
Exposed electrical wiring is present in the garage. Romex wiring needs to be installed in conduit or behind drywall. Recommend repairs be completed by a licensed electrician.

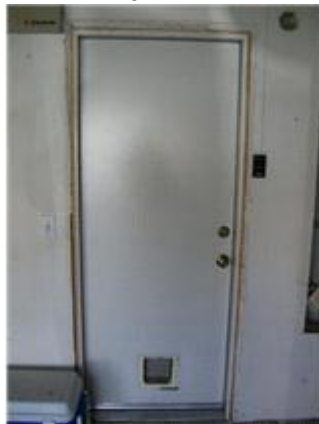
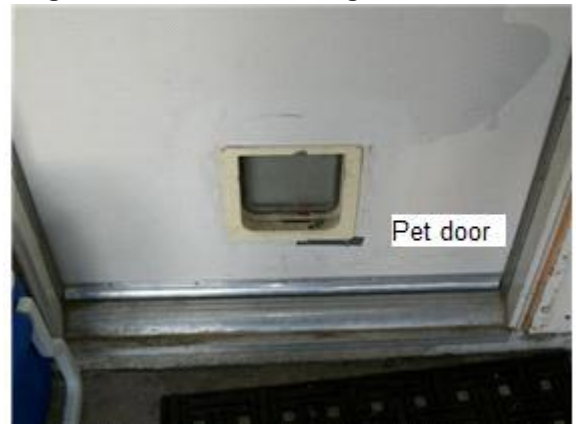
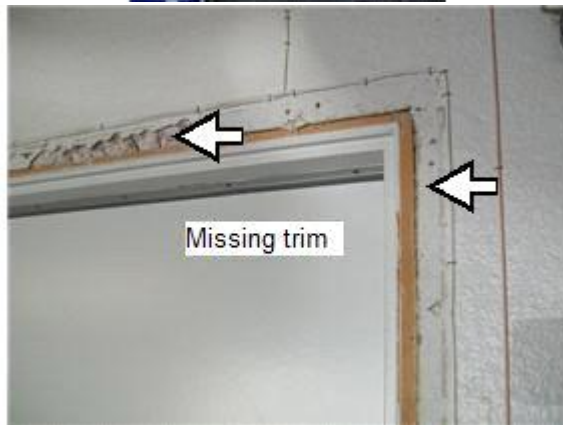
Comments : **The installation of a pet door compromises the integrity of the fire door. Recommend removing and covering the opening with a metal plate or replacing the door altogether.**

The trim around the perimeter of the door is missing. Recommend installing trim.

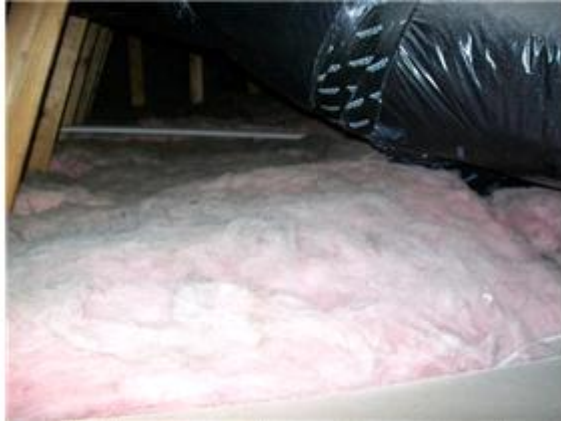
ATTIC ELECTRICAL

<input type="checkbox"/> Monitor Condition	ACC	MAR	NI	NP	DEF
<input type="checkbox"/> Recommend Repairs	<input checked="" type="checkbox"/>	<input type="checkbox"/>	<input type="checkbox"/>	<input type="checkbox"/>	<input type="checkbox"/>

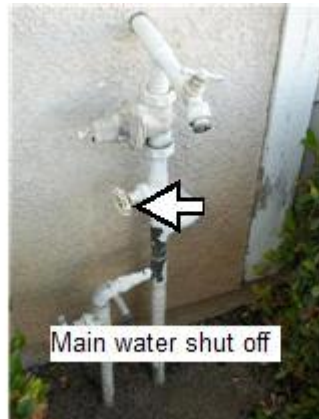
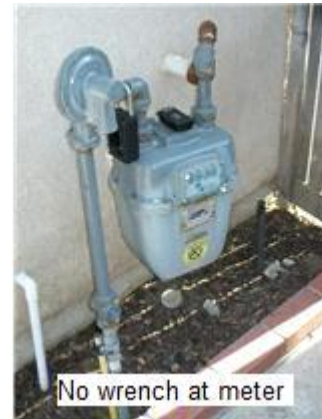
A wrench needs to be located by the gas meter for quick emergency shut off. Recommend hanging a gas or crescent wrench on one of the pipes for easy access.

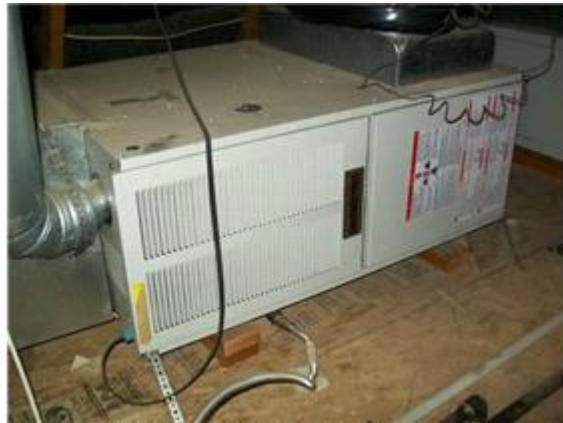
The exterior ambient temperature is higher than 65 degrees at the time of inspection. Current industry standards recommend heating units not be activated unless temperatures remain below the 65 degree mark. Activation of burners was momentarily (turned on / turned off) confirmed by this inspector only. The temperature change was not checked. Recommend further evaluation be completed by a licensed HVAC technician once temperature drops below 65 degree mark.

The condition of the heating unit and installation appear to be satisfactory. Recommend monitoring for any developments.

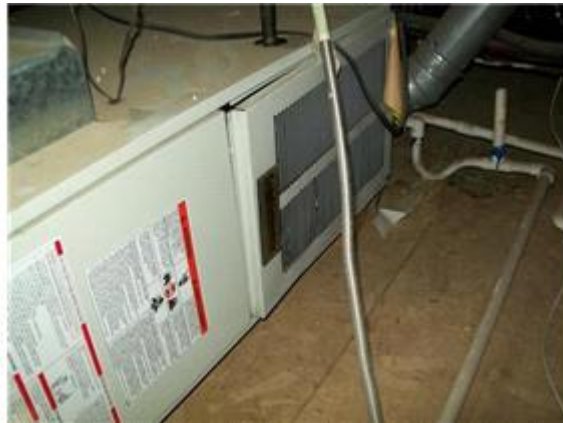
The exterior ambient temperature is higher than 65 degrees at the time of inspection. Current industry standards recommend heating units not be activated unless temperatures remain below the 65 degree mark. Activation of burners was momentarily (turned on / turned off) confirmed by this inspector only. The temperature change was not checked. Recommend further evaluation be completed by a licensed HVAC technician once temperature drops below 65 degree mark.

The condition of the heating unit and installation appear to be satisfactory. Recommend monitoring for any developments.

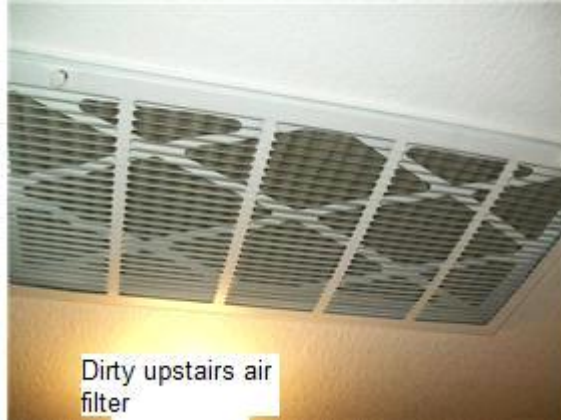
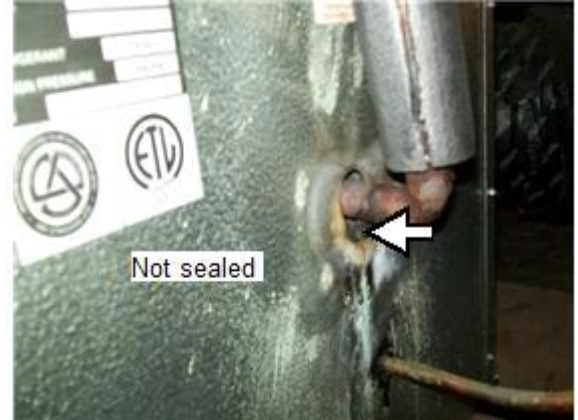
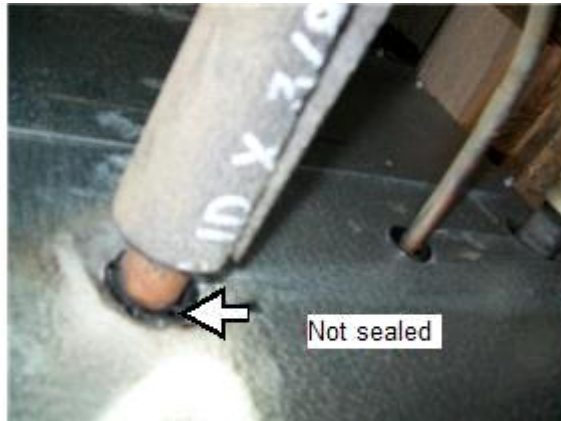
AIR CONDITIONER - DOWNSTAIRS

<input type="checkbox"/> Monitor Condition	ACC	MAR	NI	NP	DEF
<input type="checkbox"/> Recommend Repairs	<input checked="" type="checkbox"/>	<input type="checkbox"/>	<input type="checkbox"/>	<input type="checkbox"/>	<input type="checkbox"/>

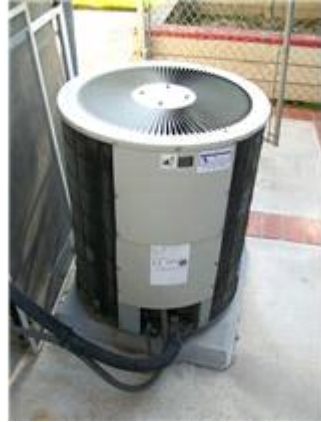
AIR CONDITIONER - UPSTAIRS

<input type="checkbox"/> Monitor Condition	ACC	MAR	NI	NP	DEF
<input type="checkbox"/> Recommend Repairs	<input checked="" type="checkbox"/>	<input type="checkbox"/>	<input type="checkbox"/>	<input type="checkbox"/>	<input type="checkbox"/>

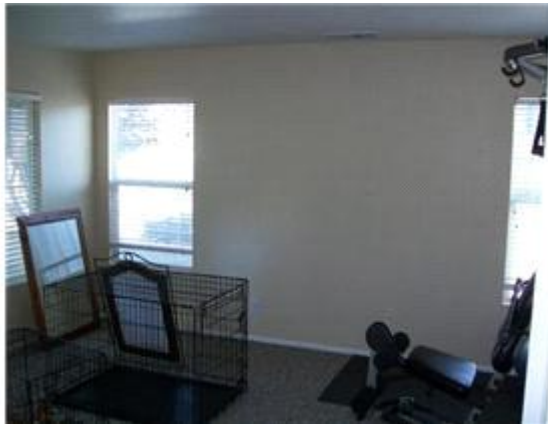
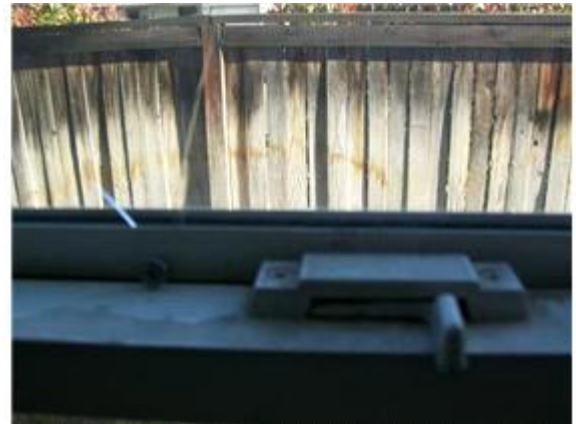
Comments : **One of the interior window panes is cracked. Recommend contacting a licensed window contractor to replace the window pane.**

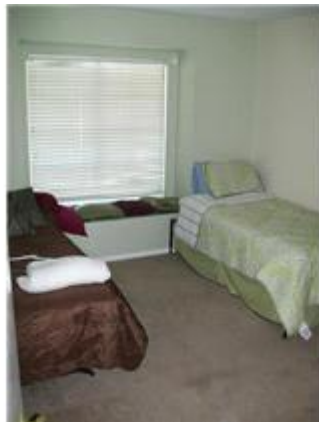
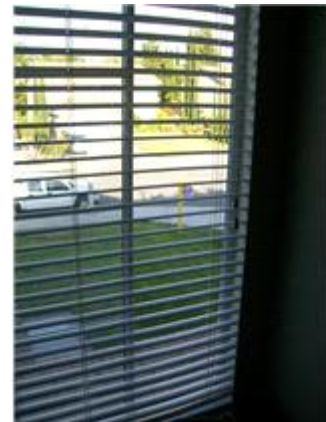
Comments : **The window screen is missing. Recommend the installation of screen to insure ventilation while preventing insect intrusion.**

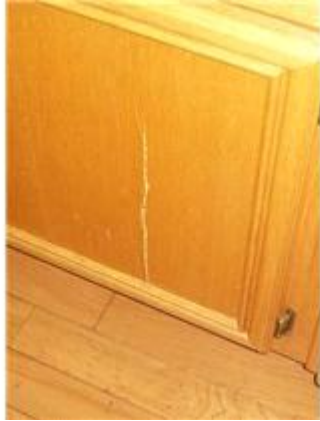
1

Damaged kitchen cabinet door

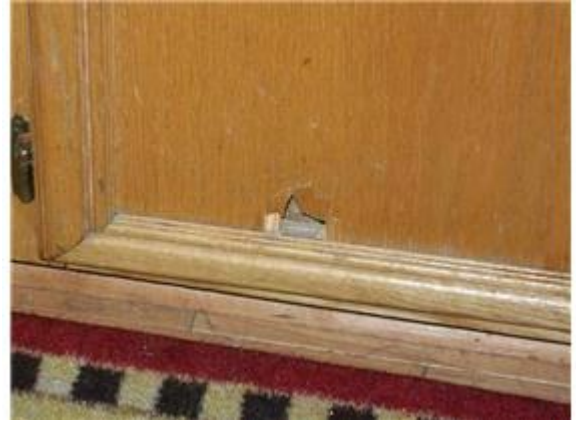
2

Damaged kitchen cabinet door
