NATIONAL
PROPERTY
INSPECTIONS®

TOP 10 RED FLAGS

Understand what issues your homebuyers are on the lookout for and how to offer solutions.

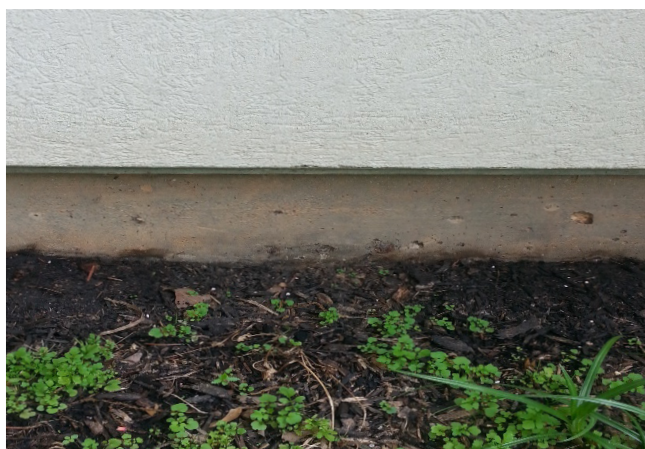
Right.

High grading around the foundation is one of the most common issues identified on inspection reports. The proper minimum clearance between the facade and the soil is 4 to 6 inches. High grades are most commonly found in planter areas. Homeowners often place new mulch without removing the old, creating potential issues.

Drainage problems are avoidable with proper grading. Site grading should always slope away from the foundation for at least 5 feet. Gutter downspouts should always direct the water at least 5 feet away from the foundation or deposit into a site drainage system.

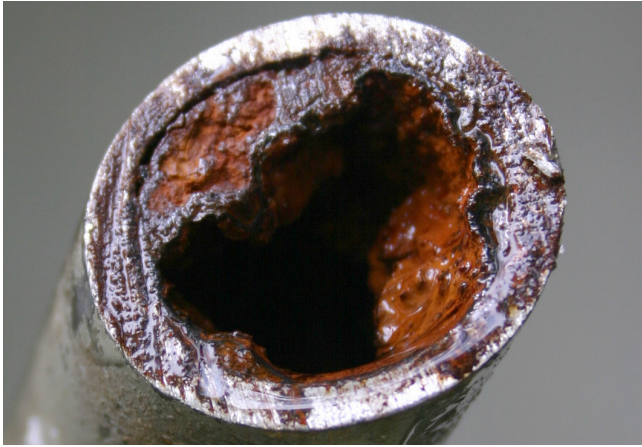
#9 - GALVANIZED PIPES

“Galvanized” pipes are zinc-coated pipes that were meant to prevent rusting. Galvanized piping was common until the 1950s and lasts around 40 to 60 years.

When galvanized pipes are found today, they are usually near the end of their lives and in need of replacement.

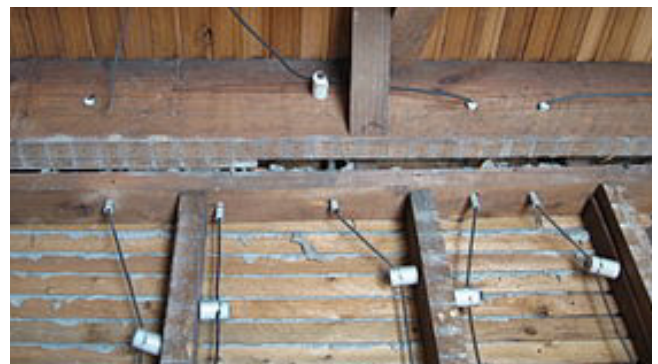
Knob and Tube Wiring

You may come across knob and tube wiring in homes built between 1880-1940. This type of system is designed so that heat from the wires can dissipate through an open space. However, this wiring is often prone to overheating when in contact with insulation or if the wires are too close together. The high risk of fire leads insurance companies to charge higher premiums or even deem a home un-insurable.

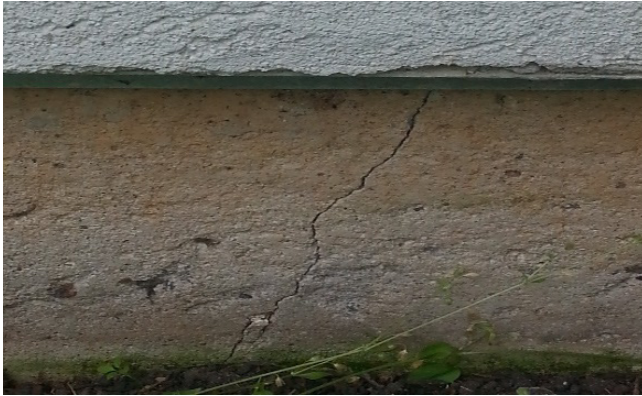
Hairline Cracks (1/16 inches or Less)

Hairline cracks are most likely caused by shrinkage during the curing process of poured concrete. They do not present any concern.

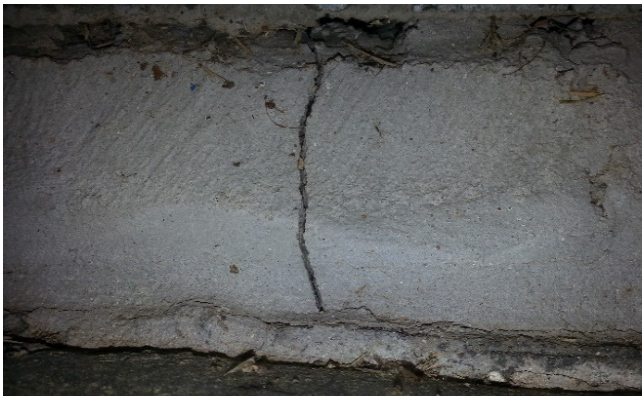
Cracks 1/8 inches or Less

Cracks this size may indicate either shrinkage from curing or foundational movement. This crack should be sealed and monitored.

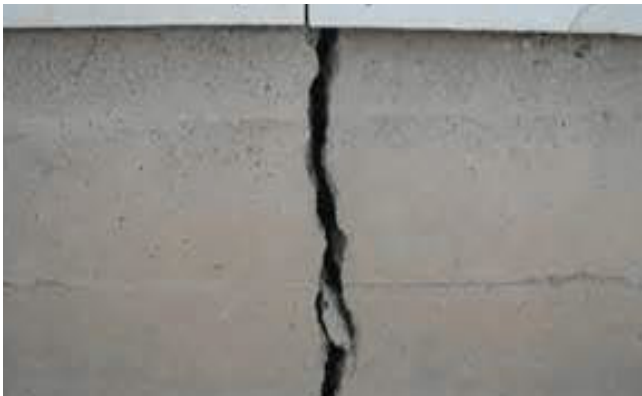
Cracks 1/4 inches or More

Cracks this large are most likely due to foundational movement. A structural engineer should be consulted.

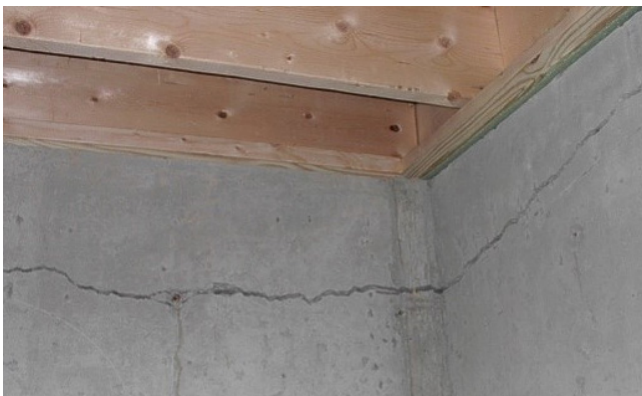
Basement Foundation Walls

Horizontal cracks found in the basement can be minor or major. Some minor cracks may be repairable DIY-style. Depending on their width and severity, some cracks may require stabilization repairs. An NPI inspector would typically suggest a consultation with a structural engineer.

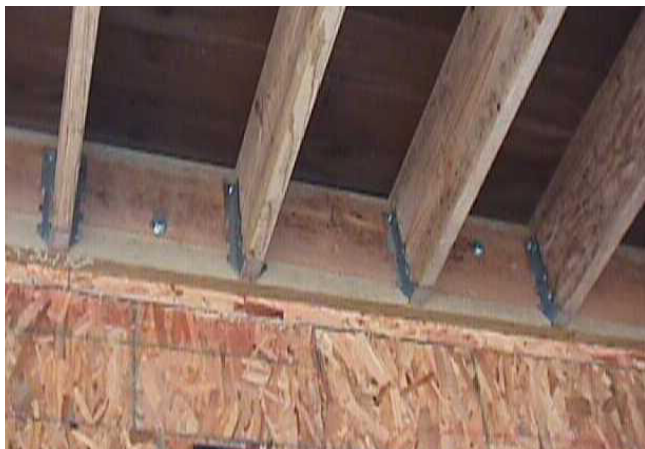
#4 - POOR DECK CONDITIONS

Poor deck conditions are often visible to untrained eyes. Check for post deterioration or chipped paint. Less obvious red flags exist in a deck's support system. Unstable support is often characterized by uneven or sloped boards.

Industry standards require all ledger boards be bolted to the house, and joist hangers must be installed on every joist with the appropriate type and amount of fasteners (left). All decks should have adequate fall protection including handrails and spindles.

Most deck issues can be self-repaired by a homeowner. For any structural concerns, a homebuyer can request an engineer consultation. Deterioration can be prevented with adequate maintenance and updated sealant.

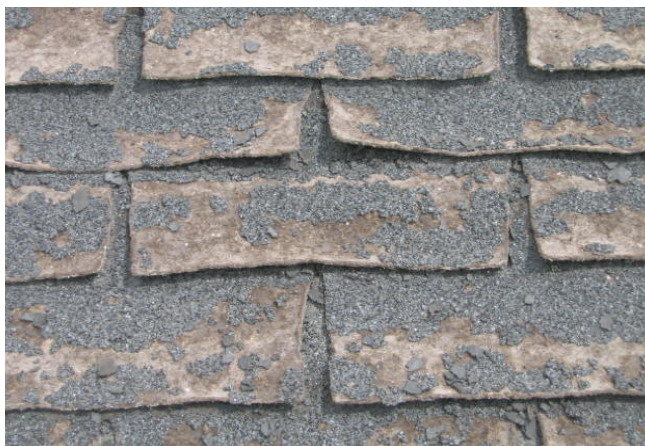
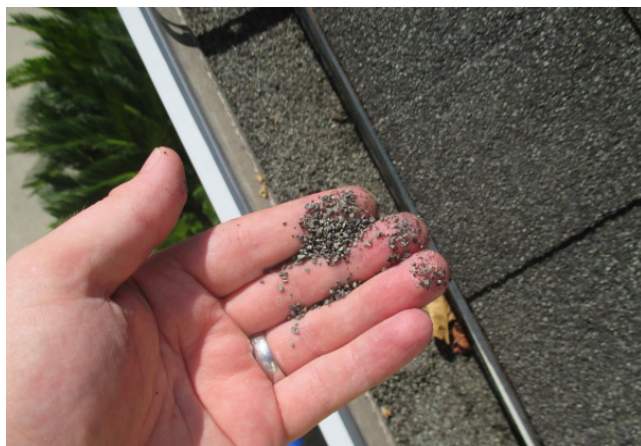
#3 - WORN ROOFING OR LEAKAGE

Roof condition is often a key factor in home appraisal. Excessive granular loss (pictured above) is a key indicator of poor condition. Note that the south-facing side of a house always displays the most wear.

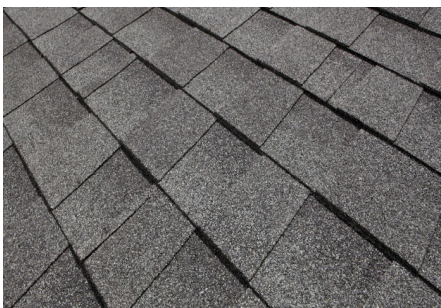
New, 0-5 years

Little to no granular loss
No cupping or curling
Straight edges

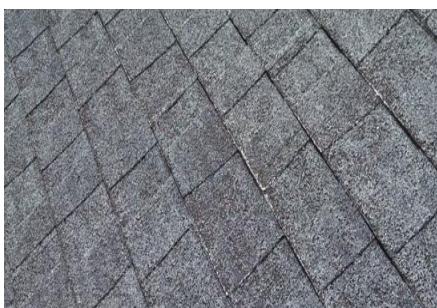
Medium Wear, 5-15 years

Mild to moderate granular loss
Some cupping or curling

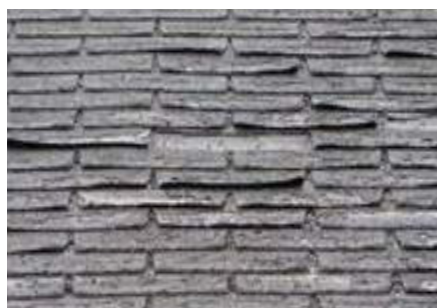
Heavy Wear, 15+ years

Excessive granular loss
Excessive cupping or curling
Deformed edges

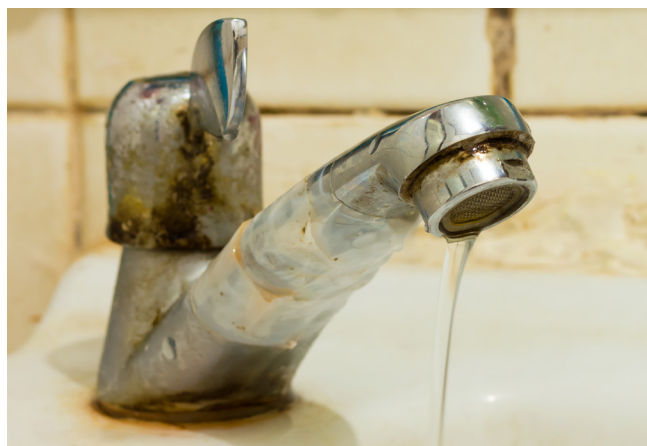
Small amounts of mold and mildew around showers, tubs and sinks are normal (above, left). Small amounts of mold on window sills are normal and most likely caused by condensation. These do NOT present a major problem or concern.

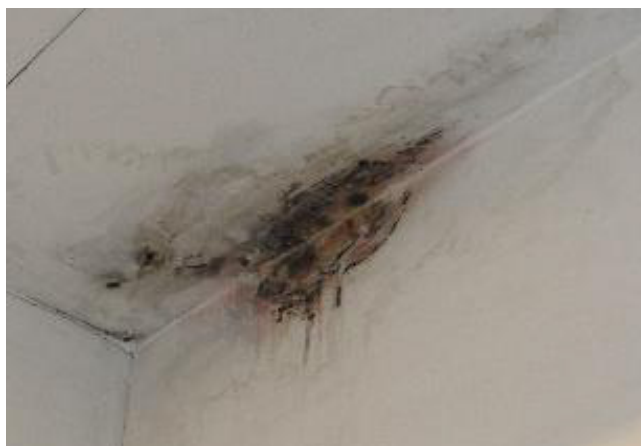
However, mold found on walls or ceilings outside of a kitchen or bathroom DOES signal a problem (above, right). Typically, this indicates a roof or plumbing leak. Any amount of mold to the sides or below a window or door indicates a leak as well. These are definitely a major problem.

If you suspect a home has mold, encourage the owners to schedule a mold inspection immediately. Locating mold as soon as possible is key to saving thousands of dollars.
