PROPERTY INSPECTION REPORT

National Property Inspections**6310 Millwood Court****Arlington, TX 76016****Office 817-492-0161****Fax 817-451-0233****Mobile 469-964-4414****www.npidfw.com****service@npidfw.com****Inspected By: Eric Evans TREC #7077****Inspection Date: 4/25/2006****Client**

111 Your Home

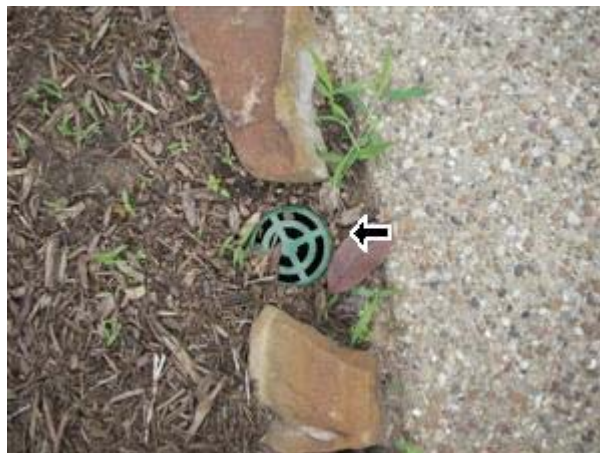
B. Picture 7

Surface drains will need periodical cleaning and maintenance. Recommend future monitoring to maintain their effectiveness.

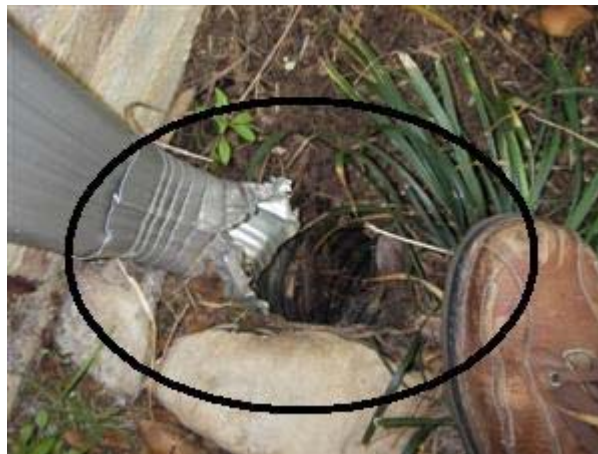
B. Picture 9

Noted gutter and drainage system in need of minor repairs and cleaning at various points around structure. Recommend qualified contractor evaluate and repair.

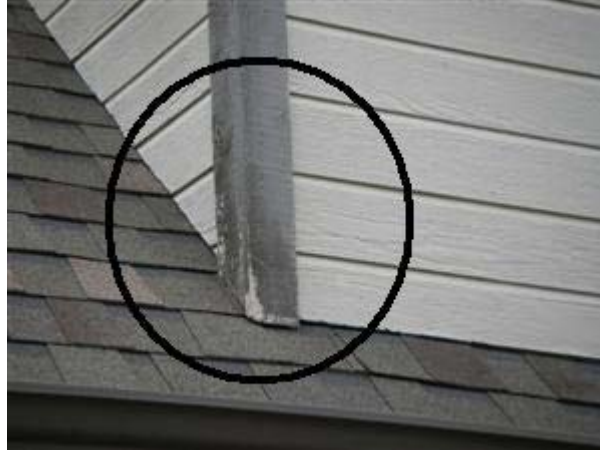
E. Picture 2

Noted caulk deteriorated or missing at points around structure. These are moisture retention issues. Today's standard building practices do not mandate the caulking of some of the noted points, however maintaining caulk and paint in these areas will realize prolonged life expectancy of building materials. Recommend qualified contractor evaluate and repair.

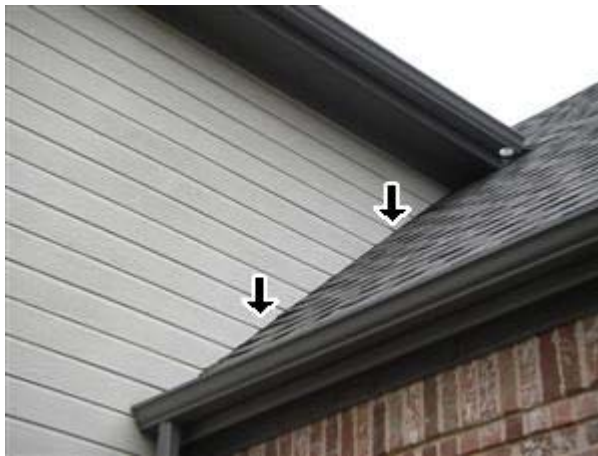
E. Picture 15

Siding, trim boards and fascias need separation from roofing materials. Recommend establishing and maintaining a minimum 1/2 inch gap between sidings, trim boards and fascias and roofing materials to allow adequate run-off. Recommend evaluation and repairs.

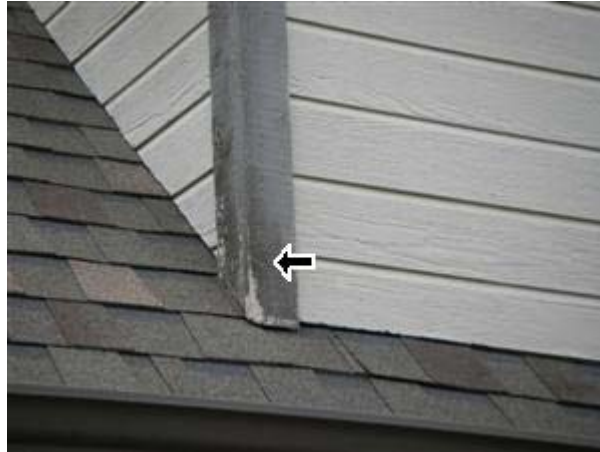
E. Picture 17

Noted paint at or near life expectancy on siding and trim at a few various points. Recommend qualified contractor evaluate and repair.

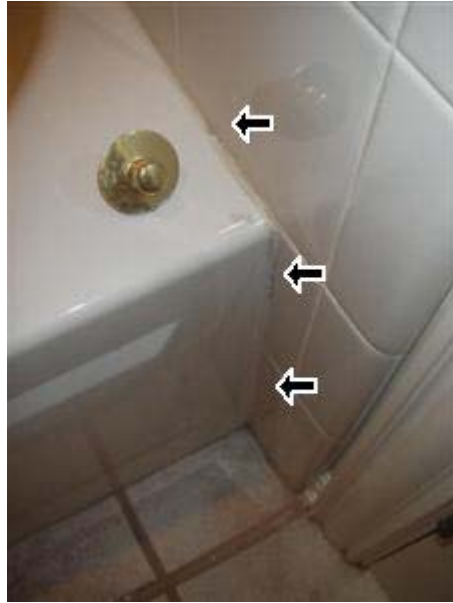
E. Picture 21

Noted caulk-grout at tile surround at bathtub-shower walls is deteriorated and needs repair or replace at a few specific points at most shower and bathtub areas. Recommend qualified contractor evaluate and repair.

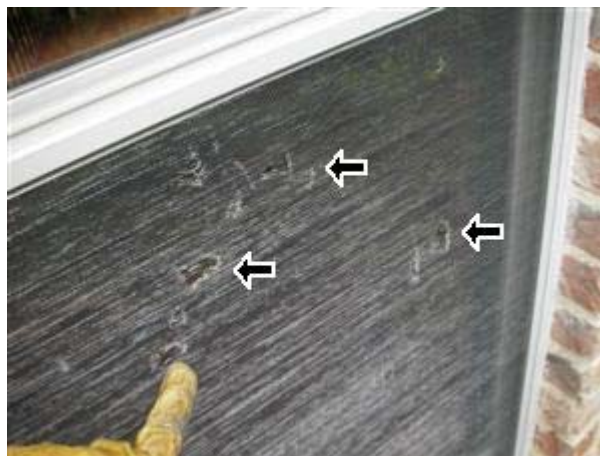
G. Picture 4

Noted a few window screens missing or damaged at various points around home. Recommend qualified contractor evaluate and repair.

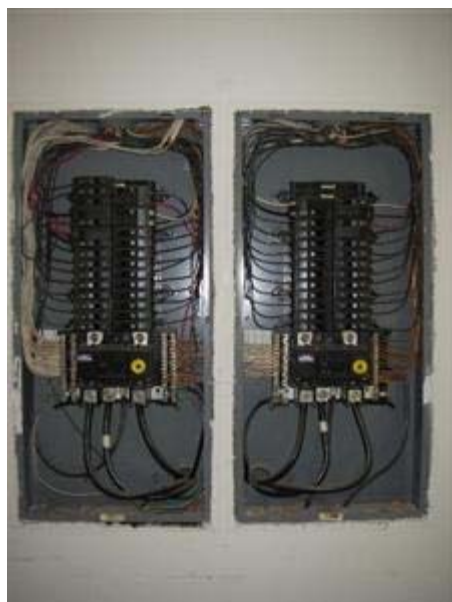
A. Picture 1

Noted lack of wire protection at some panel entry points. Recommend licensed electrician evaluate and repair.

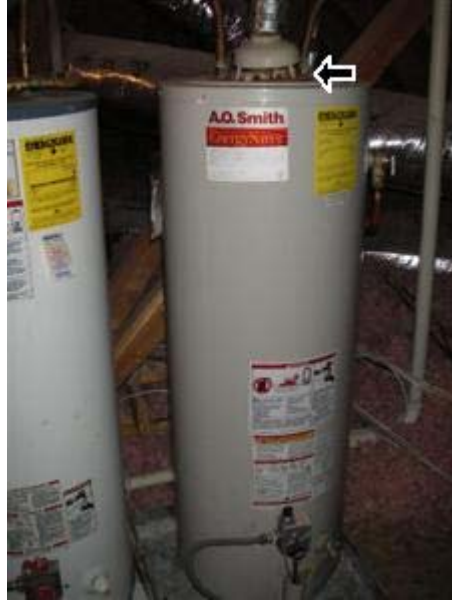
C. Picture 4

Noted vent stack at attic mounted water heater is mis-positioned and not adequately venting gases out of attic area. Recommend licensed plumber evaluate and repair.

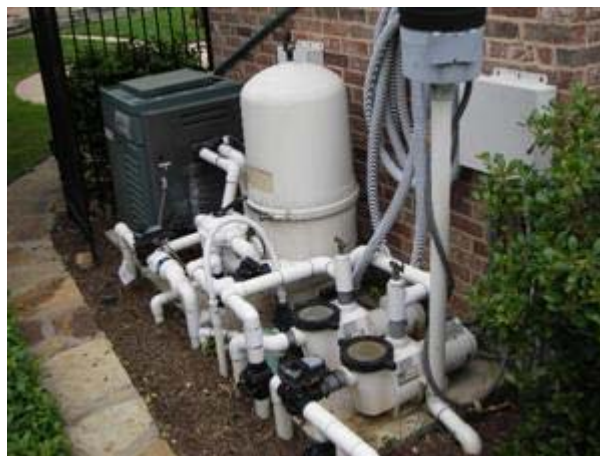
E. Picture 1

Noted air bubbles at jets which indicate a possible plumbing leak. Recommend qualified contractor evaluate and repair.
