National Property Inspections

Property Location

Riverside, Ca 92507

1. Executive Summary

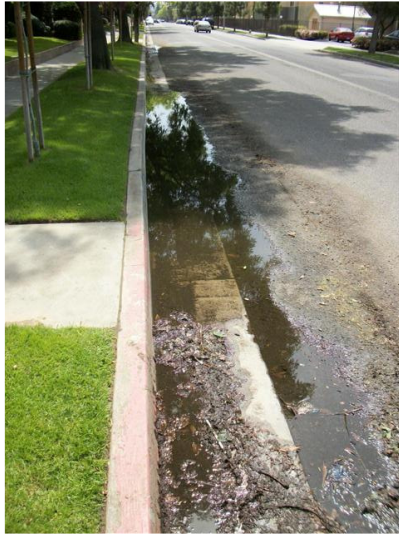
Excessive pooling in front of building

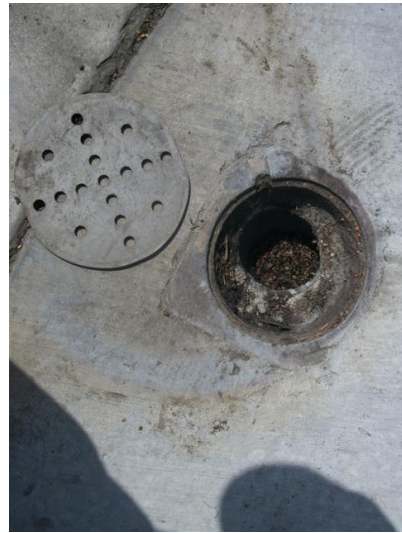
Clogged drain line on walkway

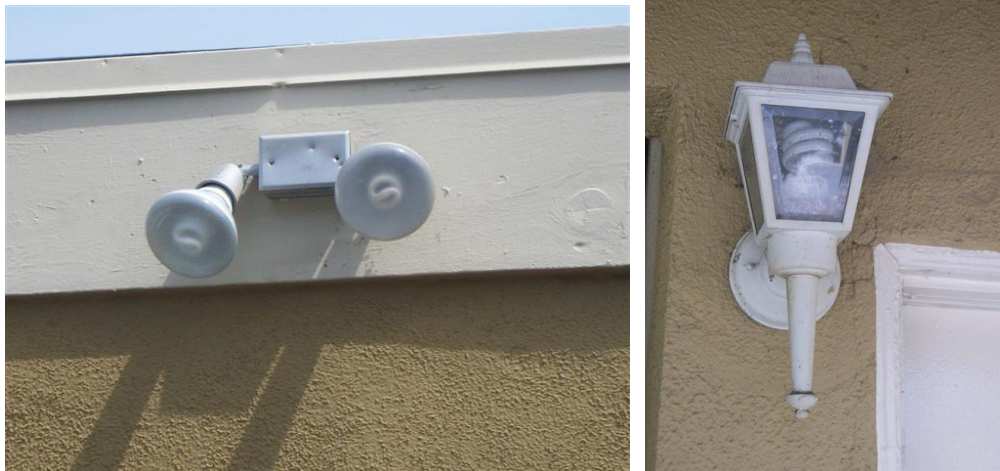
Exterior light fixtures were reported to be in fair condition and according to the tenants, offered adequate light at the time of the assessment. The parking lot and swimming pool lights are on a timer and were not observed at night. No major deficiencies were observed or noted. Recommend monitoring for any developments.

Exterior light fixtures

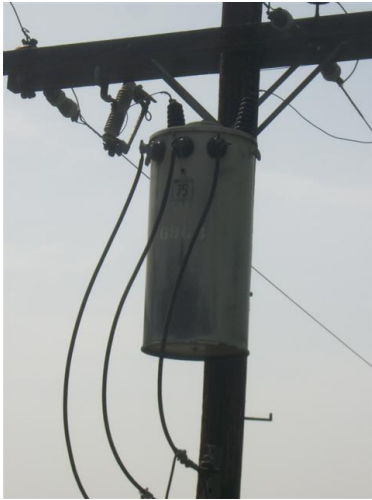
One of two pole mounted transformers

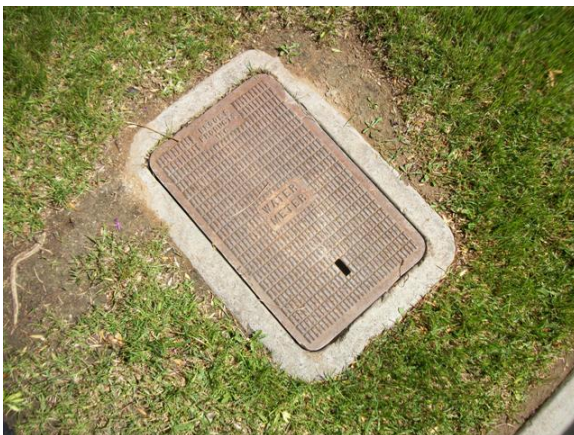
View of water meter

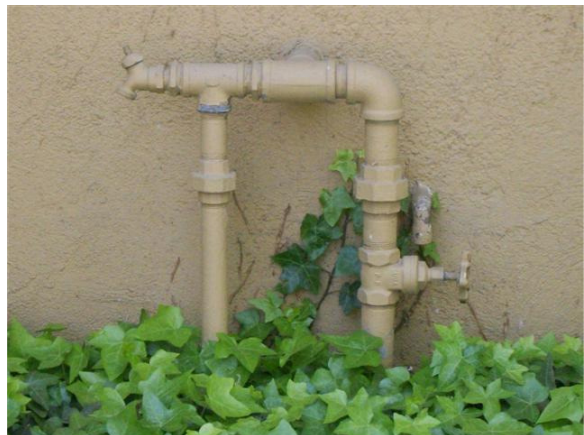
View of one of the water valves

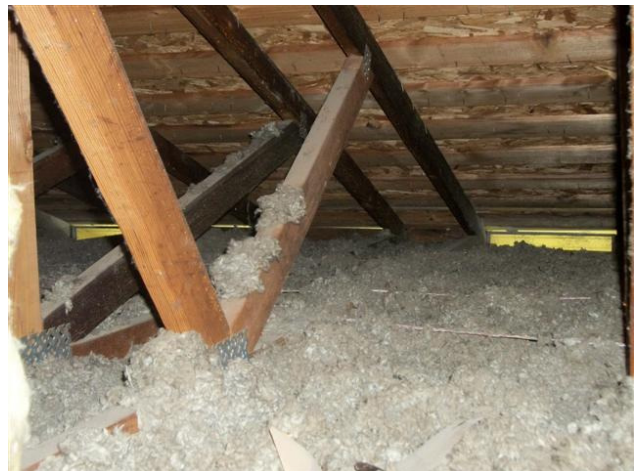
View of insulation

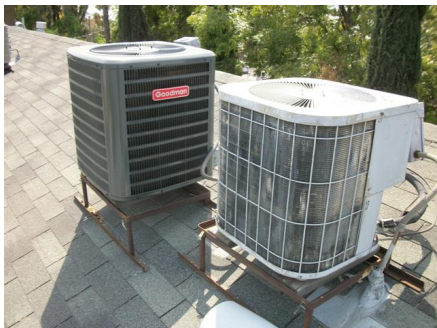
The operation the HVAC system will be addresses in the individual apartment unit section of this report. Some of the pressurized lines exiting from the condensers are missing insulation. Recommend applying insulation were needed to insure efficiency while the air conditioning is in use.

View of condensers

Estimated cost: Minimal

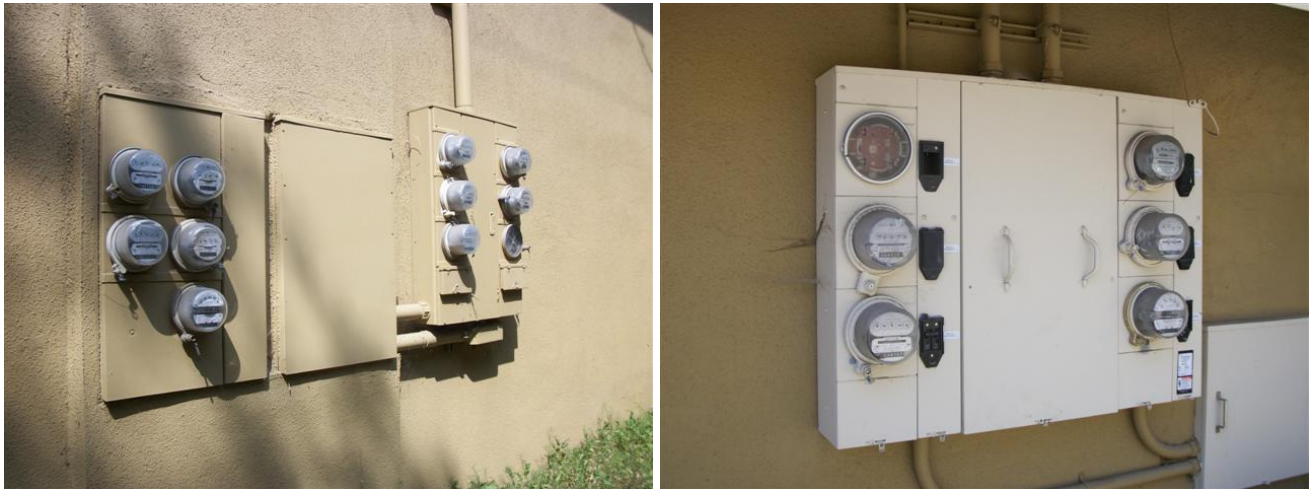
Detailed load calculations were not performed during the observation. The electrical system appears to be properly grounded. These services appear to be adequate for the present usage. Interior electrical deficiencies will be addressed in the individual apartment section. No major deficiencies were observed or noted.

Main panel on right side of building and right side of laundry room

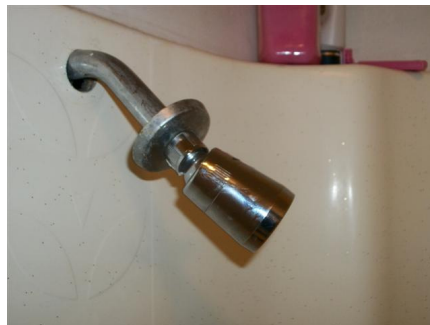
Shower head weak water pressure

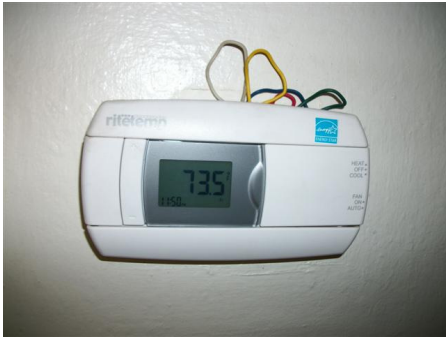
HVAC system not operable
