**PROPERTY CONDITION REPORT**

Client(s): Daniel Chavez  
 Property Address: 3722 W Fallen Leaf Ln  
 Glendale, Az 85310  
 Realtor: Michael St Paul,  
 Date: 09/27/2019  
 Inspector: Zach Shawd  
 Report #: Z092702-19RT

**Report:** Z092702-19RT

**Inspection Address:** 3722 W Fallen Leaf Ln, Glendale, Az 85310

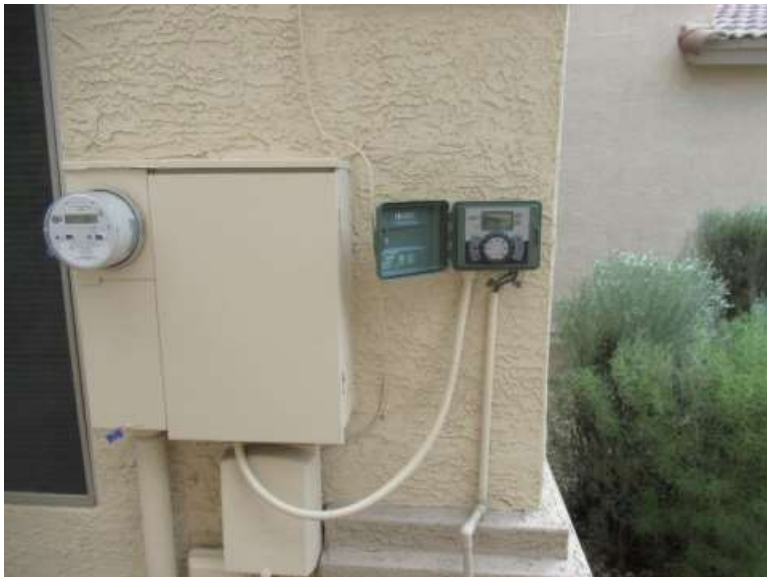
**Repair:** Although not every head or emitter was checked, it was observed that one or more of the emitters/heads were missing or broken and needs repair by a qualified contractor.

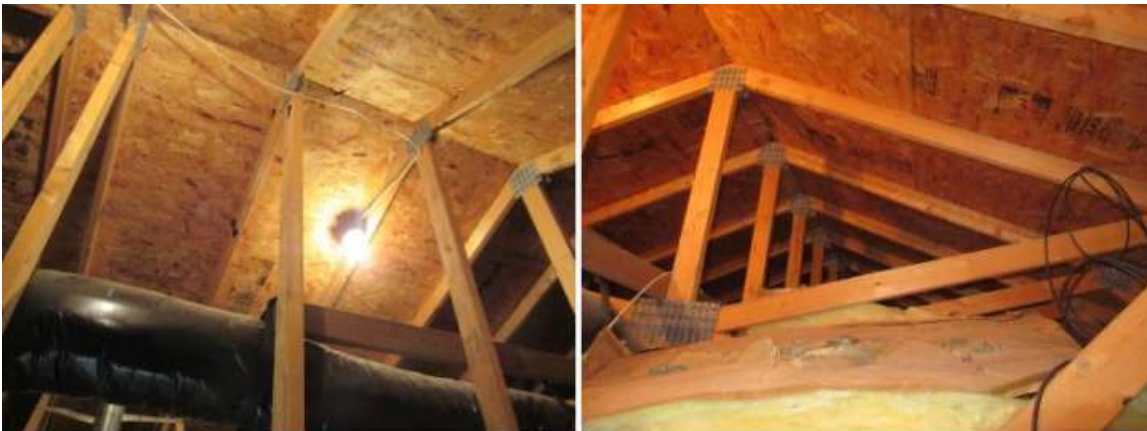
**Further Review:** The gusset plate (gang-nail connector) is missing on one of the trusses. Since the plate is required and a part of the original truss, it will need to be corrected and engineering will be required (8 1/2" X 11 sheet of paper show truss and repair with engineers stamp).

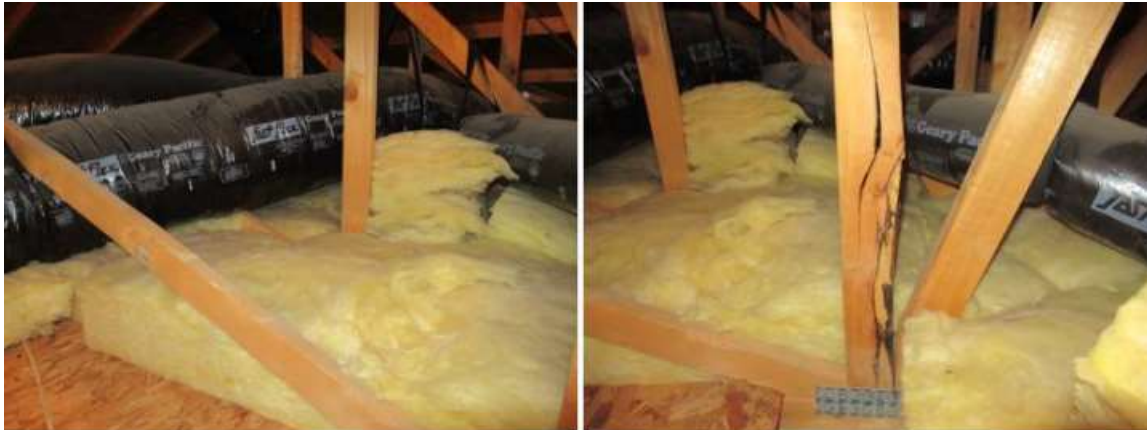
**Repair:** One or more of the insulation batts have fallen, are missing and/or have been displaced. They should be reinstalled to reduce thermal loss between the home and the attic.

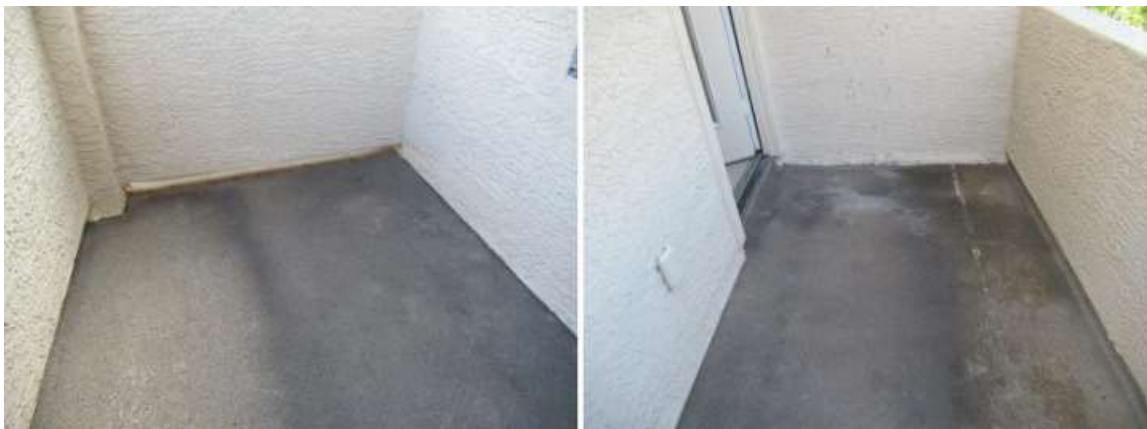
**Repair:** There are gaps noted along the lap joints and/or seams. Repair by a licensed roofing contractor is recommended.

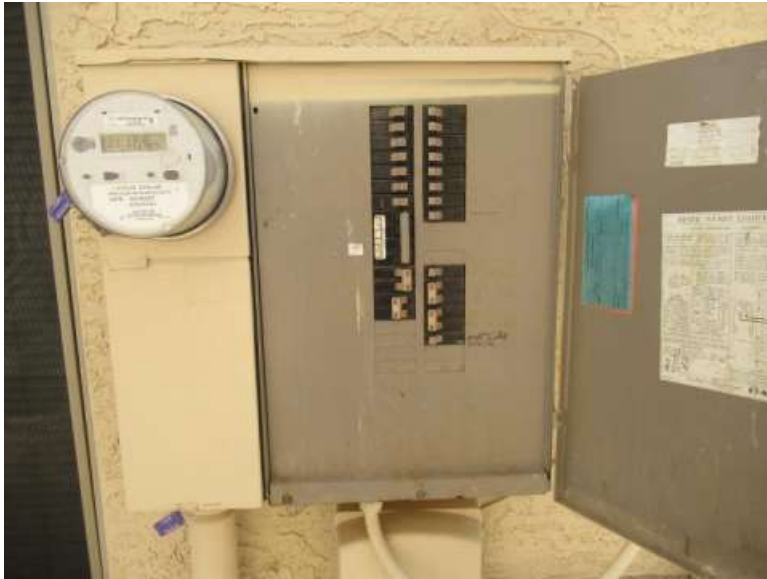
**Repair:** The breakers in the panel are not labeled and/or the labeling has worn off. For safety, all of them should be

identified with some sort of permanent label.

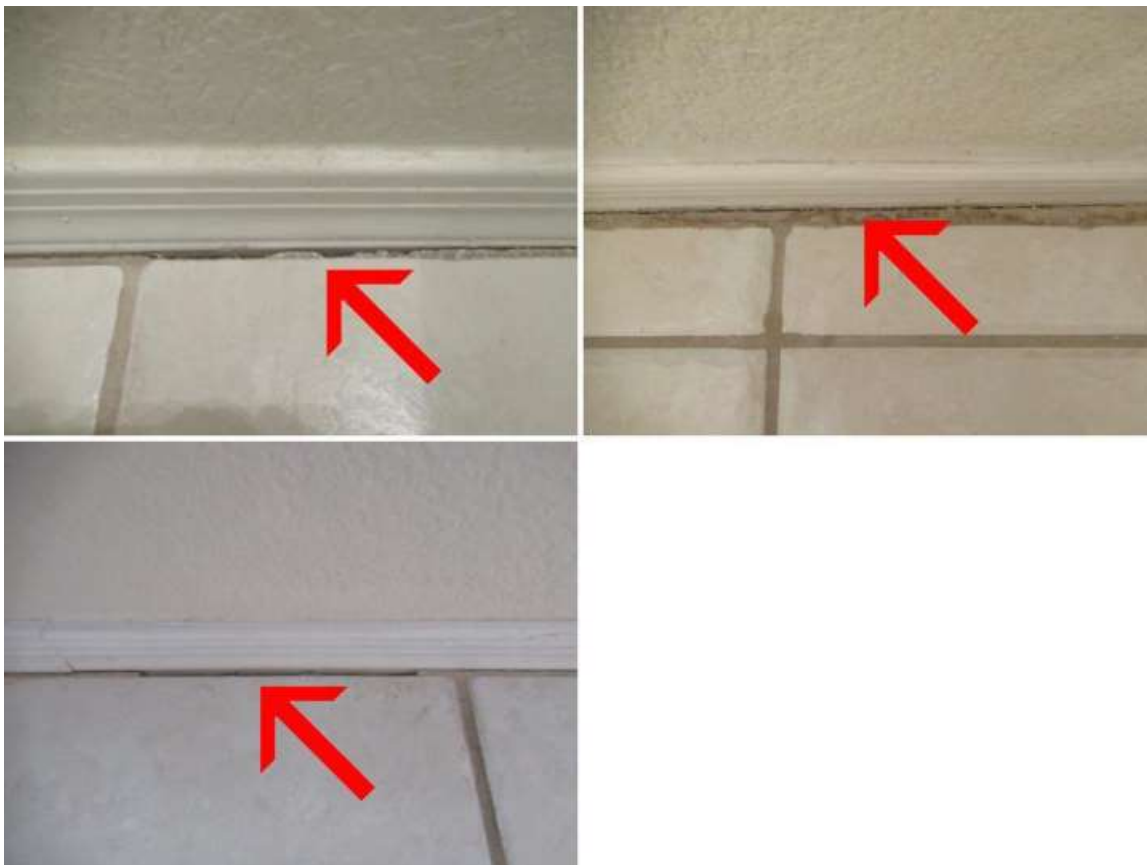
**Repair:** Some repairs to the tile and grout is needed throughout, especially at dissimilar materials and needs repair by a qualified contractor.

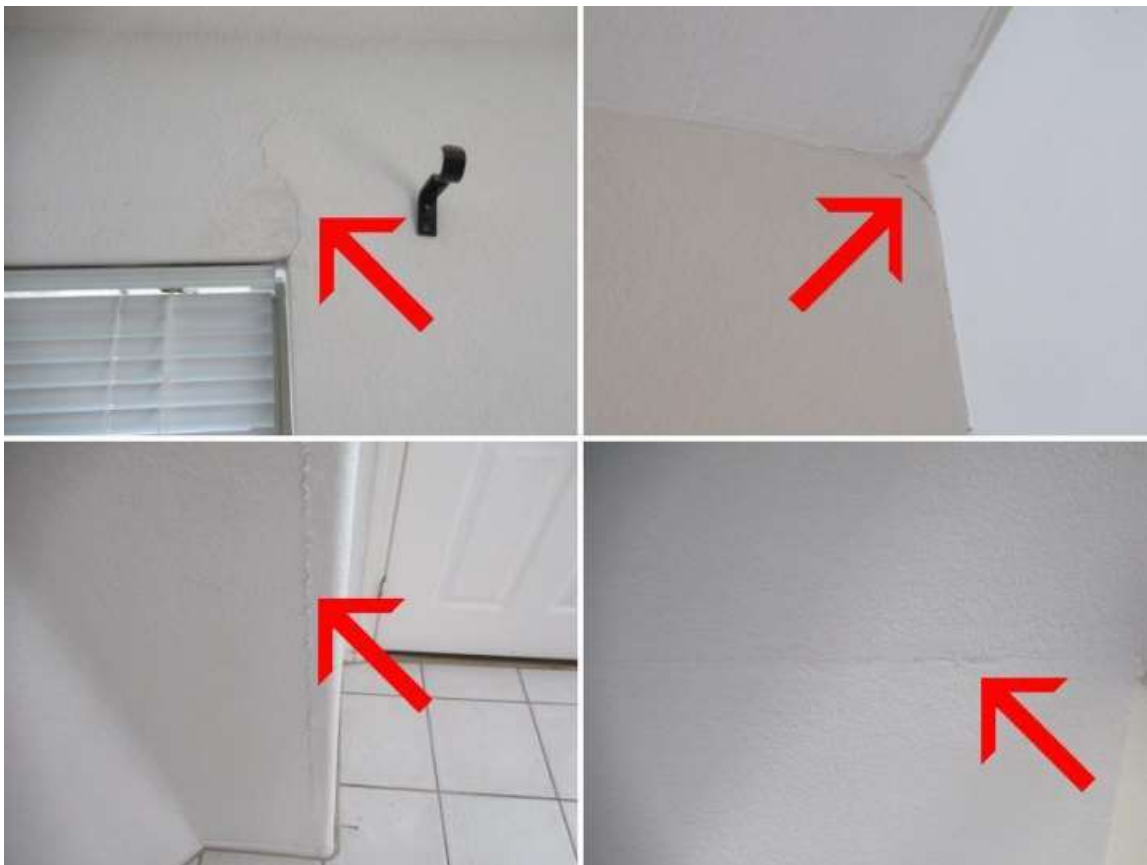
**Further Review:** There multiple settling cracks (1/8 inch) noted at the ceiling/wall that should be monitored at minimum for any additional movement. However, we do recommend it be check for any underlying problems that could be causing the cracking.

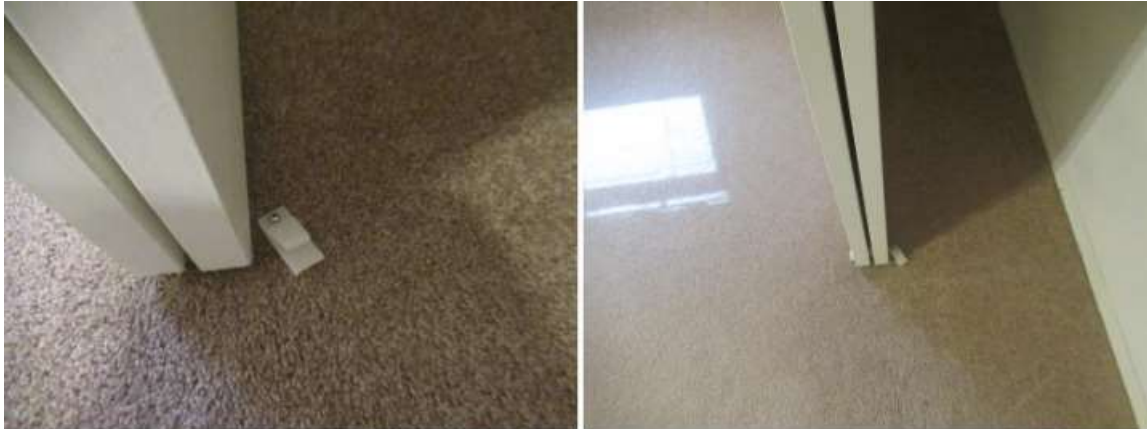
**Safety Concern:** The upper level loft closet floor guide is broken. Repair by a licensed contractor is recommended.
