National Property Inspections

Mr. and Mrs. Jones, 1715 Beach Dr., Oak Island, NC, 28465

Saturday, June 30, 2018

GENERAL INFORMATION

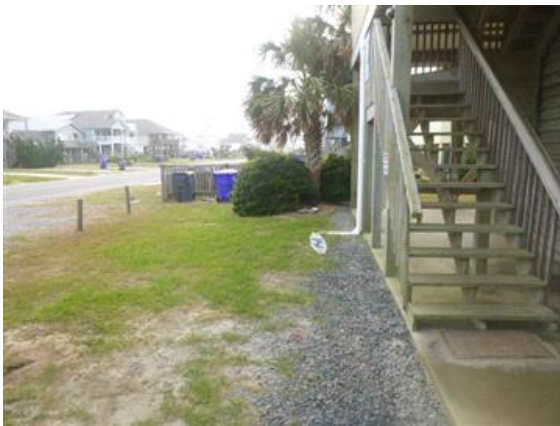
Front Of Property

The property consists of near level slopes on all four sides of the house. See photos. This condition is providing drainage away from the foundation.

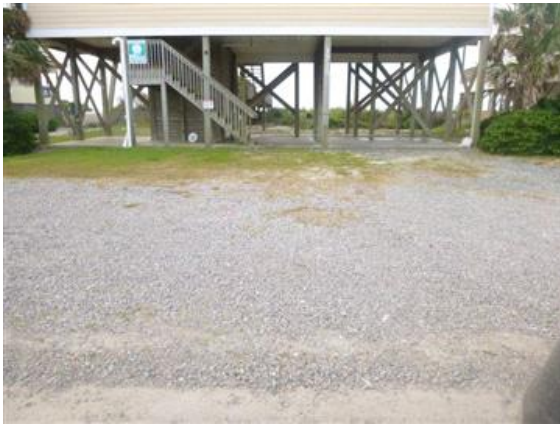
The driveway in front of the house consists of gravel/dirt and has a positive slope away from the house needed for proper drainage.

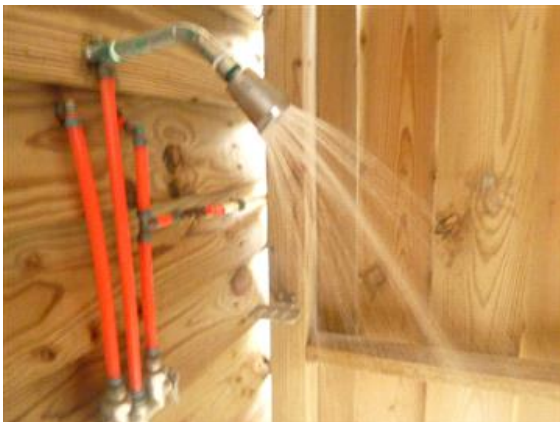
The exterior shower plumbing, fixture and door were tested and functioned as intended.

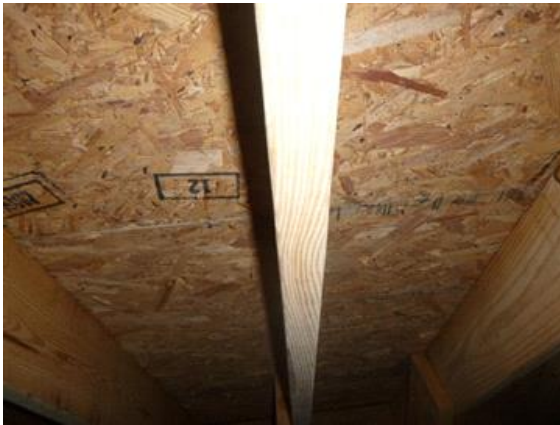
OSB Sheathing

There are 2" x 8" wood roof rafters that are 16" on center with OSB (oriented strand board) sheathing. See photos. There are no signs of cracked roof rafters or water penetration.

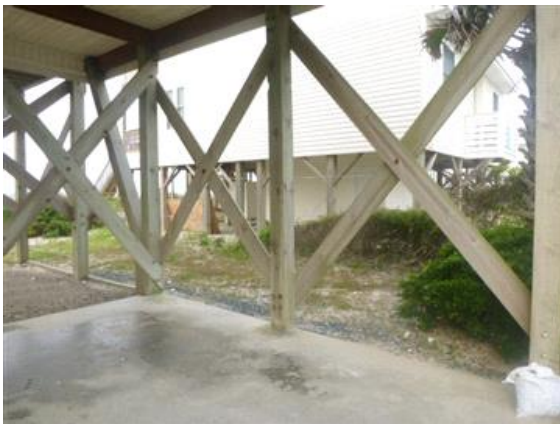
Typical Pilings With Cross Bracing

The framing support is provided by 8" x 8" pilings driven down until a certain friction point is reached. Typically 2" x 10" or 2" x 12" girders are attached to the pilings. Then 2" x 8" or 2" x 10" wood floor joists and rim joists are joined with floor decking to form a solid framing deck. The pilings were inspected at the ground entry point for wood deterioration and were found to be solid with no signs of deterioration.

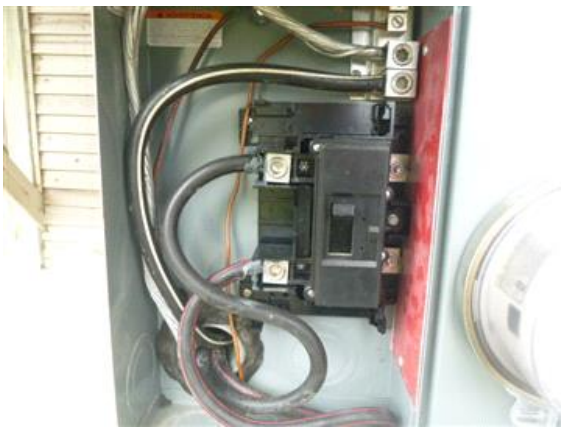
Main Disconnect Panel

- 1) There is a 200 Amp main electric disconnect panel located outside at the meter and a 200 Amp sub panel, located in the first floor hall outside the laundry room, that is installed properly and well labeled.
- 2) The smoke detectors, located in and out of the bedrooms, were tested by pushing the test buttons and the alarms sounded at the time of inspection. **NOTE:** Smoke detector manufacturers recommend replacing smoke detectors every 10 years and their batteries every 6 months for safety purposes.

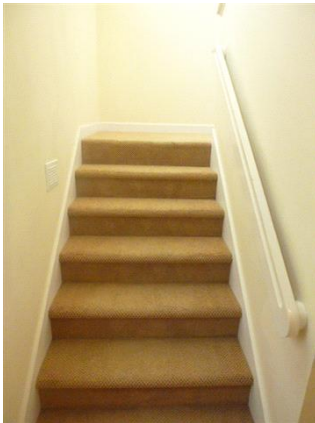
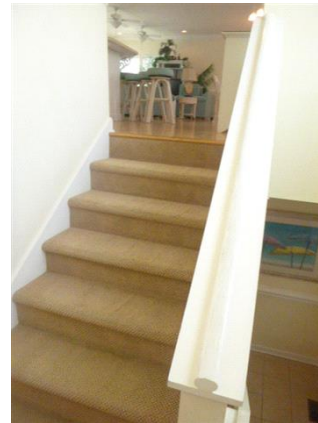
The stairs leading up to the second floor have the appropriate lighting, hand railing, riser and tread size for safety purposes.
