National Property Inspections

Jack & Jill Hill, 62 Button Ct, Southport, NC, 28461

Inspection Date:
06/30/2018

GENERAL INFORMATION

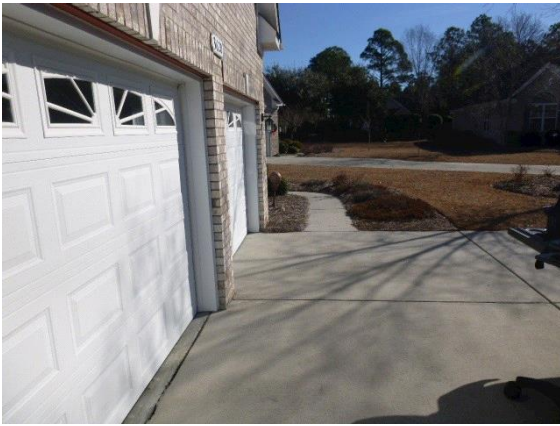
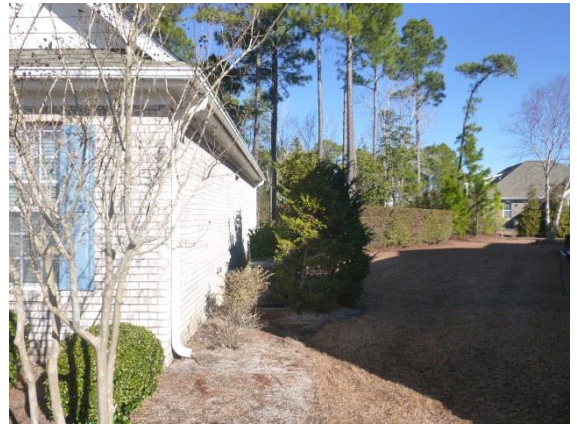
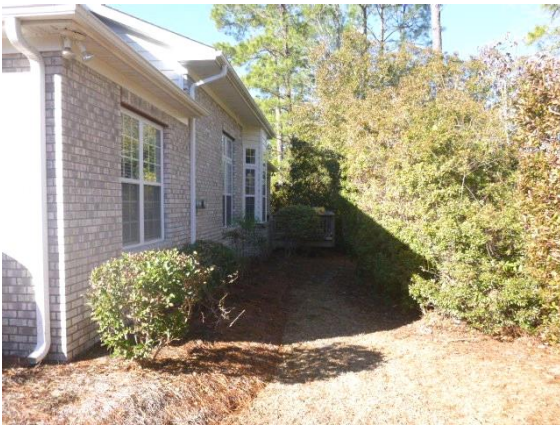
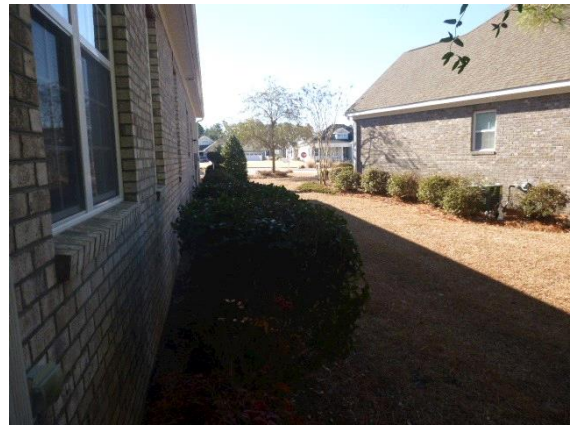
The property consists of positive slopes on all four sides of the house. See photos. This condition is providing good drainage away from the foundation.

Grading / Drainage: View of front property

Grading / Drainage: View of right side property

Grading / Drainage: View of rear property

Grading / Drainage: View of left side property

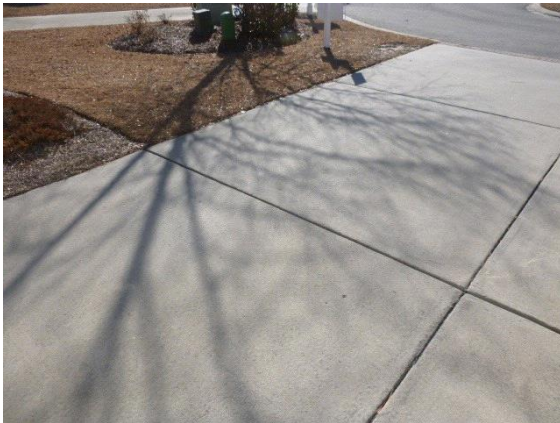
The driveway, located in front of the house, is concrete and has the proper expansion joints present which are needed to help prevent cracking.

Driveway: Overall view of concrete driveway

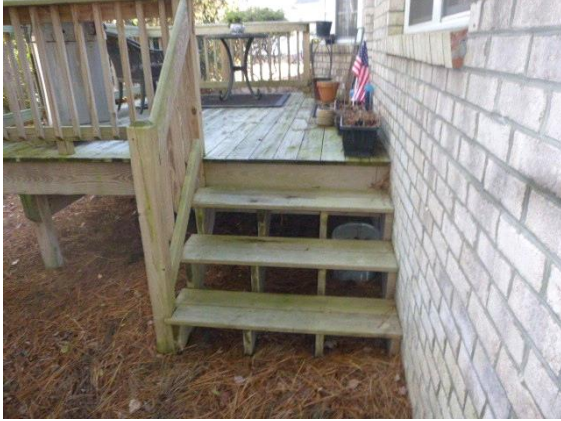
1. The wood stairs leading up to the rear wood deck have multiple cracks in the stair stringers. See photos. Evidence suggests this condition creates a safety hazard.
2. The wood step located on the left side of the house, at the garage side entry door, is loose when operating. See Photo. Evidence suggests this condition creates a safety hazard.

Walks / Steps: Overall view of rear wood steps

**Recommend a licensed general contractor evaluate items 1 and 2 and make the necessary repairs.

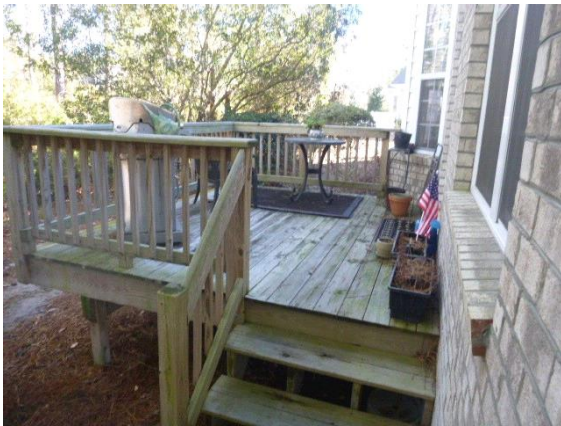
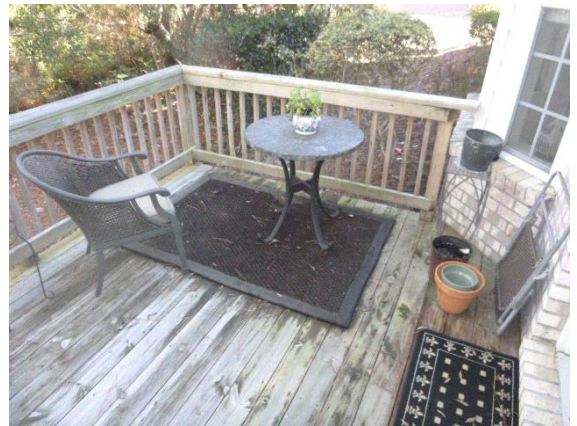
There is a wood deck located at the rear of the house. See photo. The deck has the appropriate guard rails that measure approximately 32 inches to 36 inches high with the appropriate balusters no wider than 4 inches apart.
Note: visibility of the rear deck was limited due to items on the deck surface and around the perimeter. See Photos.

Decks / Balcony: Overall view of rear wood deck

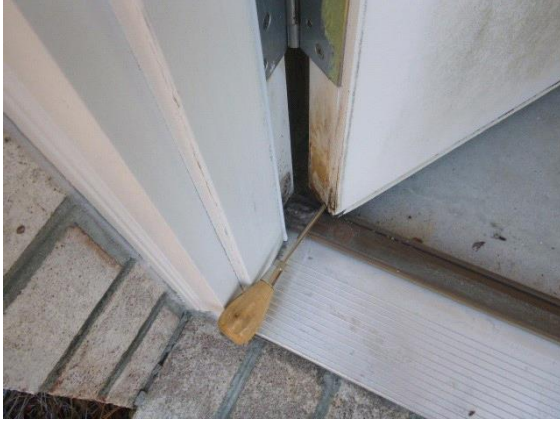
1. The garage side entry door has soft wood present at the lower section of the door core. See photo. Evidence suggests that there has been water intrusion into this area and that it has weakened the structure of the door and framing. Recommend a qualified general contractor evaluate, determine the cause and extent of the damage, and make the necessary repairs.

Exterior Doors: View of soft wood present at garage side entry door

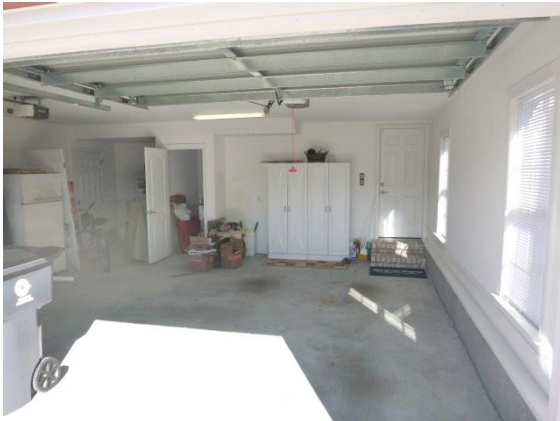
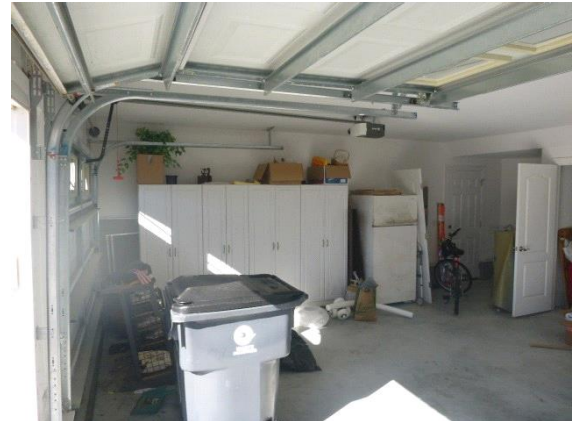
Limitation: The garage has limited visibility due to items located around the perimeter walls and covering the garage floor. See photo.

Garage/Carport: Overall view of garage

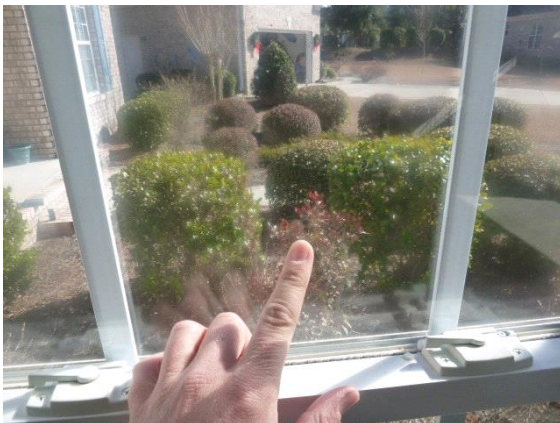
There is condensation present inside the rear double-pane glass window, located at the front of the garage. See photo. Evidence suggests the desiccant strip designed to absorb moisture from the space between the panes has become saturated and will no longer prevent condensation from forming. In some situations repair is possible, but if irreparable damage has occurred, the window pane assembly will need to be replaced. Recommend a qualified contractor evaluate and make the necessary repairs or replacements.

Garage/Carport: View of fogged window located in the garage

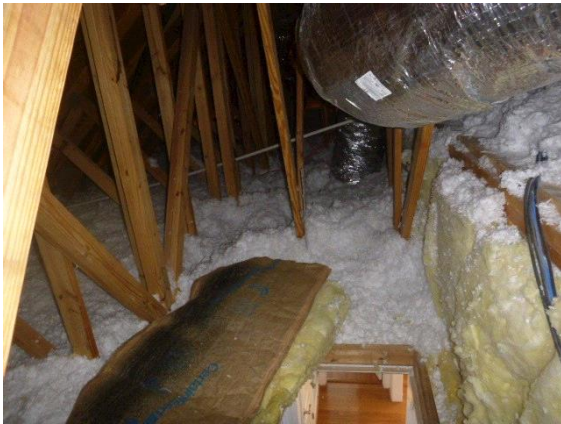
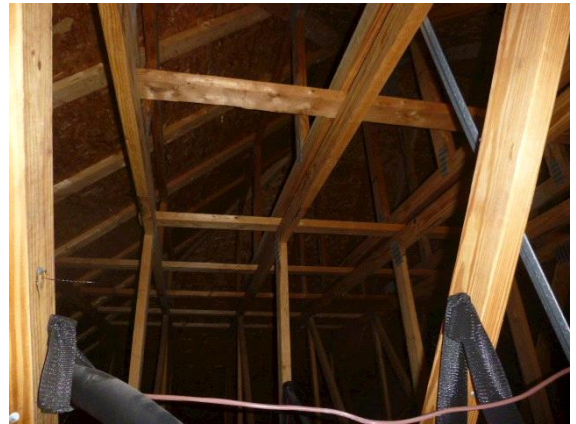
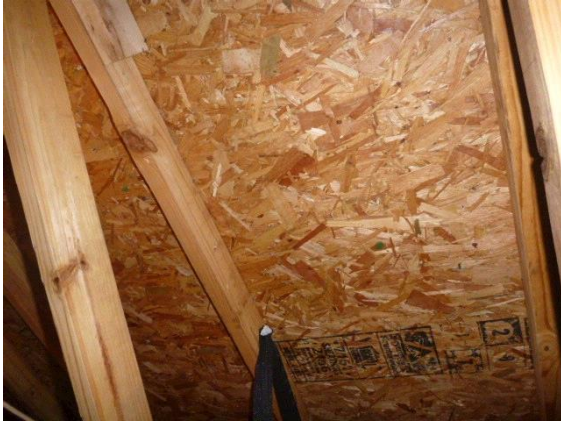
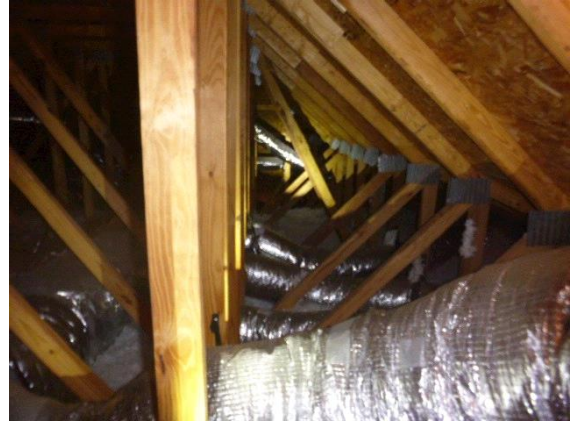
The attic roof framing consists of engineered 2" x 4" wood trusses that are 2 feet on center and are designed to carry the full load of the bearing roof. The sheathing type is OSB (oriented strand board) See photos.

Attic Framing/Sheathing: Views of attic framing and sheathing

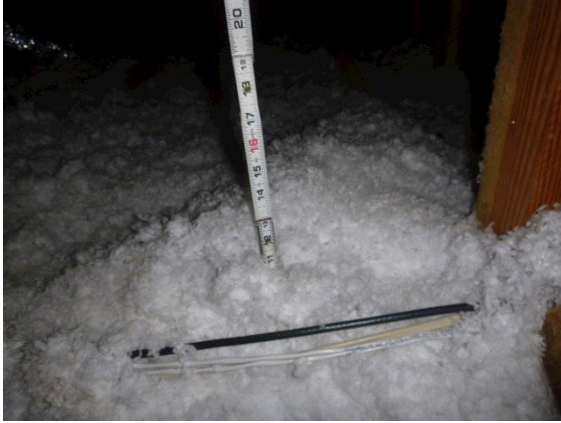
There is 10 to 12 inches of loose fill blown wool type insulation present in the attic area and it is evenly distributed. The attic insulation has an R value of approximately R30.

Attic Insulation: View showing the depth of insulation located in the attic

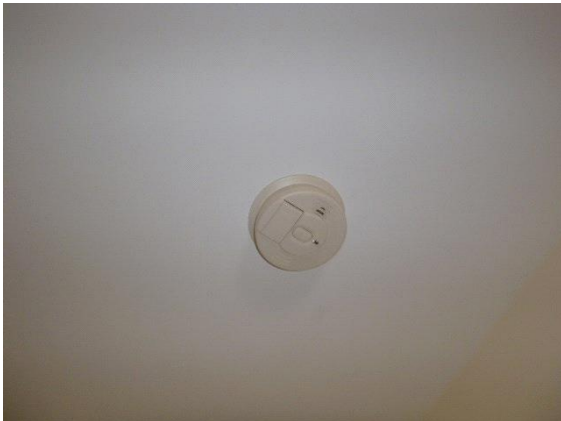
Electrical: All smoke detectors were checked and were operational at the time of the inspection

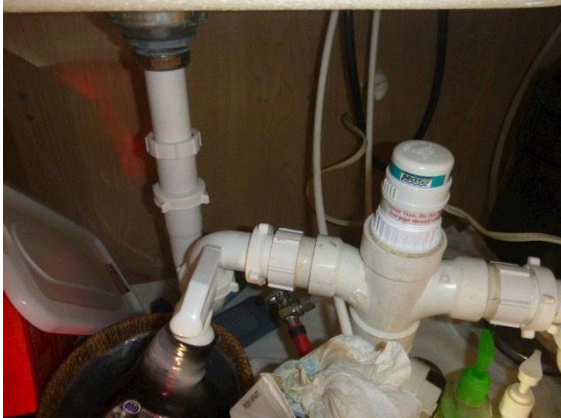
Picture shows typical plumbing setup located under sinks. All sink water supply lines are PEX tubing and have PVC drain and vent pipes.

Plumbing: View of plumbing pipes below sinks

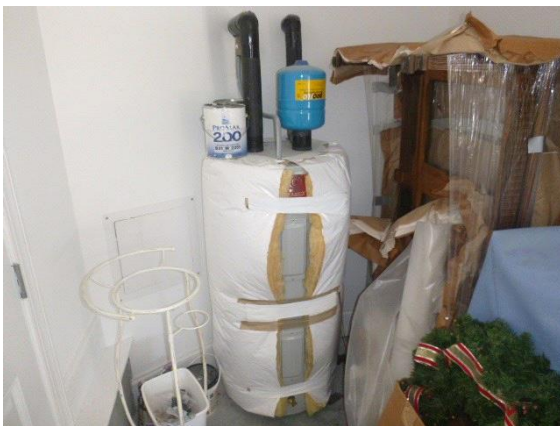
Limitation: The electric water heater, located in the garage, could not be fully physically inspected because there is an insulated blanket fully covering the unit. See photo.

Water Heater: View of insulation installed on water heater

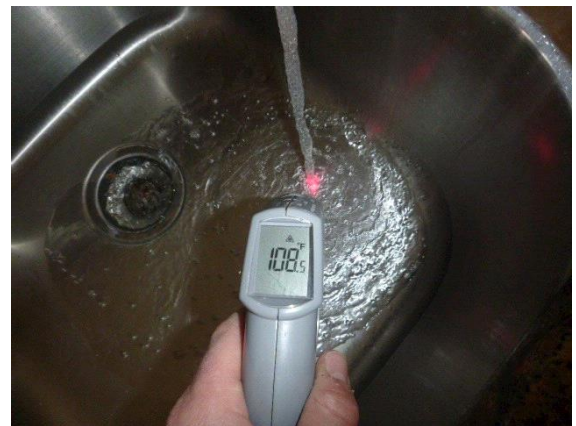
The electric water heater is supplying hot water at the kitchen sink at 108 degrees. See photo. Even though the water heater is operating as intended, due to it's age, I recommend a licensed plumber to evaluate the water heater to determine its condition, in order to plan for any anticipated future repairs and/or replacement, before closing on this home. **Note:** Because of the age of the water heater, it will not be covered by our warranty or insurance.

Water Heater: View of water temperature at the kitchen sink

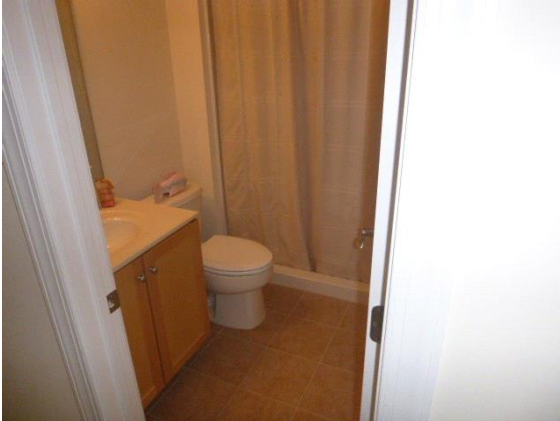
1. There was no power present at the GFCI receptacle located next to the bathroom sink. See photo. Evidence suggests the receptacle does not function as intended.
 2. One bulb in the light fixture, located over the bathroom sink, did not light when the wall switch was turned on. See photo. Recommend changing the light bulbs first.
- **Recommend a licensed electrician evaluate items 1 and 2 and make the necessary repairs.

Bathroom #3 - Guest - 2nd Floor : Overall view of bathroom

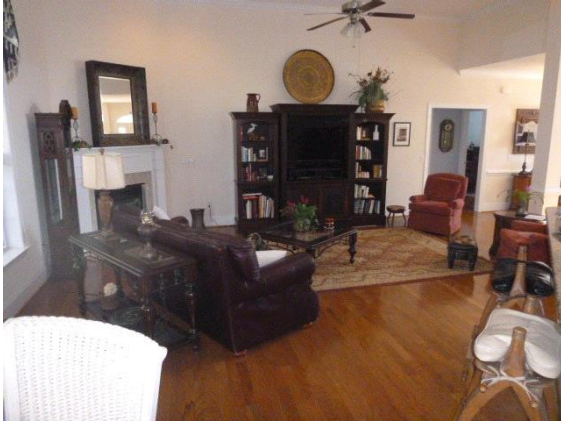
Living Room: Overall view of living room

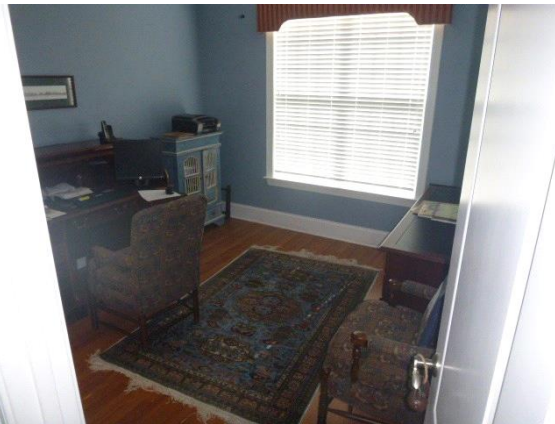
The bedroom entry door is hitting the threshold when closing. See photo. Evidence suggests the door is not operating as designed. Recommend a qualified contractor evaluate and make the necessary repairs.

Bedroom #2 - Guest - Right Side - Front : Overall view of bedroom

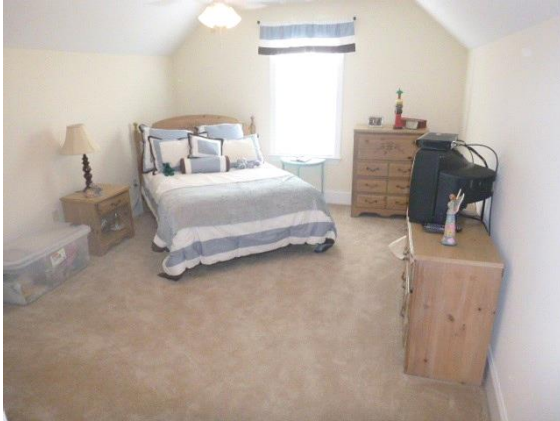
Finished Room Over Garage: Overall view of finished room over garage

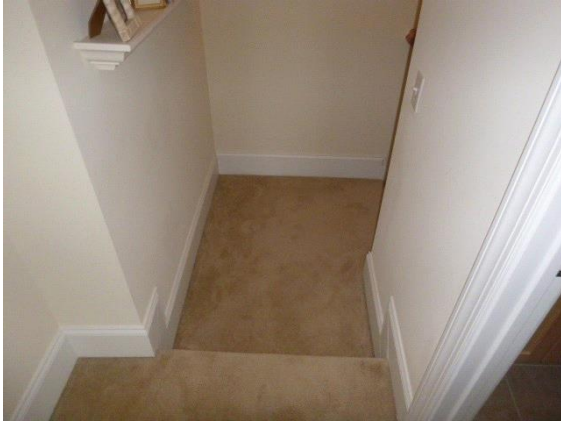
Stairs / Railings: Overall view of interior stairs and railings

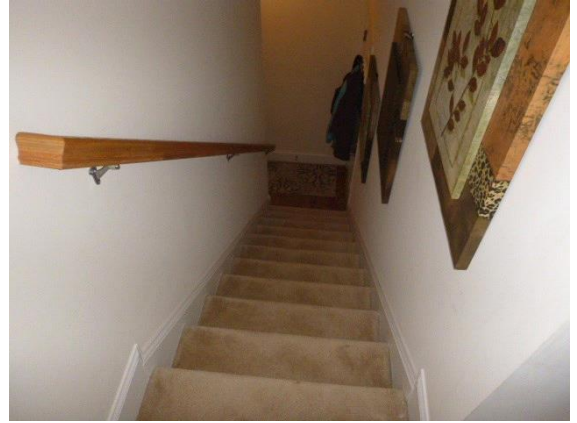
Stairs / Railings: Overall view of interior stairs and railings
