Commercial Inspection Report

Sample - Union Grove, WI

Prepared for: **Sample**

Prepared by: **National Property Inspections
2053 Quincy Ave.
Racine, WI 53403
Inspection Date: 11/16/2017**

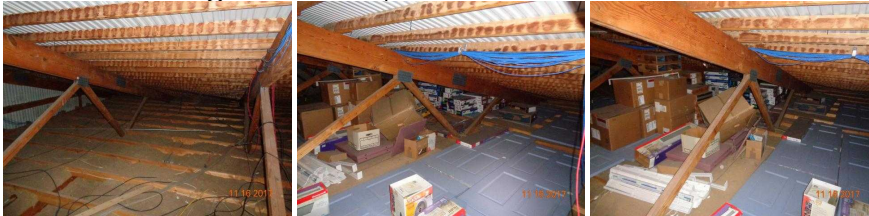
- 3. Acceptable Sheathing: Metal
- 4. Repair or Replace Ventilation: None
- 5. Repair or Replace Insulation: Blown in

Recommend add proper ventilation.

Approx 3-4" present. Recommend add more insulation on the ceiling.

The wall to the warehouse has no insulation, recommend add to complete heating envelope.

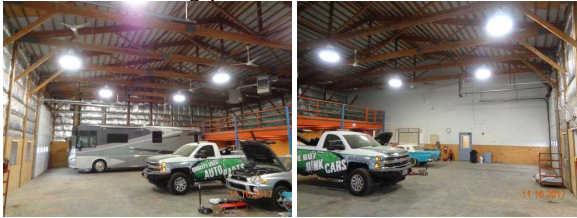
Structure Type: Pole Barn

Wood post and wood trusses with wood purlins.

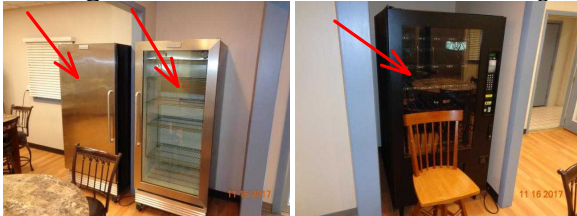
- 2. Acceptable Sink: Stainless Steel
- 3. Repair or Replace Electrical: 110 VAC, 110 VAC GFCI
- 4. Acceptable Plumbing/Fixtures: PVC
- 5. Acceptable Counter Tops: Laminate
- 6. Acceptable Cabinets: Wood
- 7. Monitor Ceiling: Suspended ceiling
- 8. Repair or Replace Walls: Paint

One outlet on North end is missing a cover plate. One switch on North end, not sure what it operates.

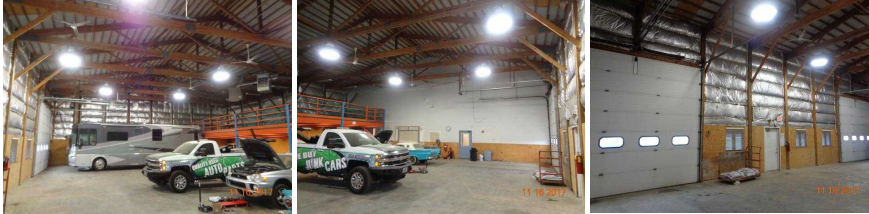
- 21. Monitor Floor: Concrete There are a few typical cracks present.

- 22. Acceptable Doors: Metal
- 23. Repair or Replace Overhead Doors: Aluminum Insulated The West wall South door opener does not work properly and lift the door. South door opening on West wall has some damaged trim.
