Inspection Report

Sample Report

Property Address:
123 Home Sweet Home
Nice City OH 45312

National Property Inspections

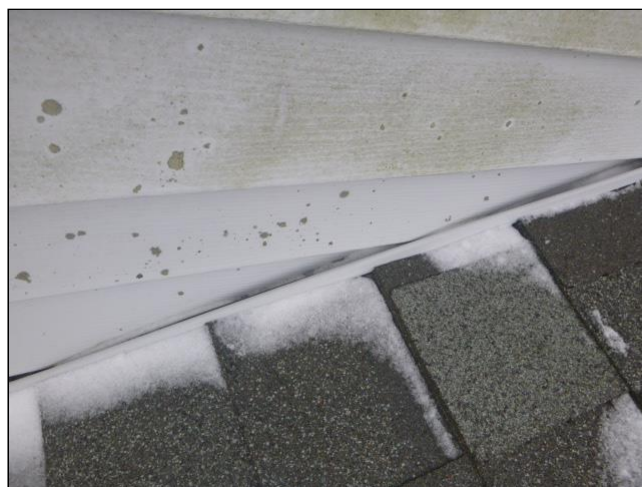
1.1 Item 2(Picture)

Asphalt fiberglass dimensional roof shingles, estimated age is 2-5 years old with one layer. Shingles found in good repair and laying flat at the time of the inspection.

Roof surface was inspected from the ground level due to snow and ice covered surface conditions.

Metal flashing visible along the perimeter of the roof line or eaves. Surface found in good repair at the time of the inspection. Vent pipe seals and exhaust vent flashing found in good repair the day of the inspection.

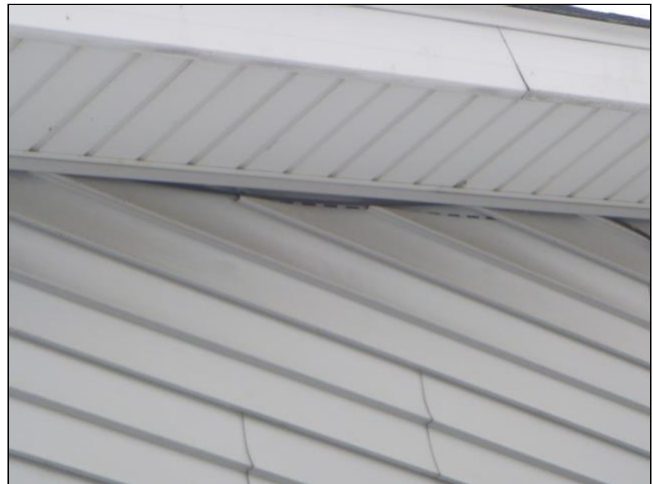
2.2 Item 2(Picture)

Vinyl siding found loose and moving out of position at the gable end at the garage and over the double doors at the walkout basement. Recommend having the siding secured to prevent damage or insects nesting behind the siding.

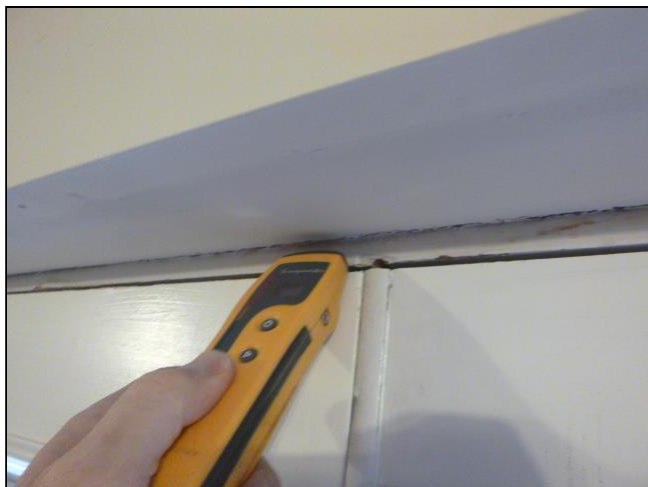
2.4 Item 3(Picture)

Double doors at the walkout section of the basement marked for repair or replacement. Doors are not flashed correctly on the exterior and suspect past and future leaks on the interior.

Secondary door is badly rusted at the base, wood rotted frame and primary door has loose hinge screws. Thermal glass in the two doors were noted with fogging.

We recommend evaluation and repairs or replacement by qualified contractor.

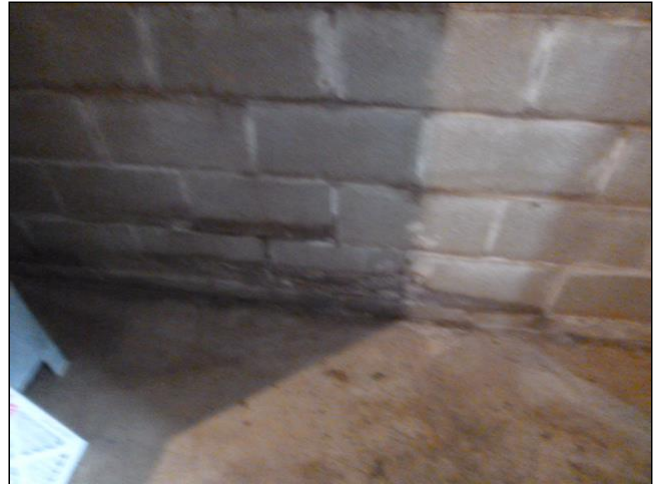
4.0 Item 2(Picture)

Water entry into the basement workshop below the in-law suite because of staining noted on the block. We would recommend monitoring and keep gutters and down spouts in good working order to manage moisture around the structure.

Foundation is marked for further evaluation and repair due to visible moisture entry and/or efflorescence on walls in the (LOCATION) of the basement/crawlspace. Recommend further evaluation and repairs by a qualified foundation waterproofing contractor.

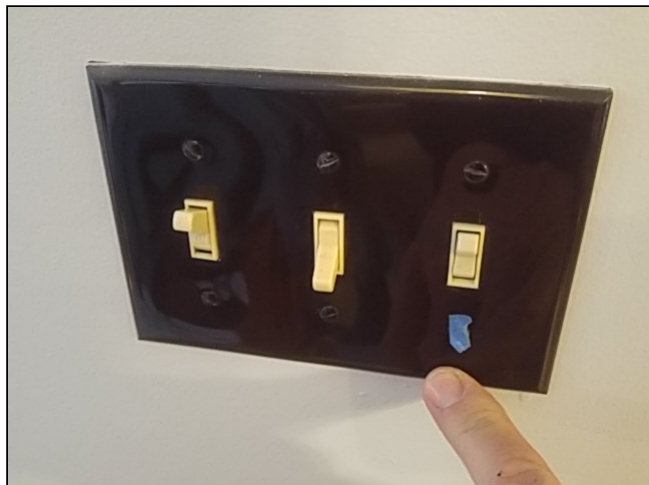
6.3 Item 1(Picture)

(1) Three way switch in the near front door (marked with tape) is not wired correctly or has incorrect switch. The light(s) could not be controlled properly from both locations as designed. Recommend having the location checked and repaired by qualified electrical contractor.

The above items are considered electrical hazards that effect the safety and habitability of the occupant. A qualified electrical contractor is recommend for these repairs.

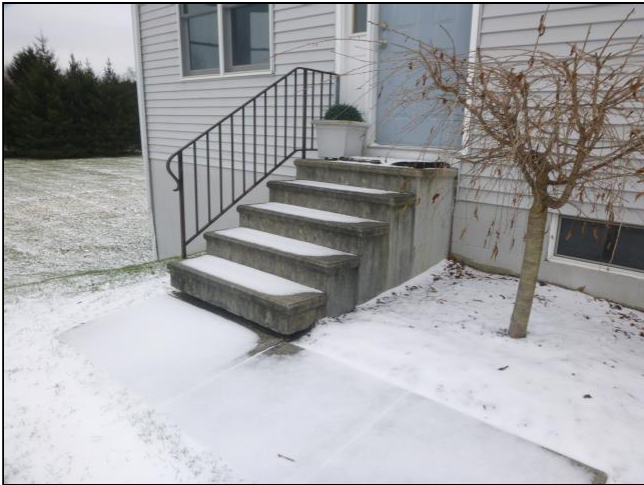
2.1 Item 1(Picture)

(1) Side entry to the in-law-suite was found with settlement and erosion. The pre-cast concrete steps was found sloping towards the home and with 2-3 inch gap below the first step and side. We recommend having the steps adjusted and repaired. Recommend additional railing on the right side for safety due to the height.

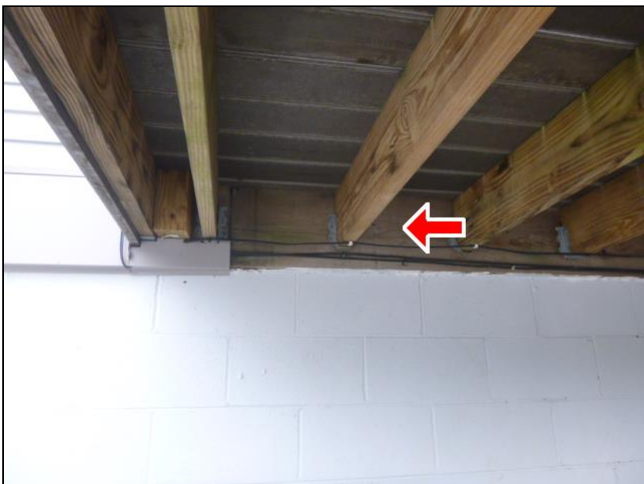
2.1 Item 4(Picture)

(2) Wooden deck marked for repair because of undersized or missing fasteners (lag bolts) in the ledger board below the south side doors. The undersized or missing fasteners can allow the ledger board to pulling away from the exterior of the house.

Exterior flashing missing or not visible along the ledger and behind the siding.

We recommend having the fasteners and flashing evaluated by a qualified deck contractor for safety.

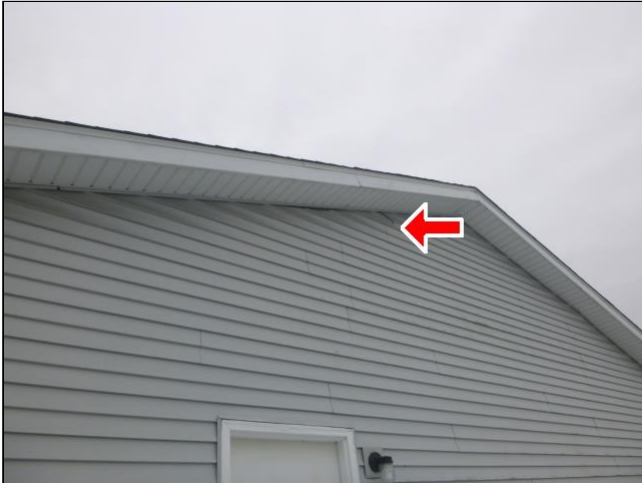
2.2 Item 1(Picture)

Vinyl siding found loose and moving out of position at the gable end at the garage and over the double doors at the walkout basement. Recommend having the siding secured to prevent damage or insects nesting behind the siding.

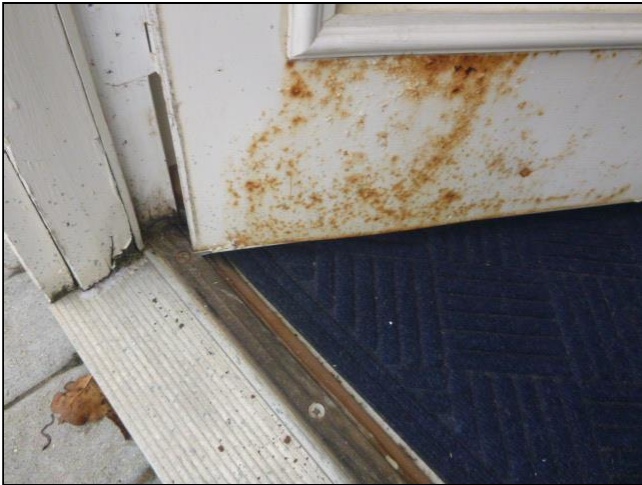
2.4 Item 1(Picture)

Secondary door is badly rusted at the base, wood rotted frame and primary door has loose hinge screws. Thermal glass in the two doors were noted with fogging.

We recommend evaluation and repairs or replacement by qualified contractor.

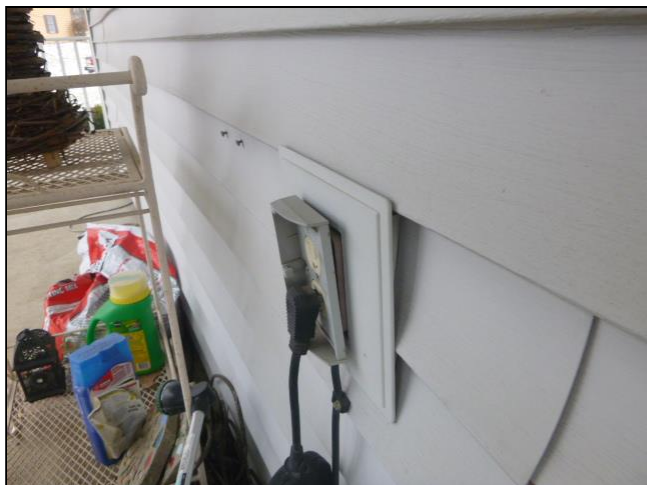
2.7 Item 1(Picture)

Exterior plug at the rear of the home tested good for ground circuit and correct polarity. No GFCI protection. GFCI protection should be present due to age of the build. Recommend evaluation by qualified electrical contractor as needed.

Porch plug was found loose and missing protective cover. Recommend having the plug or electrical box secured for safety.

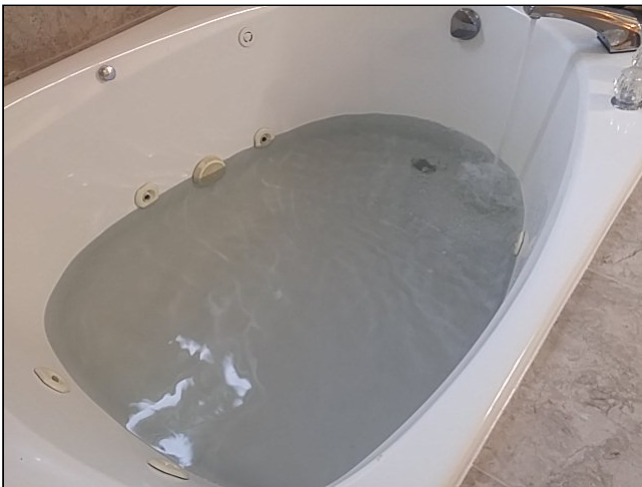
5.1 Item 1(Picture)

(1) Metals or debris in the water making it cloudy and dark. Recommend a whole house filter and softener check-up.

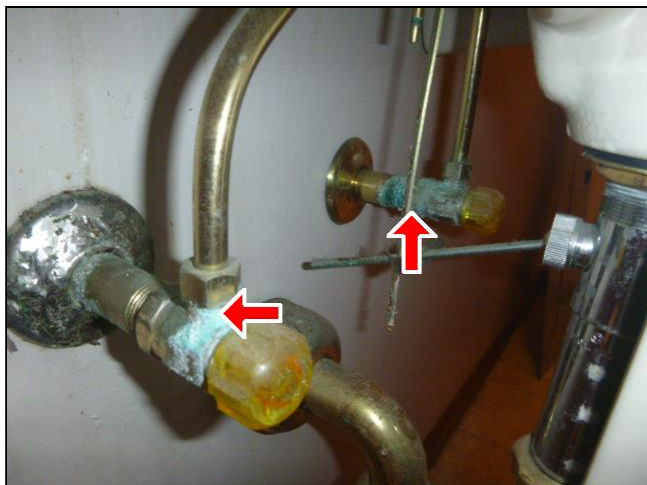
5.1 Item 2(Picture)

(4) Water supply line leaks noted at the basement pedestal sink. Recommend having the supply valves & nipples repaired by qualified plumbing contractor.

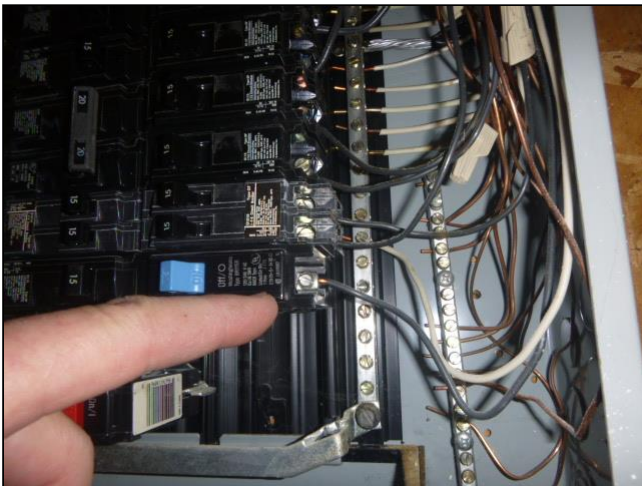
6.2 Item 1(Picture)

(1) Sub panel located in the basement bathroom is marked for repair because of incorrect wire gauge to the breakers. Two breakers are oversized to the gauge of wire.

Panel and circuits should be checked and repaired by qualified electrical contractor.

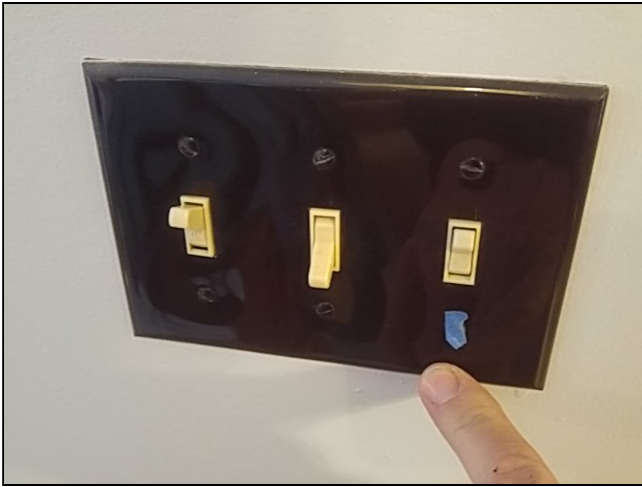
6.3 Item 1(Picture)

(1) Three way switch in the near front door (marked with tape) is not wired correctly or has incorrect switch. The light(s) could not be controlled properly from both locations as designed. Recommend having the location checked and repaired by qualified electrical contractor.

The above items are considered electrical hazards that effect the safety and habitability of the occupant. A qualified electrical contractor is recommend for these repairs.

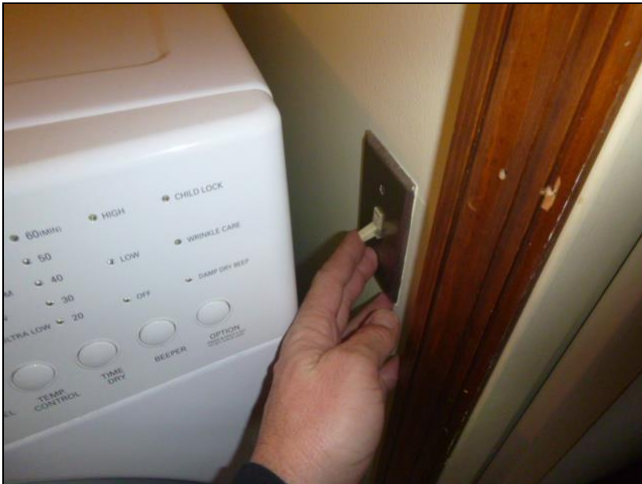
6.3 Item 3(Picture)

(2) Wall switch next to the washer/dryer had no function. Switch should control ceiling light as you exit or enter the room. Recommend repairs as needed.

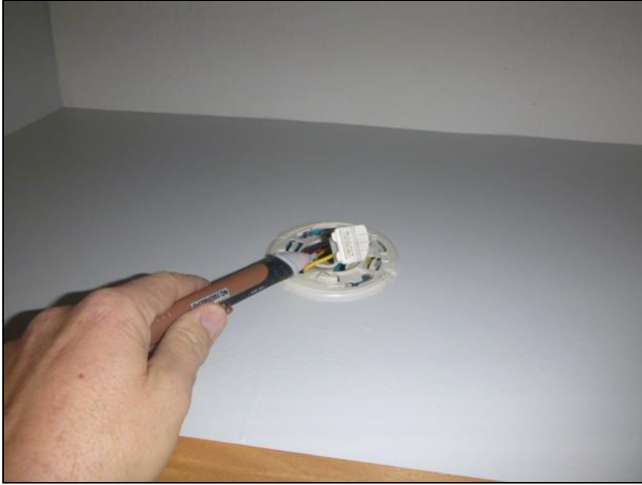
6.8 Item 1(Picture)

(1) Smoke detector has been removed from the In-Law suite. Recommend replacing for safety.

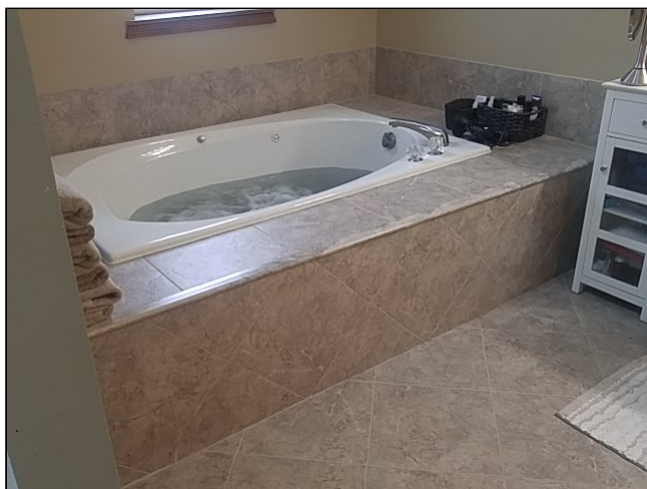
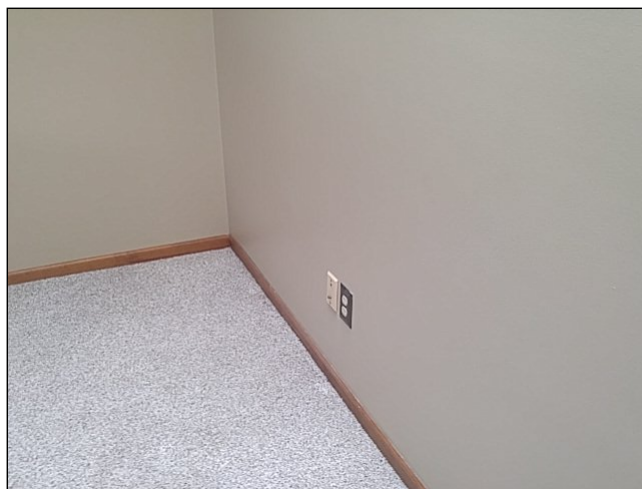
Jetted Tub was tested and appeared to operate correctly at the time of inspection. Tub had no accessible service access panel present. Inspector was not able to inspect the plumbing supply lines, plumbing drain lines or the electric source to the motor. Recommend adding an access panel to allow for future inspection or future service if necessary. Recommend repairs by qualified contractor.

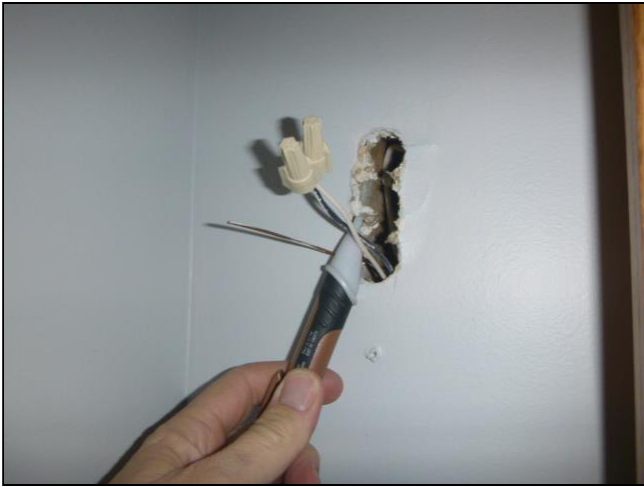
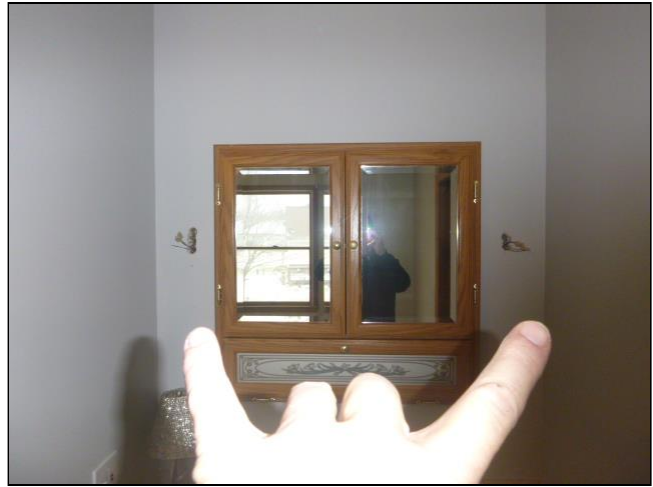
Vanity light missing and exposed electrical leads. Recommend repairs.

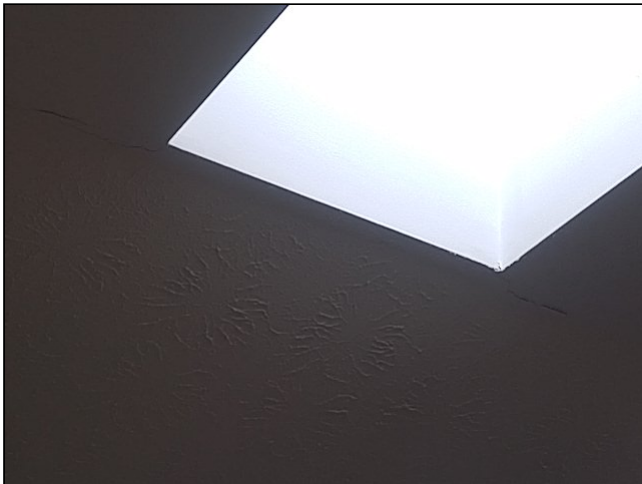
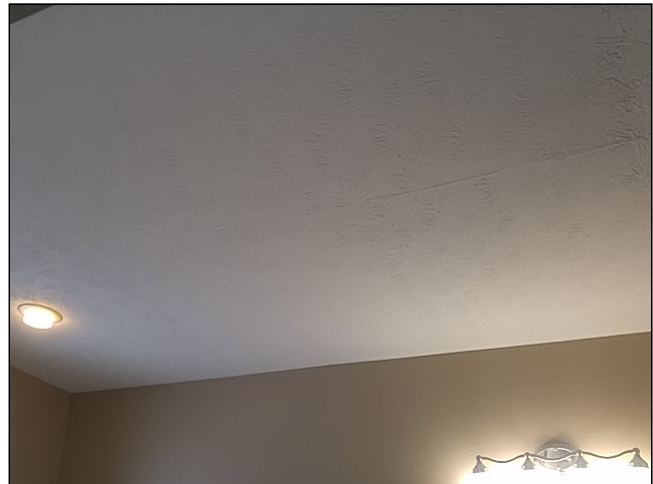
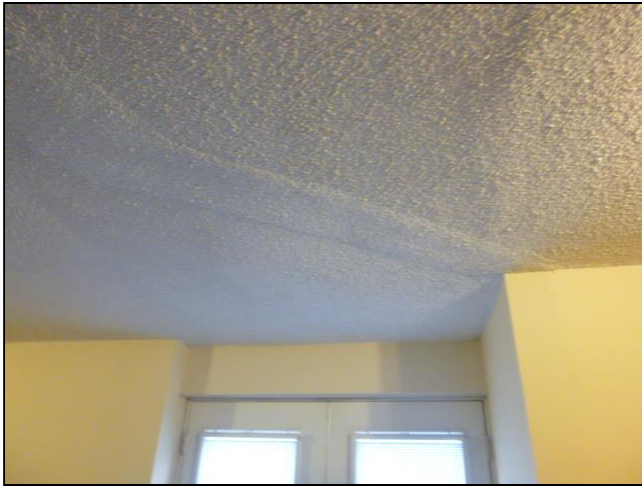
Tape joint cracks and previous repairs noted on the master bedroom and bathroom near skylights. Cosmetic details.

Previous repair noted on the basement ceiling.

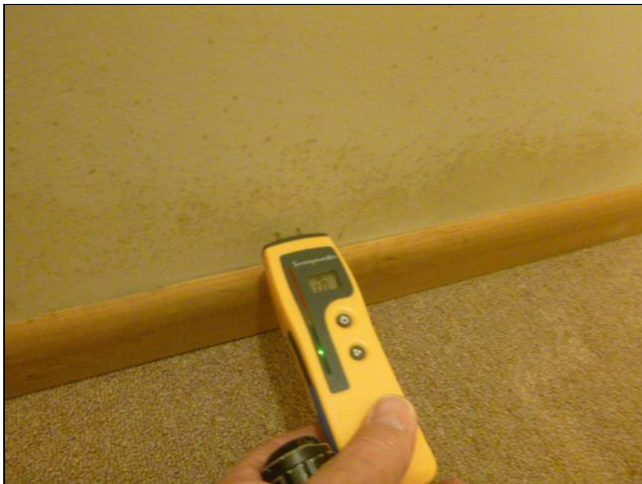
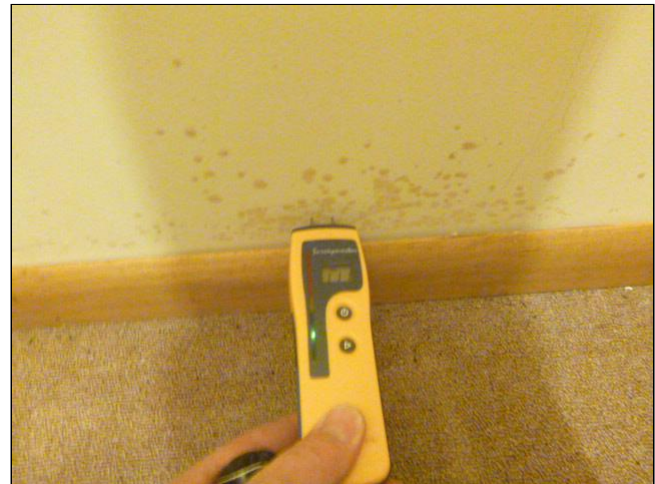
Basement closet wall in the southeast corner was found with surface residue. Area measured dry but maybe splatter or past fungal growth. Recommend evaluation by qualified handyman or contractor.

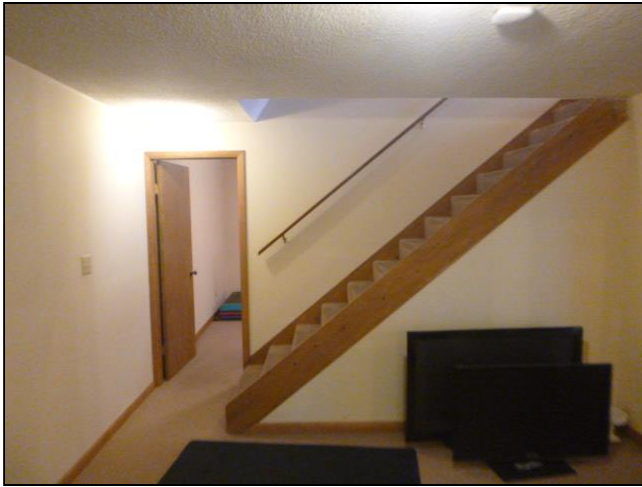
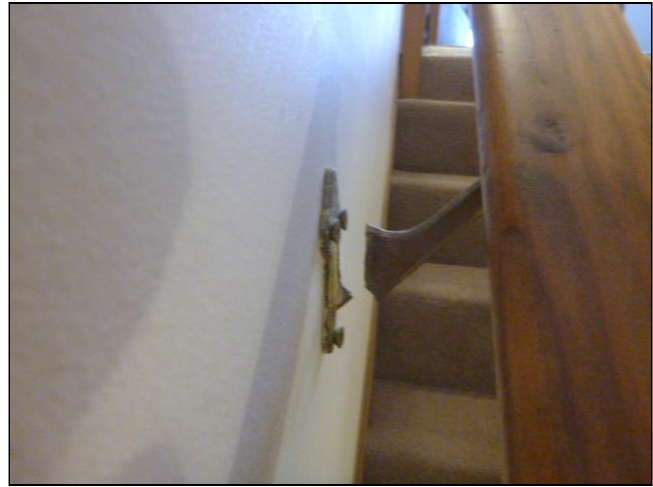
Open railing found on the stairway located in the basement. Open railing sections can become a hazard for adults, children and pets. This is a consistent configuration for the age of the home. Recommend considering balusters or solid wall installed for safety. This is for the buyers information.

Handrail at the basement stairs is loose at the wall. Recommend replacing the support to prevent injury.

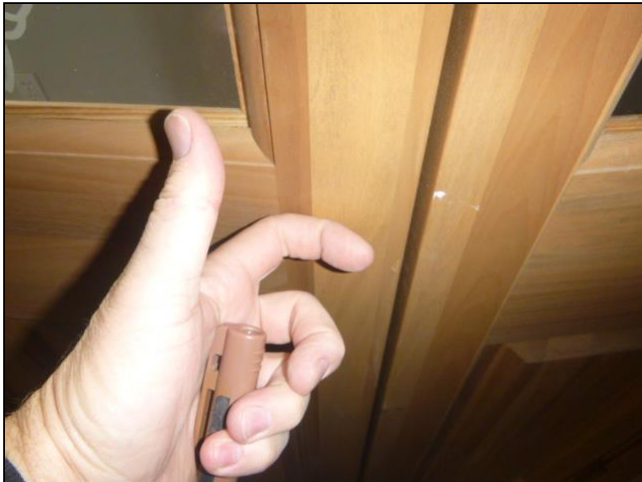
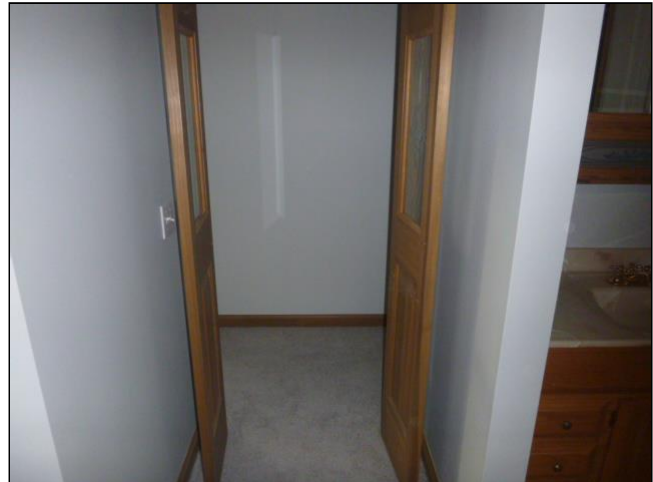
Double bedroom doors at the in-law suite are missing handles. No way to open the doors after closing. Recommend adding handles.

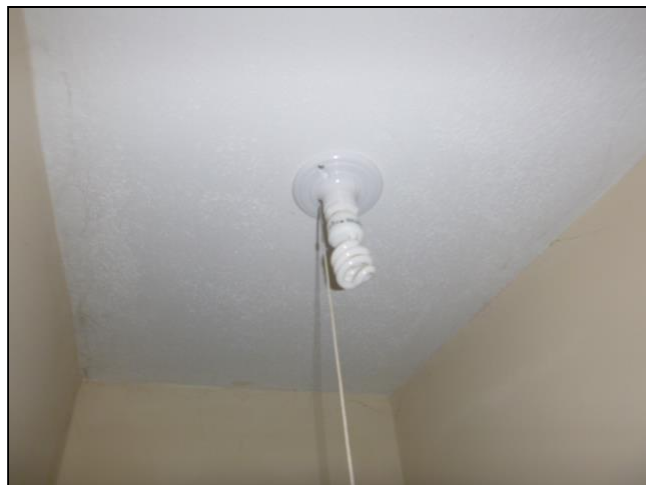
10.6 Item 1(Picture)

(1) Ceiling fan in the In-Law suite need adjusting or securing because the fixture wobbles when the fan is running (sounds like a wind chime), recommend repairs by qualified electrical contractor or handyman.
(2) Closets were found with open/surface mounted light fixtures. Recommend having replacement fixtures installed that have a globe or cover over the light because of fire hazard.
