NATIONAL
PROPERTY
INSPECTIONS®

TOP 10 RED FLAGS

Understand what issues your homebuyers are on the lookout for and how to offer solutions.

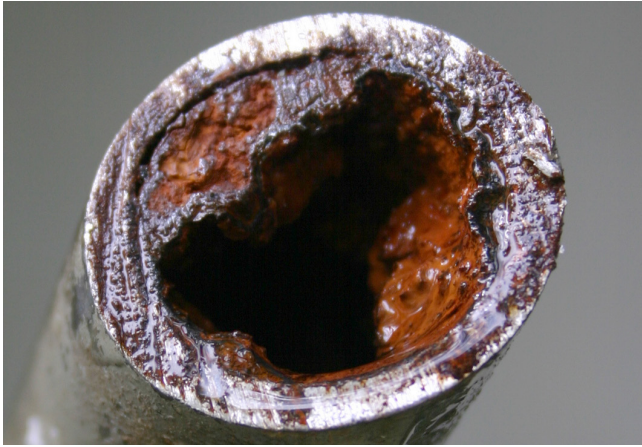
#9 - GALVANIZED PIPES

“Galvanized” pipes are zinc-coated pipes that were meant to prevent rusting. Galvanized piping was common until the 1950s and lasts around 40 to 60 years.

When galvanized pipes are found today, they are usually near the end of their lives and in need of replacement.

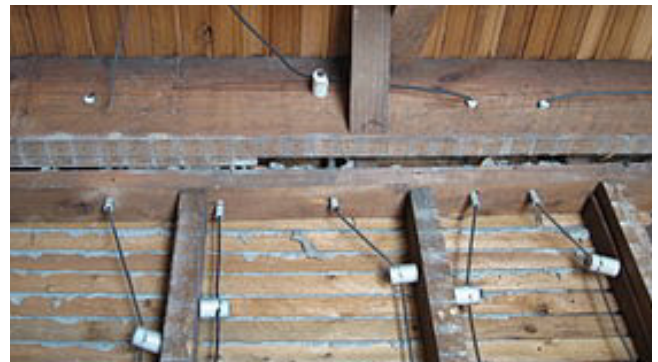
Knob and Tube Wiring

You may come across knob and tube wiring in homes built between 1880-1940. This type of system is designed so that heat from the wires can dissipate through an open space. However, this wiring is often prone to overheating when in contact with insulation or if the wires are too close together. The high risk of fire leads insurance companies to charge higher premiums or even deem a home un-insurable.

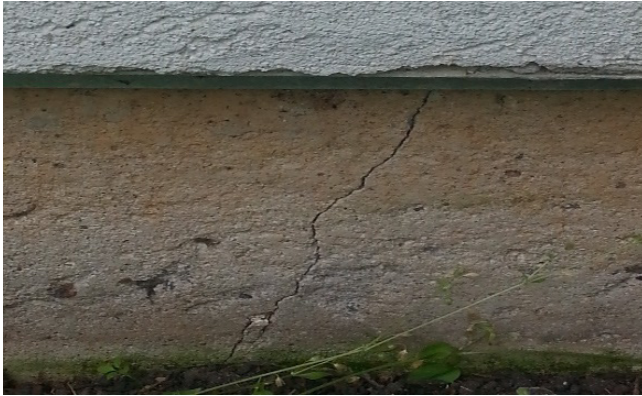
Hairline Cracks (1/16 inches or Less)

Hairline cracks are most likely caused by shrinkage during the curing process of poured concrete. They do not present any concern.

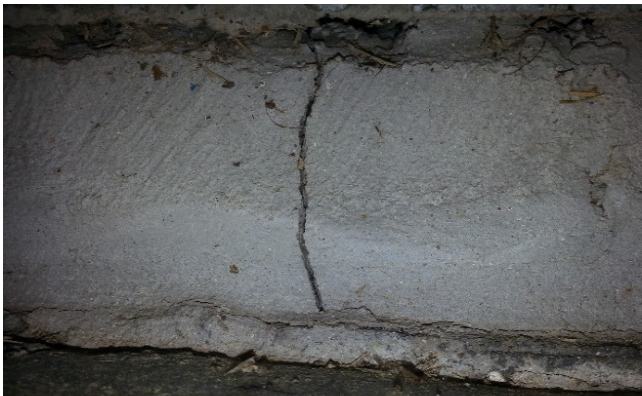
Cracks 1/8 inches or Less

Cracks this size may indicate either shrinkage from curing or foundational movement. This crack should be sealed and monitored.

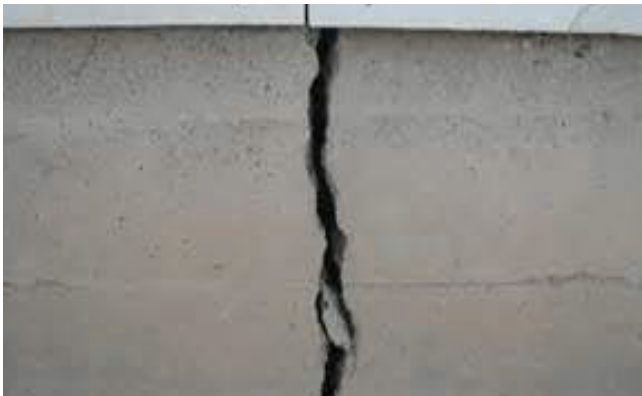
Cracks 1/4 inches or More

Cracks this large are most likely due to foundational movement. A structural engineer should be consulted.

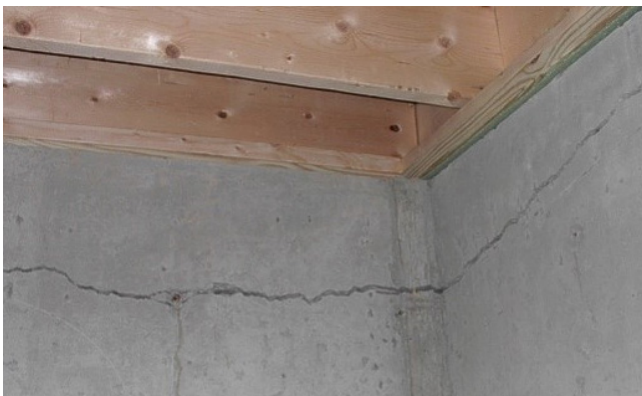
Basement Foundation Walls

Horizontal cracks found in the basement can be minor or major. Some minor cracks may be repairable DIY-style. Depending on their width and severity, some cracks may require stabilization repairs such as wall tiebacks or carbon fiber reinforcement. An NPI inspector would typically suggest a consultation with a structural engineer.

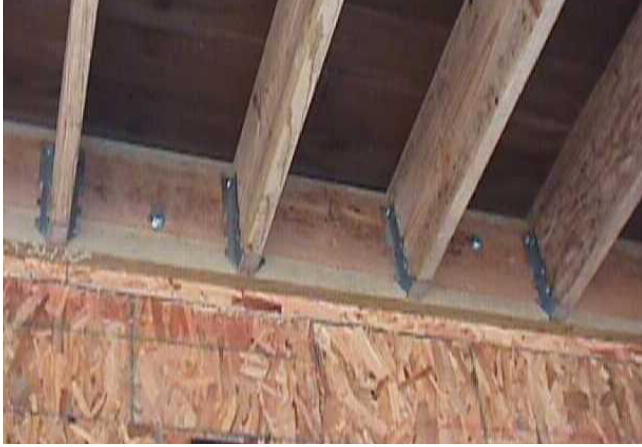
#4 - POOR DECK CONDITIONS

Poor deck conditions are often visible to untrained eyes. Check for post deterioration or chipped paint. Less obvious red flags exist in a deck's support system. Unstable support is often characterized by uneven or sloped boards.

Industry standards require all ledger boards be bolted to the house, and joist hangers must be installed on every joist with the appropriate type and amount of fasteners (left). All decks should have adequate fall protection including handrails and spindles.

Most deck issues can be self-repaired by a homeowner. For any structural concerns, a homebuyer can request an engineer consultation. Deterioration can be prevented with adequate maintenance and updated sealant.

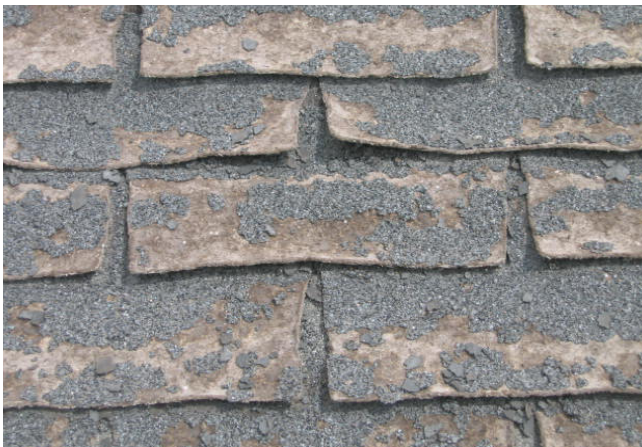
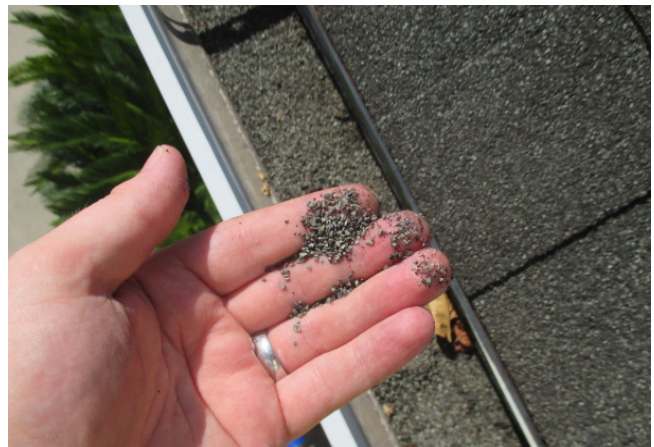
#3 - WORN ROOFING OR LEAKAGE

Roof condition is often a key factor in home appraisal. Excessive granular loss (pictured above) is a key indicator of poor condition. Note that the south-facing side of a house always displays the most wear.

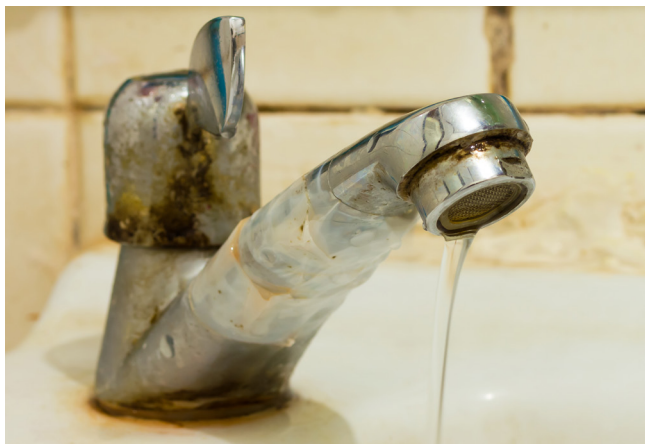
Small amounts of mold and mildew around showers, tubs and sinks are normal (above, left). Small amounts of mold on window sills are normal and most likely caused by condensation. These do NOT present a major problem or concern.
