National Property Inspections

Property Location

Riverside, Ca 92507

1. Executive Summary

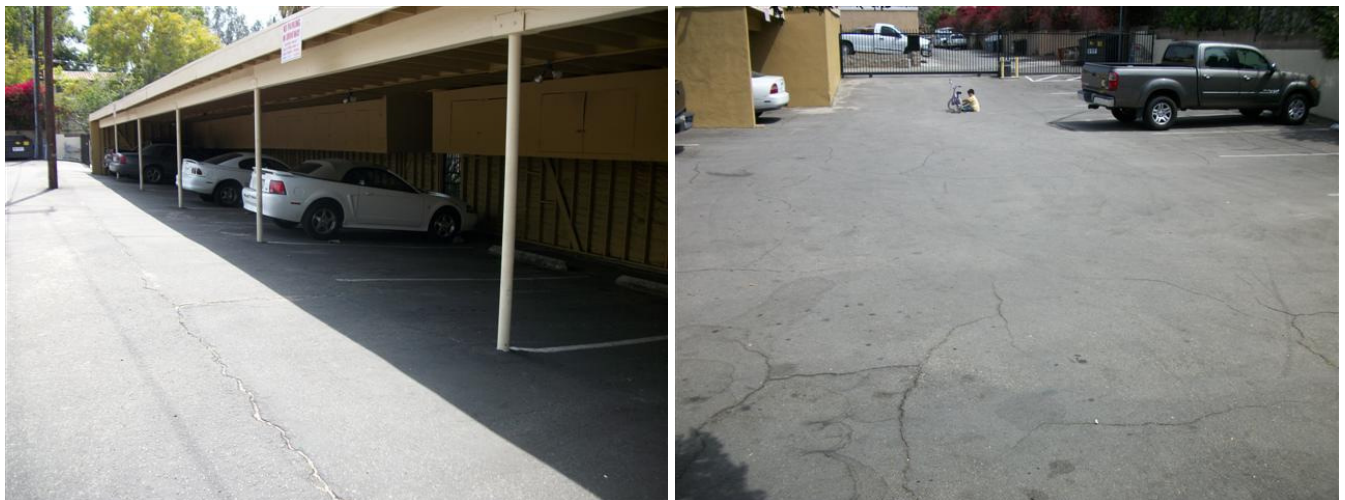
The surfaces and curbs appear to be in fair condition with some typical cracking throughout. No major deficiencies were observed or noted. Recommend monitoring for any developments.

View carports and secured parking lot

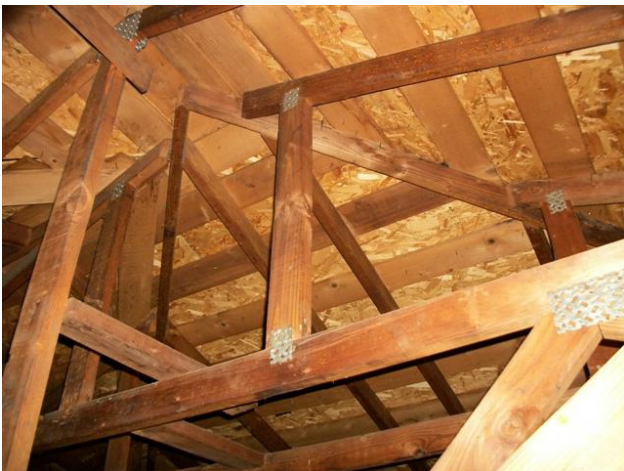
The observation of the structure was limited to exposed framework in the attic space. The overall condition of the frame appears to be fair. No major deficiencies were observed or noted. Gable and ridge vents are present to insure proper ventilation in the attic. Loose fill insulation has been applied insure interior temperature efficiency.

View of framework

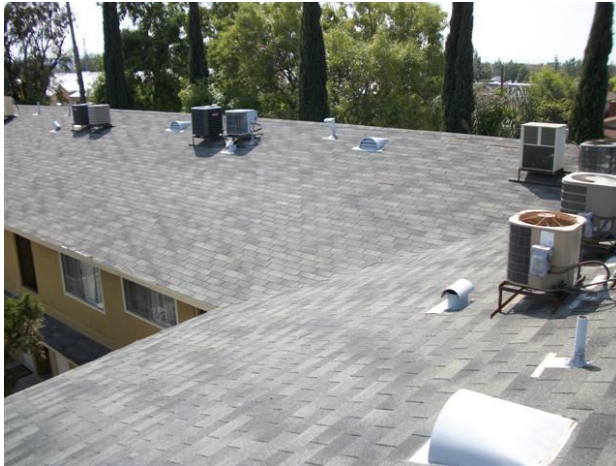
The roof was walked on and accessed above the laundry room with ladder. The surface is approximately 15 to 20 years in age and the overall condition of the roof appears to be poor with numerous areas where shingles are missing which has exposed some of the roof sheathing. Recommend further evaluation of the entire surface be completed by a licensed roofer to determine repair options which address water intrusion.

Overall view of surface

Estimated costs to further evaluate and repair: \$2,000 to \$3,000

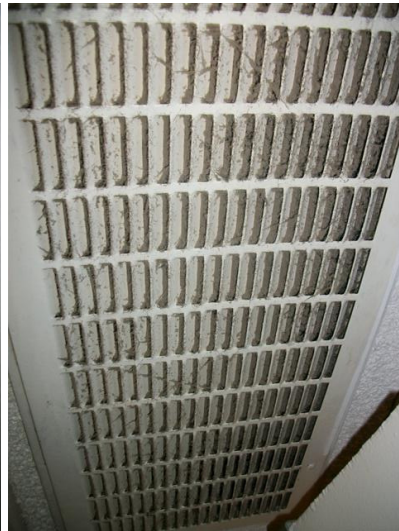
Dirty air filters
