JDeeEn Inc. DBA
National Property Inspections

Website Sample Report

Inspection Date:
06/20/2018

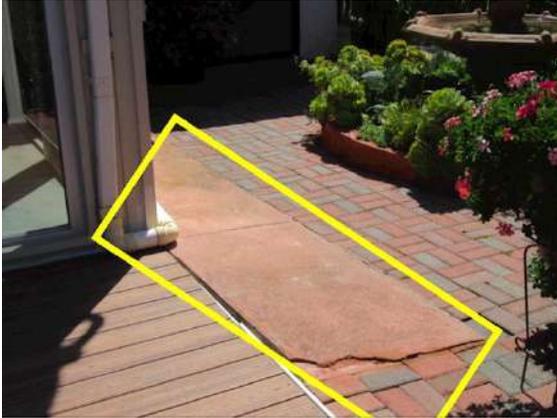
See GRADING section of this report.

FOUNDATION APRON: Observation of concrete apron around structure.

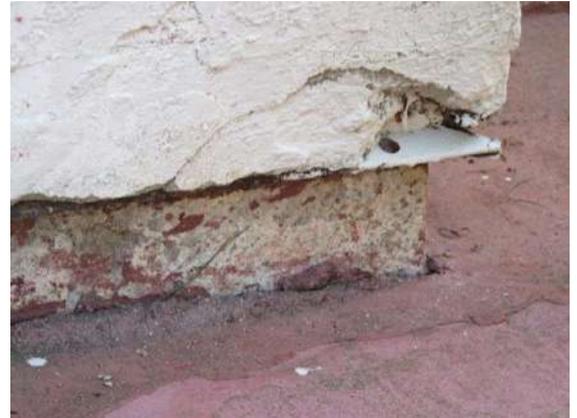
- The footprint of the structure is relatively flat.
- The bottom section of the stucco, including the lower drip screed are water damaged, and in some areas the drip screed has rusted out.

FOUNDATION APRON: Evidence of water damage at footing and stucco intersection with damaged & rusted drip screed. Also observed patching of flatwork next to house.

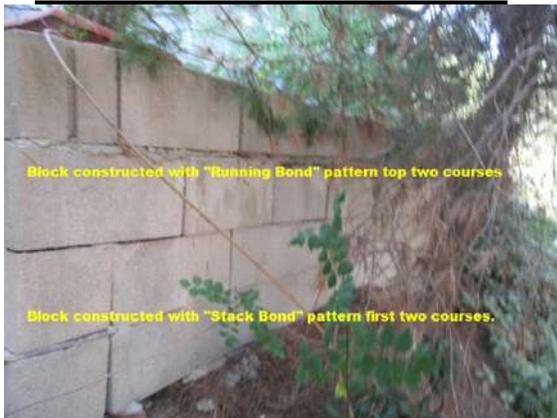
The fact that various block laying methods were used, rebar was used to hold up the wall from the outside rather than the conventional inside of the wall, mortar beds are uneven, partially missing, or filled with bit of floor tile and not struck clean, Block laid crooked and kittywampus throughout, places the entire integrity of the wall as suspect.

RETAINING WALLS: The use of various block construction patterns within the same wall indicates the likelihood that non or poor construction knowledge was used.

I strongly urge a licensed structural/geotechnical engineer inspect the walls and make recommendations for stabilization.

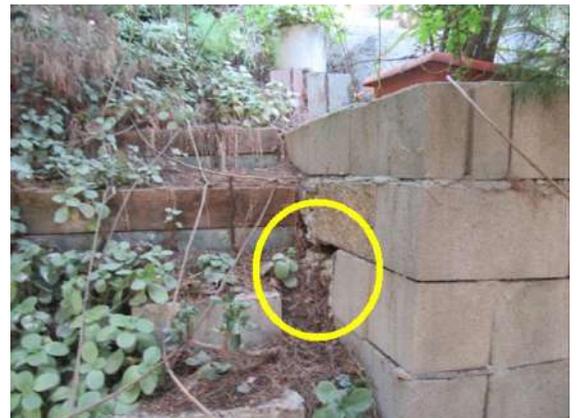
RETAINING WALLS: Evidence of possible lack of footings at retaining wall.

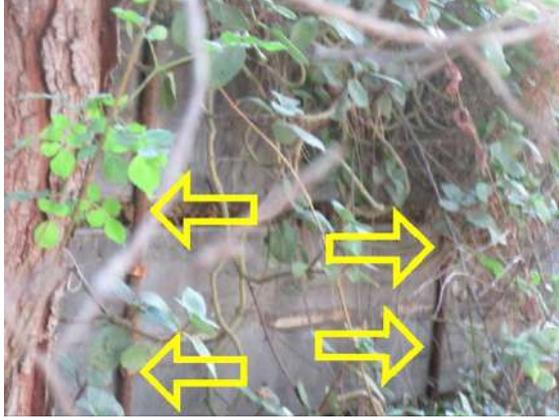
RETAINING WALLS: #3 or #4 rebar used on outside of wall for unknown reason.

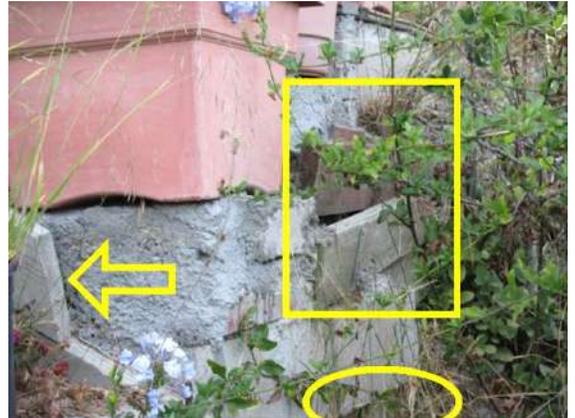
RETAINING WALLS (CONT): Arrow indicated form boards left in place, Circle indicates block not sitting on footing. Square shows form wood either left in place or used for support.

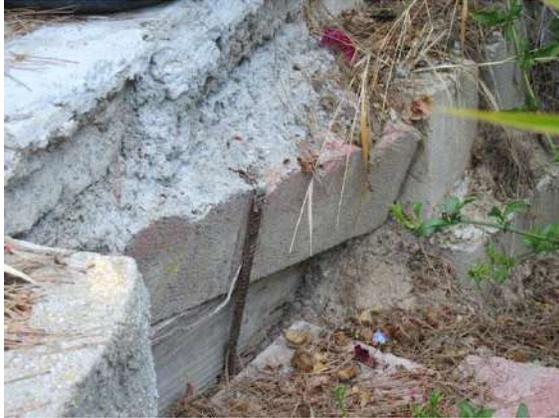
RETAINING WALLS (CONT 2): Example of poor and unconventional workmanship encompassing the entire retaining wall structure.

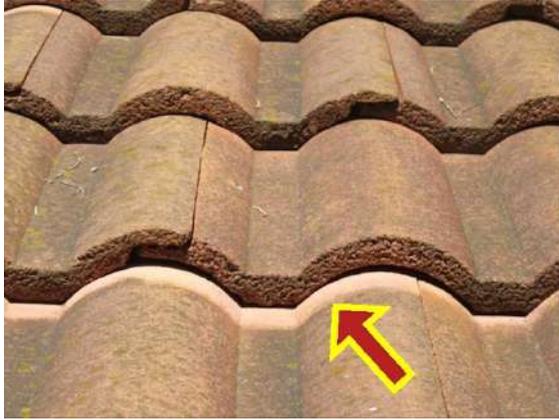
This tile roof is original to the house and is at or near its useful life. Many tiles have shifted and appear to no longer be attached to the roof structure. (I was able to push several back into place by over an inch during the inspection.) This may potentially be caused by the nails rusting and disintegrating over time. Many unconventional, non-professional roof patches have been made both at edges of roofs and around roof penetrations. This indicates the roof has leaked in many places in the past. There is no way to determine at the time of the inspection if the leaks have been repaired or are still active.

ROOFING: Lighter tan line indicates tile have slipped down about an inch within the last few years.

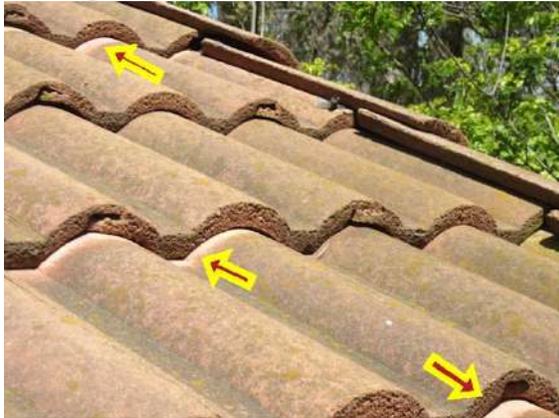
ROOFING (CONT): Lighter coloration of tile indicates areas where tiles have come loose.

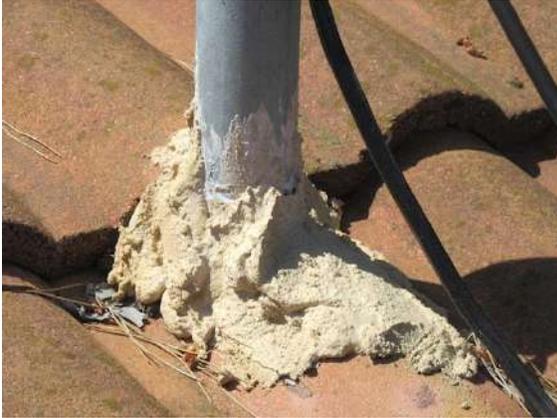
ROOFING (CONT 2): Unconventional repairs at location of previously suspected leak.

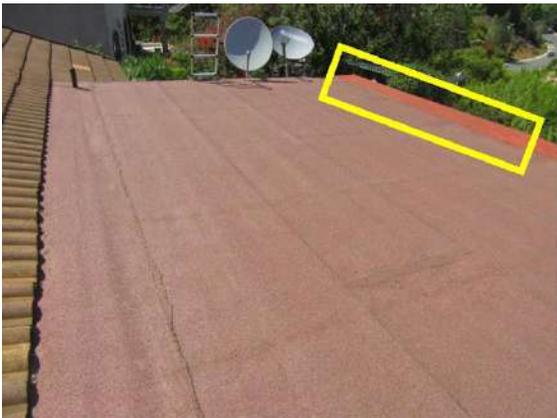
The rolled roof over the sunroom has also been repaired due to previous water intrusion. It also appears to be at or near its useful life.

FLAT ROOF OVER SUNROOM: Location of previous roof repairs at location of suspected leaks.

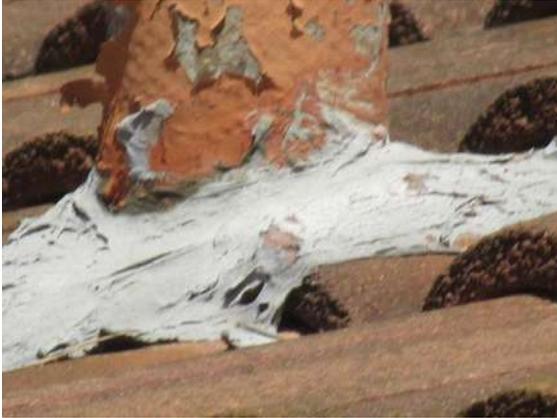
FLASHING/VALLEYS: Temporary, non-professional repair.

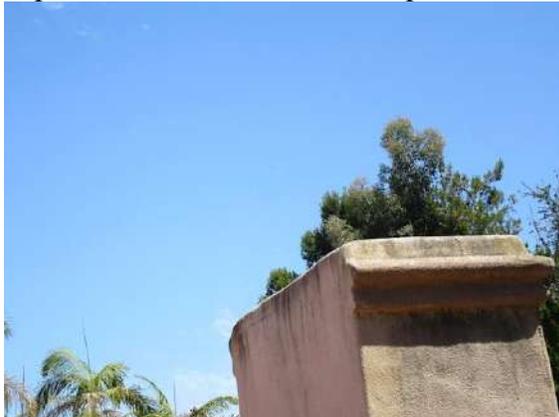
CHIMNEY: No rain cap/spark arrestor visible at the time of the inspection.

Rain cap/spark arrestor/bird screen was not visible at the top of chimney at the time of the inspection. If in fact there is no rain cap/spark arrestor, I recommend installing rain cap/spark arrestor to prevent water from entering chimney and spark retention when chimney is used as a wood burning device. This should also keep birds from nesting inside chimney when not in use. I recommend a qualified, licensed chimney sweep and/or contractor be hired to assess the situation further.

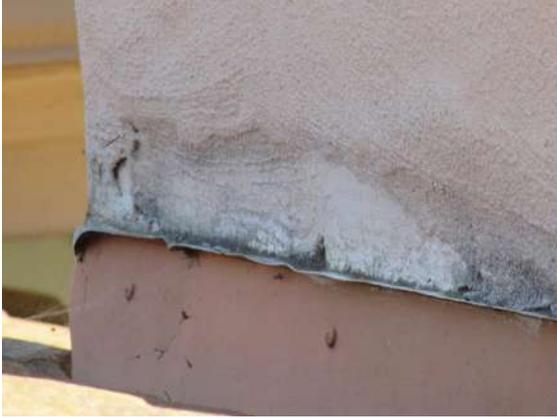
CHIMNEY: Water damage at base of chimney at flashing.

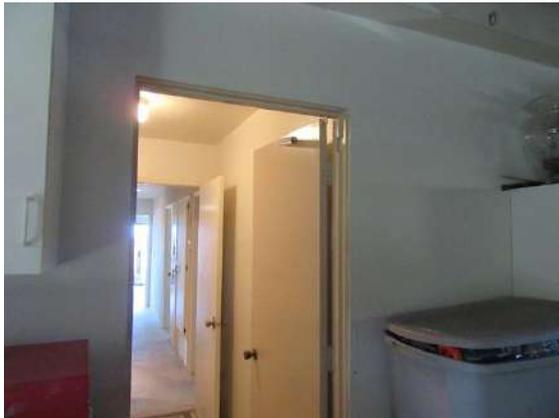
Door between garage and living space has had auto door closure disconnected and is missing self closing hinges or some other device. This is a fire-rated door and as such must self-close and self-latch any time the door is opened. This is a safety concern as the door may inadvertently be left ajar permitting fire or dangerous gases to enter the home and cause injury to occupants. I recommend proper installation of door closure by a qualified, licensed contractor.

GARAGE PEDESTRIAN DOOR INTO HOUSE: Door does not close on its own.

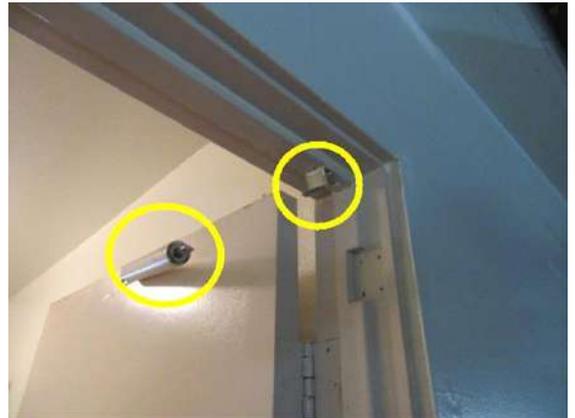
GARAGE PEDESTRIAN DOOR INTO HOUSE: Automatic door closure disconnected.

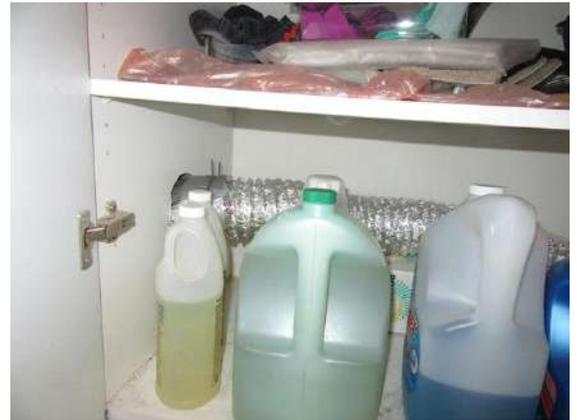
LAUNDRY FACILITIES: Dryer vent snakes through back wall into cabinet, then garage, then under water heater to the outside.

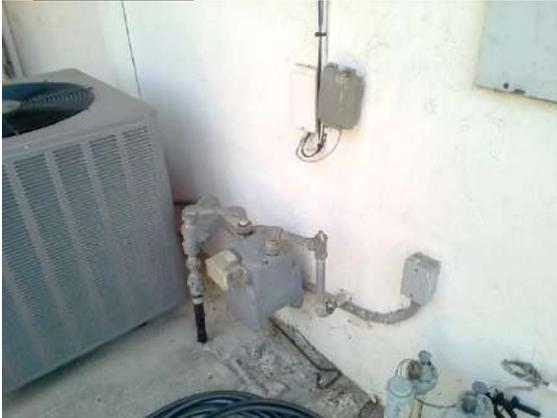
Equipment disconnect/fusebox could not be located at time of the inspection. Without a separate fuse connection at the unit, the only level of protection for over current is at the main electrical service. It is also recommended that an equipment disconnect be within visible range of the unit for safety purposes. If a technician turns off the power at a location not in view, it may get turned on by others while it is being worked on. This makes it very unsafe.

COOLING: No equipment disconnect within visible range.

It may be possible that no disconnect is installed because of the equipment's proximity to the main service panel, however this would still not include a separate fuse box. **I recommend further evaluation by an licensed electrician who is qualified with HVAC equipment installation.**

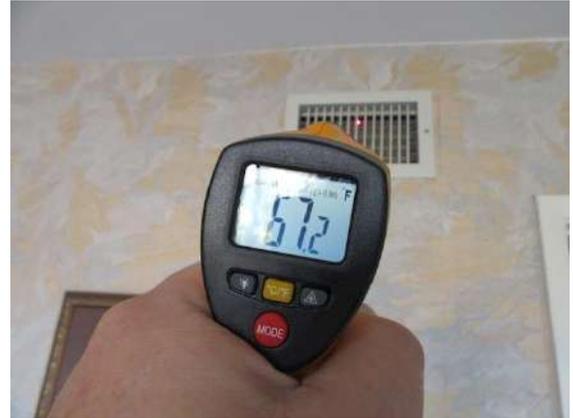
COOLING: Temp at register after about 5 minutes of operation.

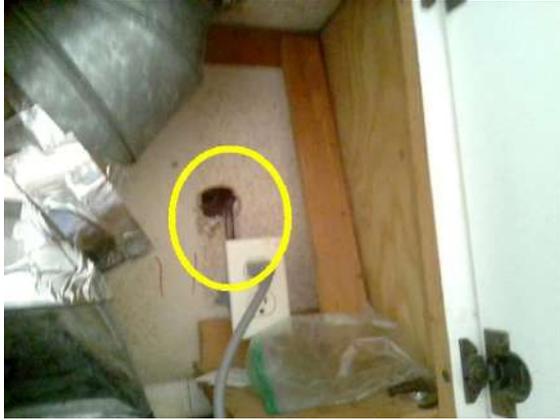
KITCHEN: Unconventional electrical wiring at rangehood/microwave.

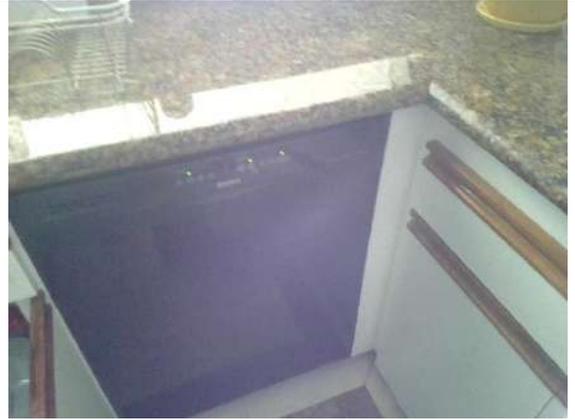
KITCHEN: Dishwasher extremely noisy. Indication of mechanical malfunction potential.

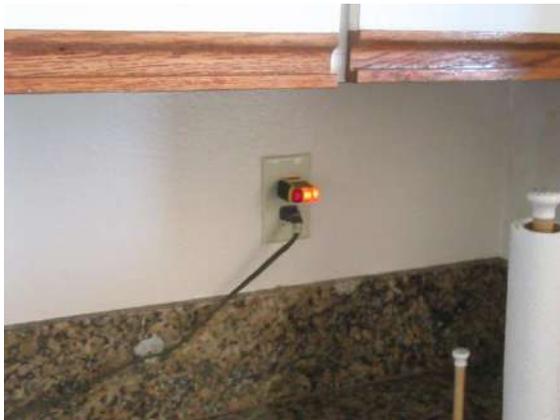
KITCHEN: GFCI not operational in kitchen.

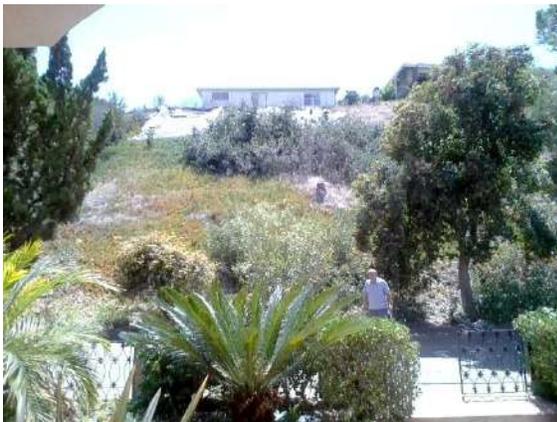
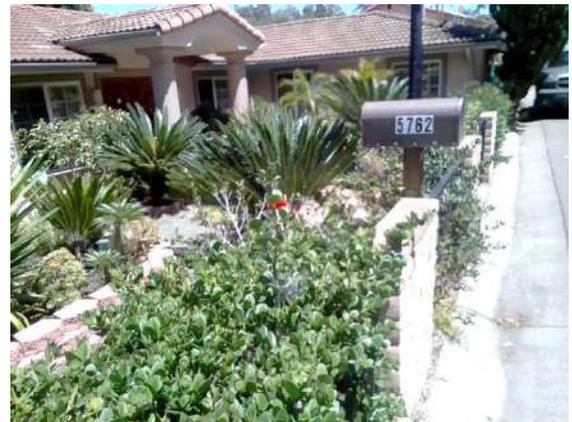
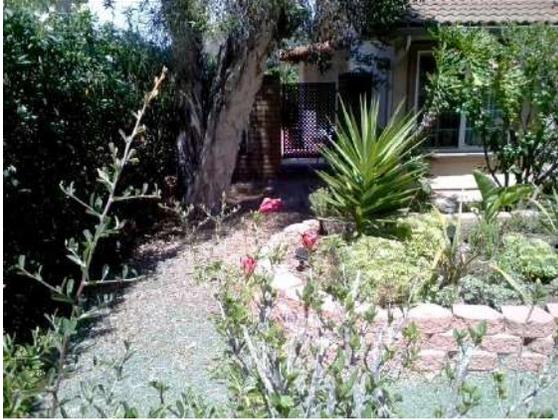
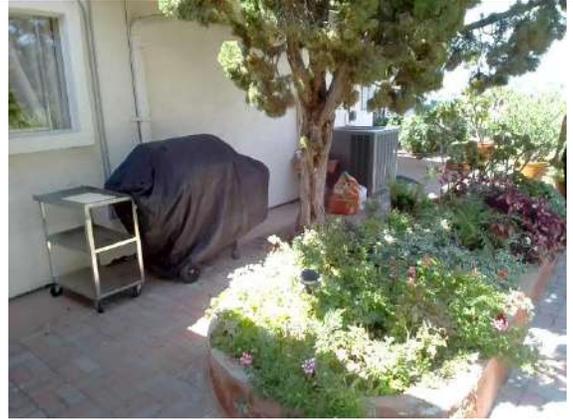
Grading / Drainage:

- There is a large berm and trench drain installed the length of the garage door.
- There appears to be an 18" concrete apron on the flatwork at the base of nearly the entire building. This is typical evidence of an installed french drain system used to keep basements dry that experience high water tables. Though this is clearly not the case, there is no obvious explanation unless it was installed to mitigate water intrusion or it is purely aesthetic in nature. Not able nor qualified to make that determination.

While none of these issues independently would be of great concern, the accumulation of observations lends itself to further investigation by a qualified civil and/or geotechnical engineer.

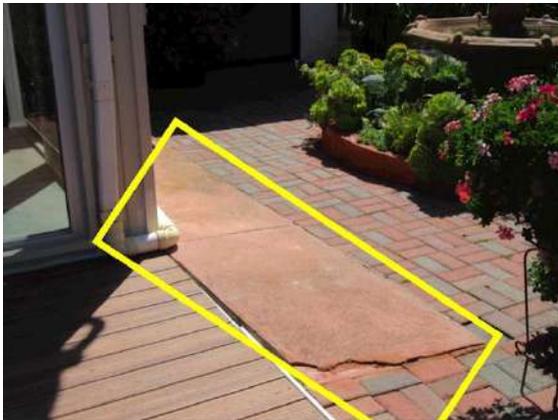
Foundation Apron: Observation of concrete apron around structure.

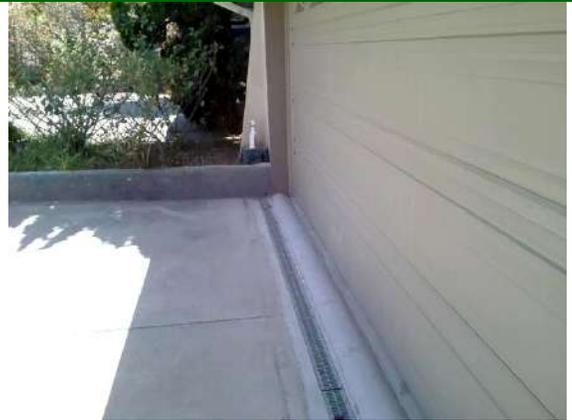
Driveway: Driveway berm/trench drain installation.

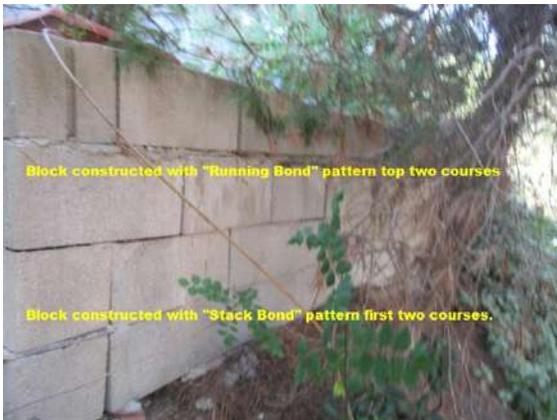
The fact that various block laying methods were used, rebar was used to hold up the wall from the outside rather than the conventional inside of the wall, mortar beds are uneven, partially missing, or filled with bit of floor tile and not struck clean, Block laid crooked and kittywampus throughout, places the entire integrity of the wall as suspect.

Retaining Walls: The use of various block construction patterns within the same wall indicates the likelihood that non or poor construction knowledge was used.

I strongly urge a licensed structural/geotechnical engineer inspect the walls and make recommendations for stabilization.

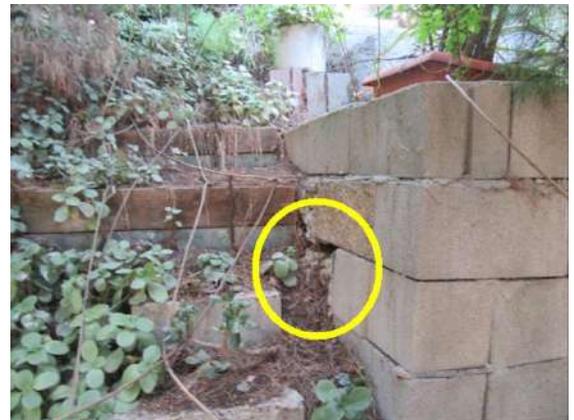
Retaining Walls: Evidence of possible lack of footings at retaining wall.

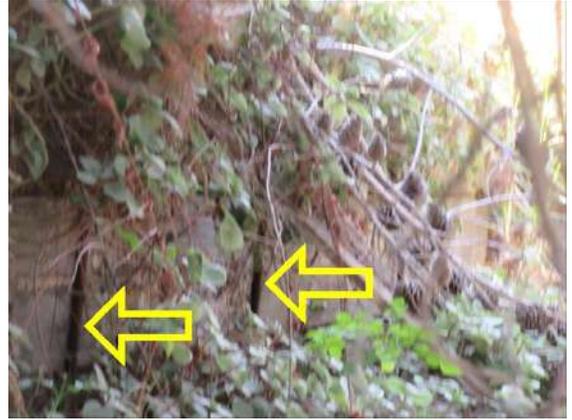
Retaining Walls: #3 or #4 rebar used on outside of wall for unknown reason.

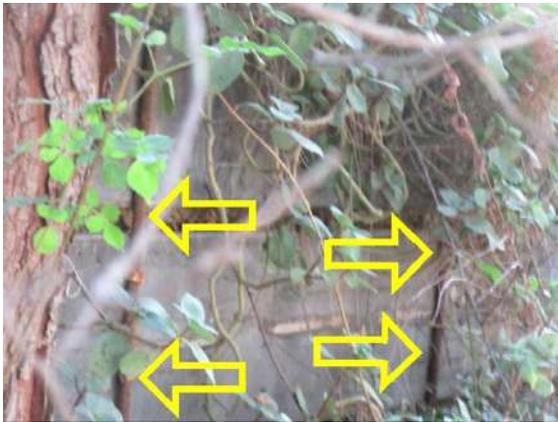
Retaining Walls: #3 or #4 rebar used on outside of wall for unknown reason.

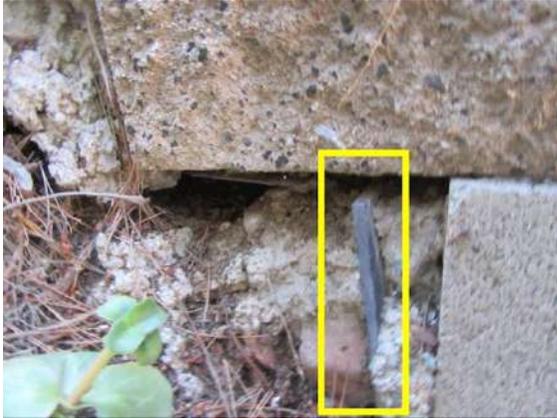
Retaining Walls (cont): Metal concrete form stake used in an unconventional manner.

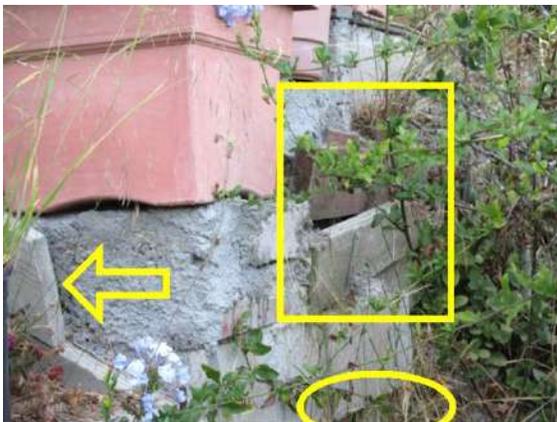
Retaining Walls (cont): Arrow indicated form boards left in place, Circle indicates block not sitting on footing. Square shows form wood either left in place or used for support.

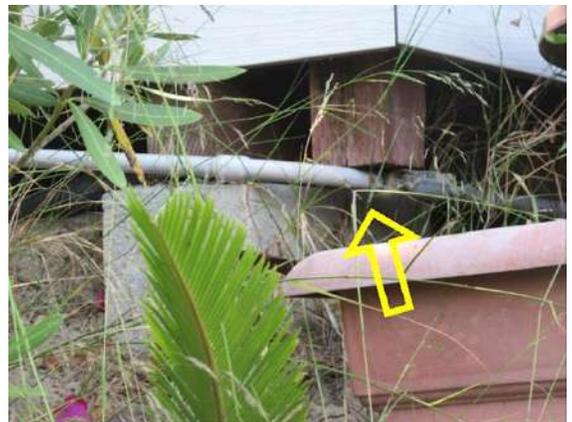
Retaining Walls (cont): Wood support post for deck resting on grey PVC pipe for support.

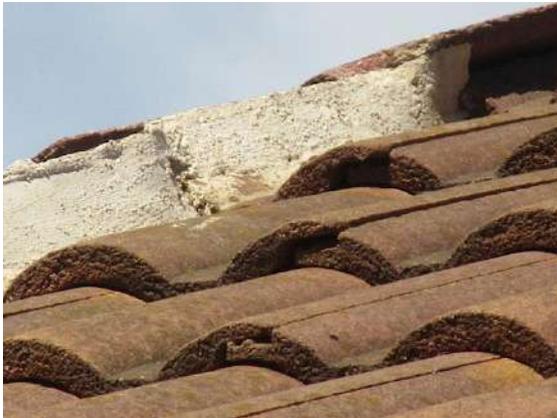
Roofing: Unconventional roof patch at location of previous leak.

I'd strongly recommend a qualified, licensed roofing contractor inspect the roofs and make a determination if they are water-tight, if the current patches will last, and if further repairs are needed or the entire roof structure should be removed and replaced.

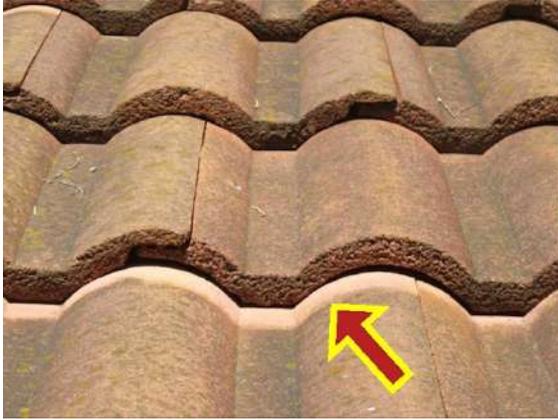
This tile roof is original to the house and is at or near its useful life. Many tiles have shifted and appear to no longer be attached to the roof structure. (I was able to push several back into place by over an inch during the inspection.) This may potentially be caused by the nails rusting and disintegrating over time. Many unconventional, non-professional roof patches have been made both at edges of roofs and around roof penetrations. This indicates the roof has leaked in many places in the past. There is no way to determine at the time of the inspection if the leaks have been repaired or are still active.

Roofing: Lighter tan line indicates tile have slipped down about an inch within the last few years.

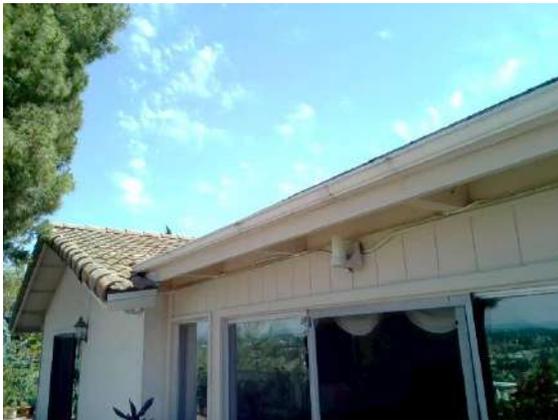
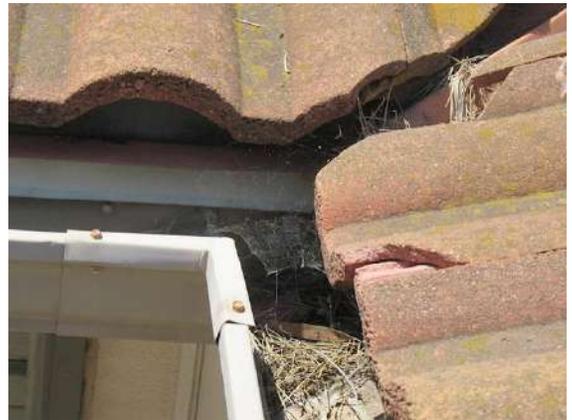
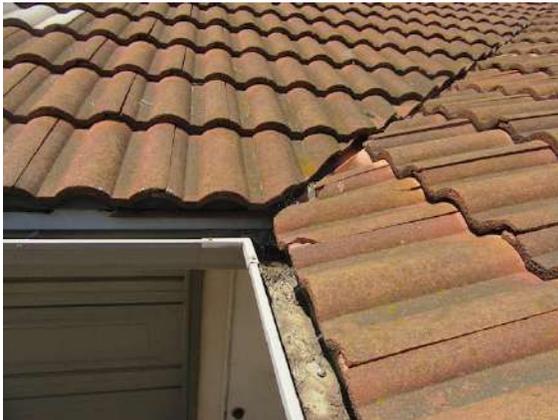
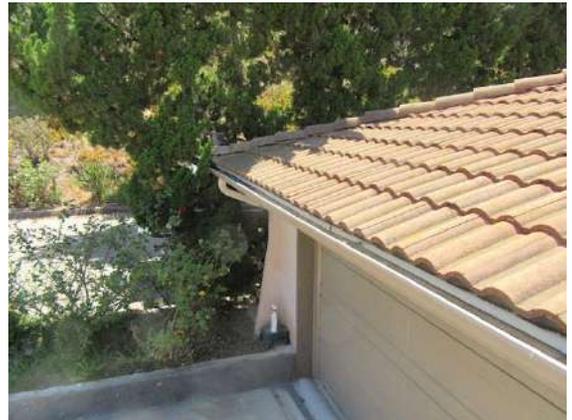
Gutters full of debris, which will inhibit water movement and may cause water ponding and gutters being ineffective. Recommend cleaning.

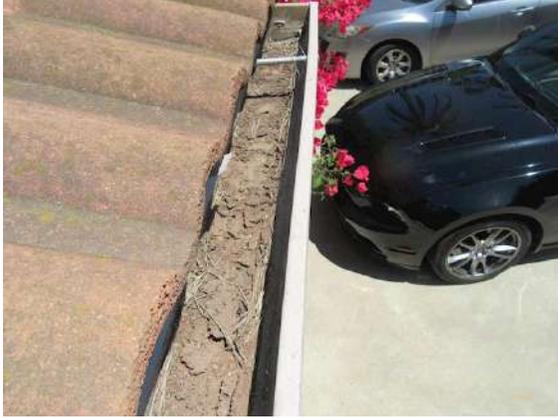
Gutters/Down Spouts: Some area had caked on mud in gutters which affects operation.

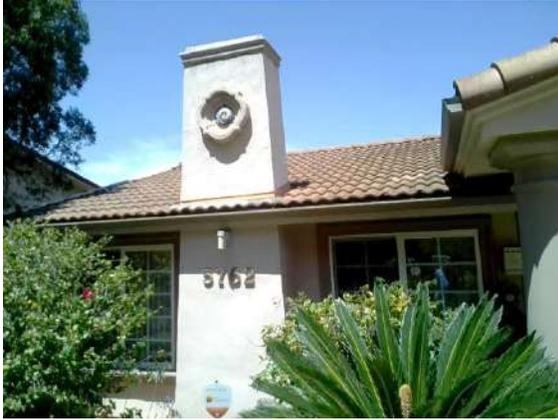
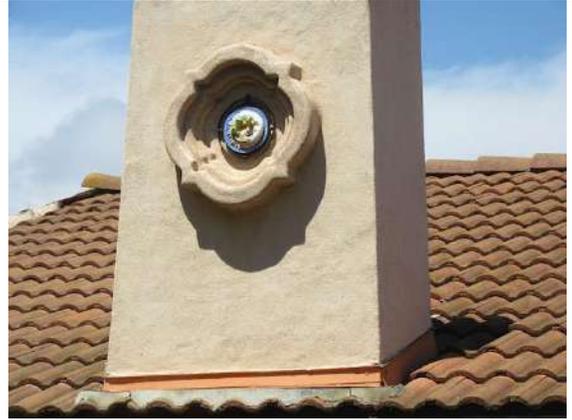
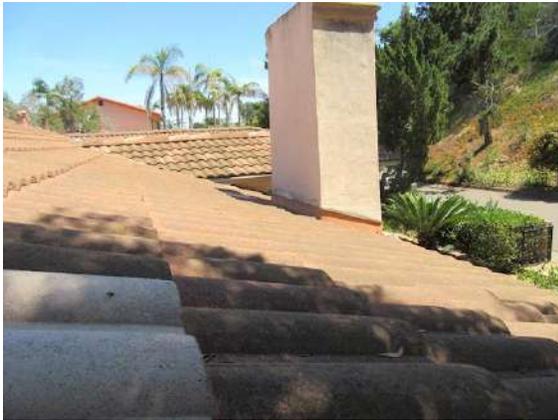
Chimney is 30 inches or wider and is missing cricket or saddle flashing at roof intersection. Water damage at flashing/stucco intersection indicates the lack of a cricket is causing issues. I recommend installing cricket/saddle flashing by a qualified roofing contractor to divert water away from the back side of the chimney.

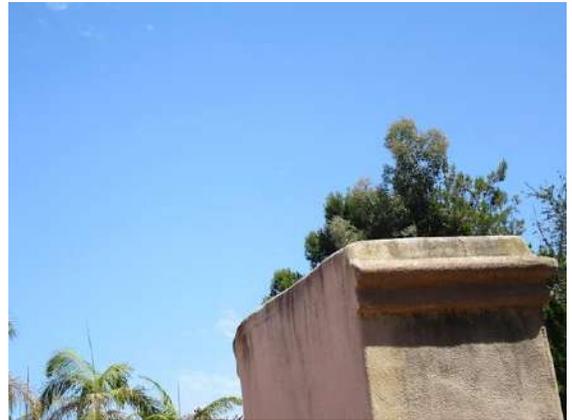
Rain cap/spark arrestor/bird screen was not visible at the top of chimney at the time of the inspection. If in fact there is no rain cap/spark arrestor, I recommend installing rain cap/spark arrestor to prevent water from entering chimney and spark retention when chimney is used as a wood burning device. This should also keep birds from nesting inside chimney when not in use. I recommend a qualified, licensed chimney sweep and/or contractor be hired to assess the situation further.

Chimney: No rain cap/spark arrestor visible at the time of the inspection.

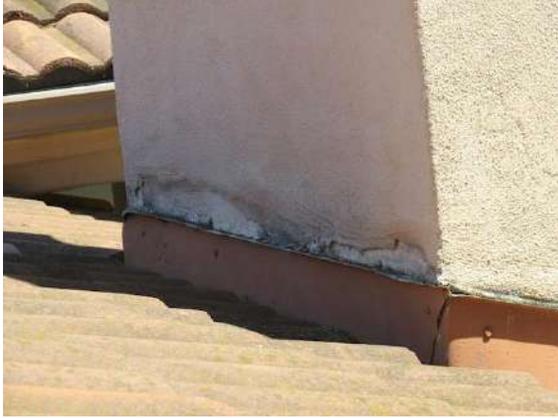
Chimney: Water damage at base of chimney at flashing.

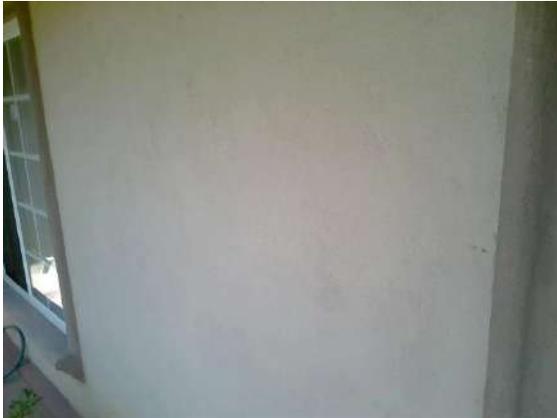
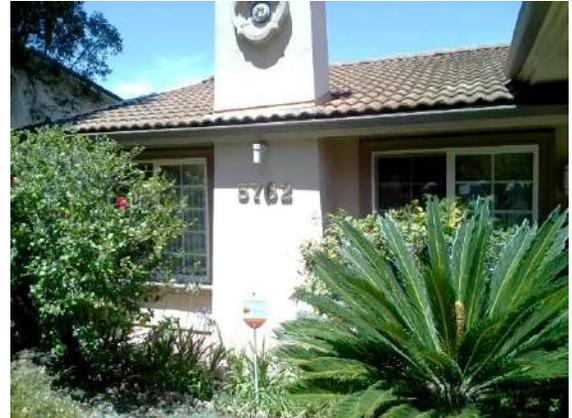
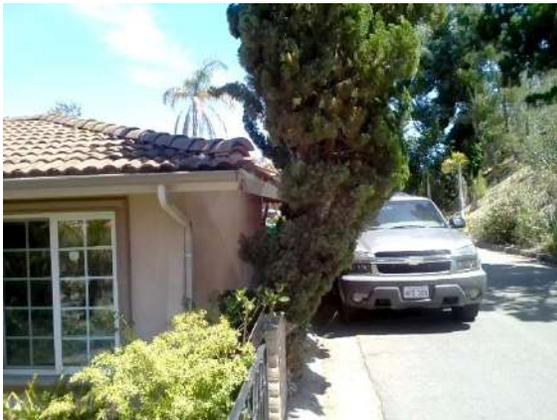
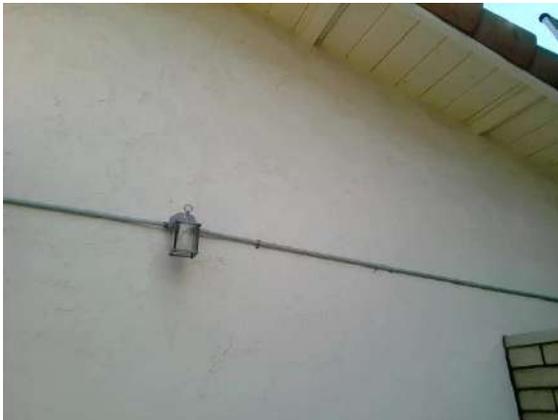
This stucco has been painted, which requires continuous upkeep and maintenance. Observed loose flaking paint in several locations. Also observed damage to bottom of stucco and drip screed in several places. This is typically caused by excessive moisture. As noted in other sections of this report this may indicate a need for further investigation.

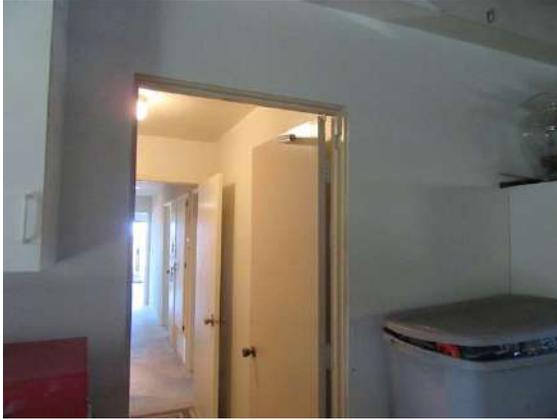
Door between garage and living space has had auto door closure disconnected and is missing self closing hinges or some other device This is a fire-rated door and as such must self-close and self-latch any time the door is opened. This is a safety concern as the door may inadvertently be left ajar permitting fire or dangerous gases to enter the home and cause injury to occupants. I recommend proper installation of door closure by a qualified, licensed contractor.

Garage Pedestrian Door into House: Door does not close on its own.

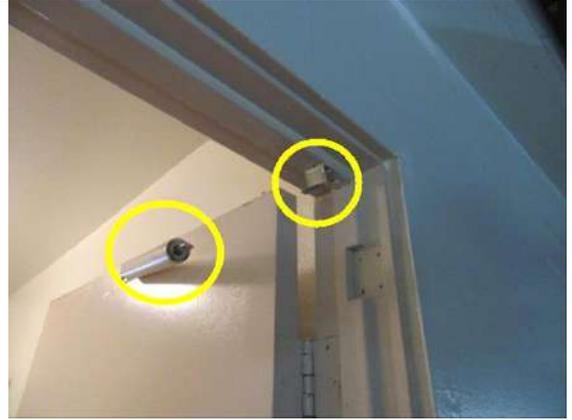
Garage Pedestrian Door into House: Automatic door closure disconnected.

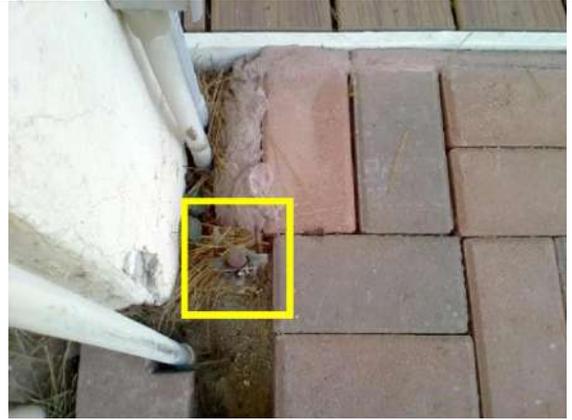
Electrical: Grounding rod next to main electrical service panel.

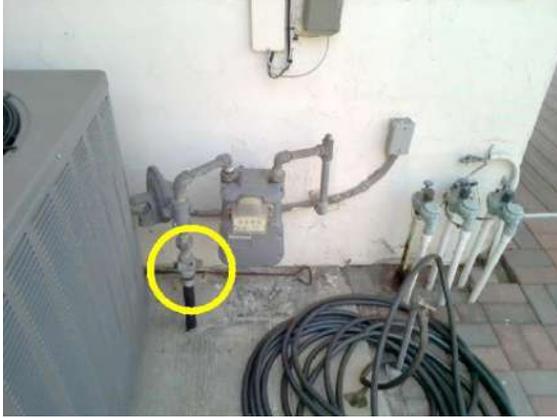
Plumbing: Gas meter and emergency shut off next to A/C unit at right/south side of house.

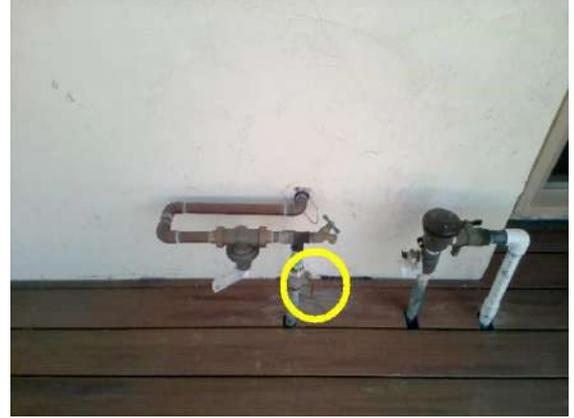
Plumbing: Main service entrance and shut-off valve at back deck.

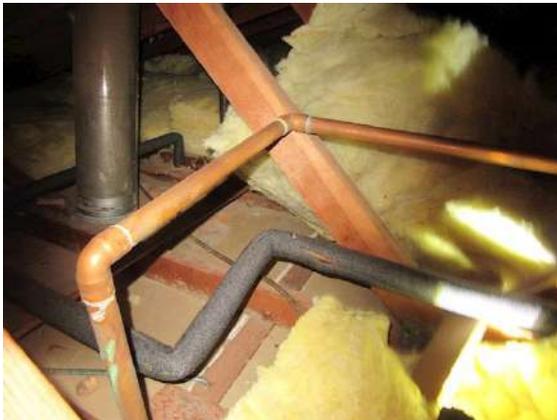
Plumbing: Copper pipe in attic.

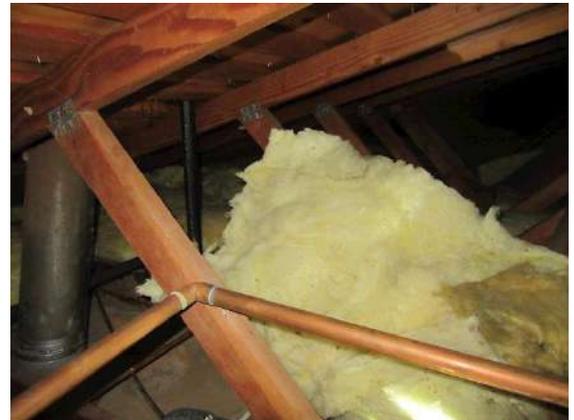
Plumbing: Copper pipe in attic.

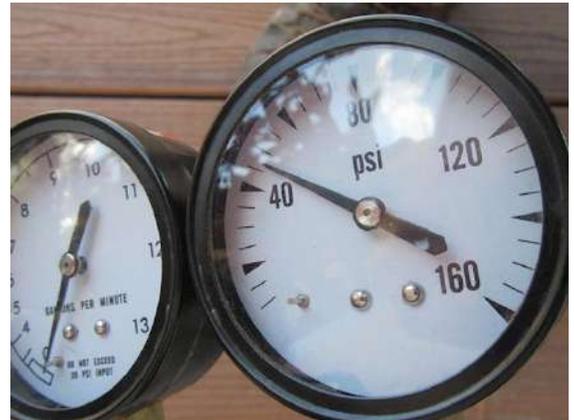
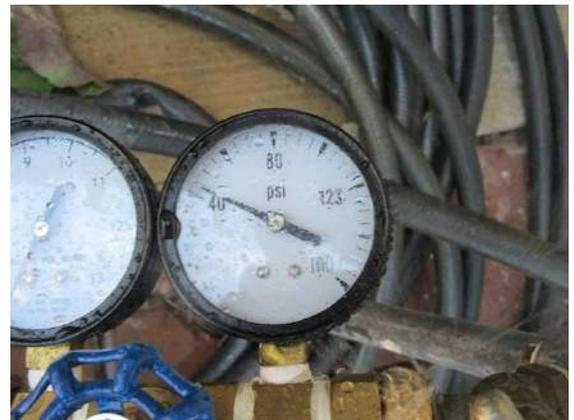
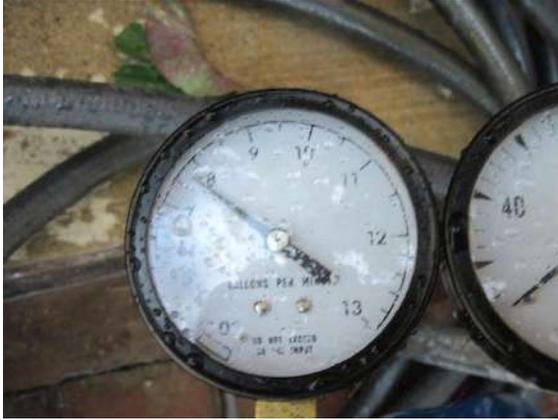
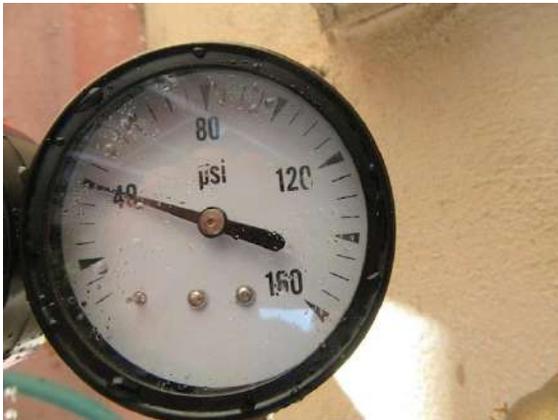
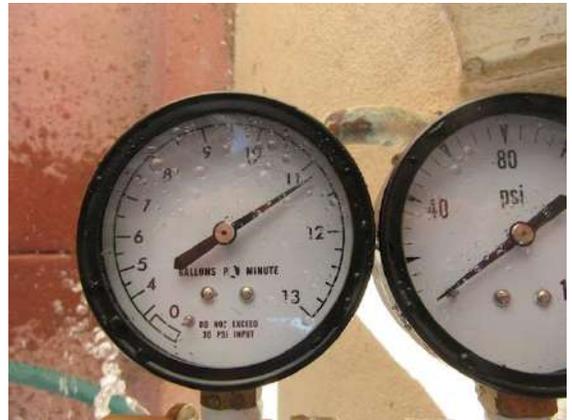
Water pressure registered at about 40 psi and water flow was between 8 and 13 gallons per minute at three different hose bibs. Both measurements are within acceptable standards.

Water Pressure/Flow: Water pressure registered at about 40 psi at three different hose bibs.

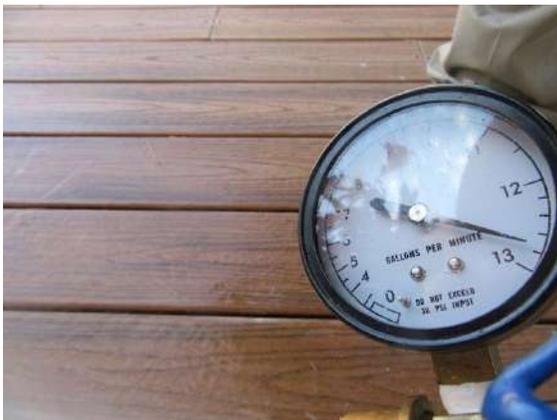
Water Pressure/Flow: Water flow was between 8 and 13 gallons per minute at three different hose bibs.

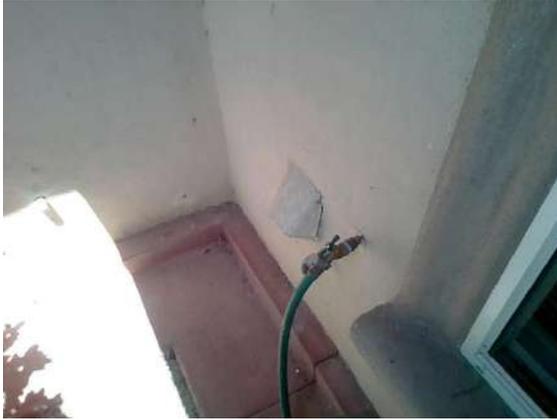
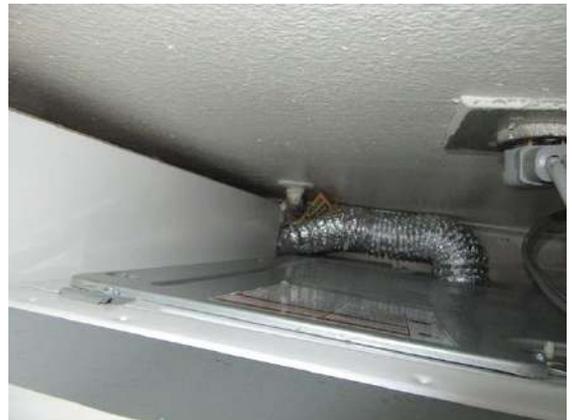
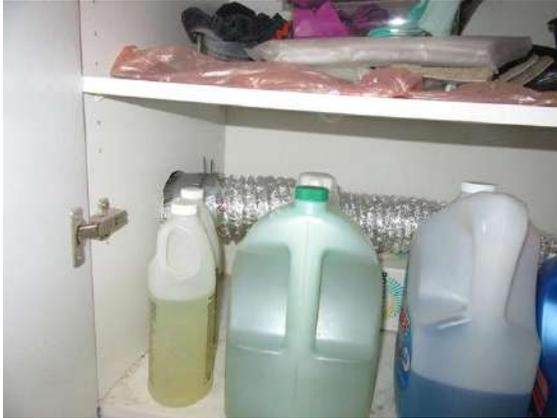
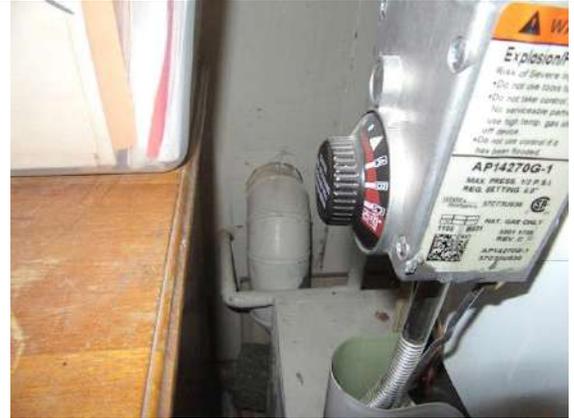
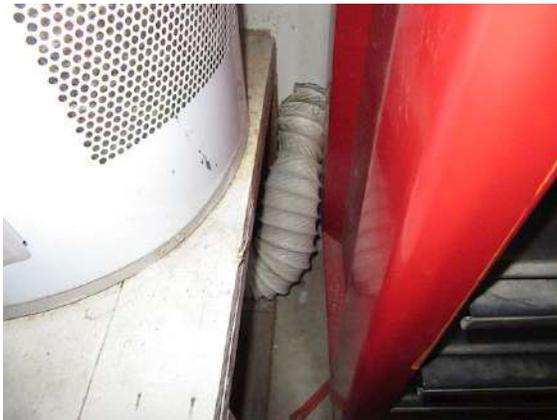
Dryer vent hose is made of a plastic fabric wrapped around a wire spiral and is not intended to be used for this purpose. Recommend installation of the proper type of metal flex pipe as recommended by dryer manufacturer by a licensed, qualified plumber.

Laundry Facilities: Dryer vent snakes through back wall into cabinet, then garage, then under water heater to the outside.

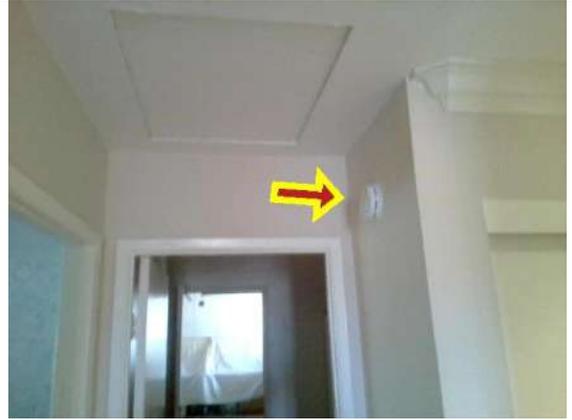
Laundry Facilities: Smoke detector located outside laundry room in hallway.

Observed a smoke detector in the kitchen area and in the hallway next to laundry room. Today's recommendation is to locate a smoke detector in every sleeping room and have them "tied together" typically wirelessly, so that if one alarms, they all alarm. I'd recommend upgrading the current smoke detectors in the near future for added safety.

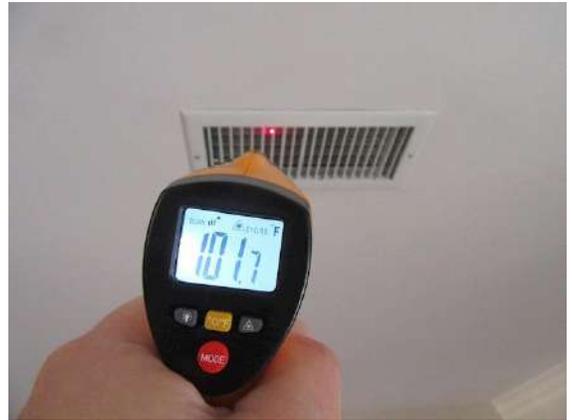
Heating: Temp reading at vent after about 5 minutes of operation.

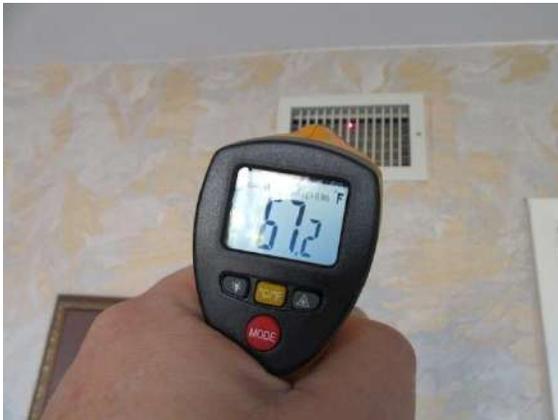
Cooling: Temp at register after about 5 minutes of operation.

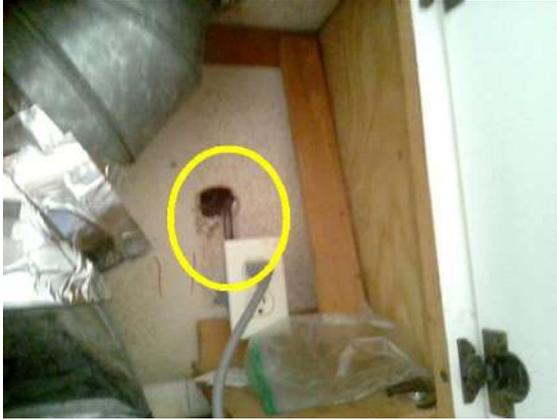
Unconventional electrical wiring at rangehood/microwave. I recommend further review by a qualified, licensed electrician to rewire this within acceptable standards.

Kitchen: Unconventional electrical wiring at rangehood/microwave.

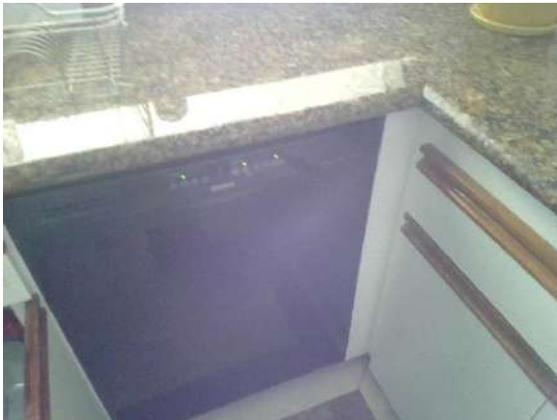
Kitchen: Dishwasher extremely noisy. Indication of mechanical malfunction potential.

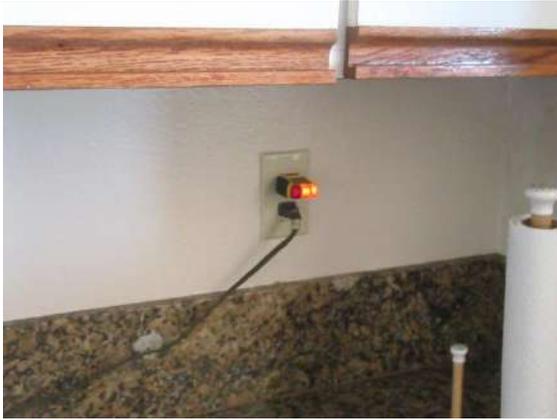
Electrical outlet(s) not GFCI protected. Ground Fault Circuit Interrupters (GFCI) are to be installed at all kitchen countertops, though they may not have been required at the time the house was built. Recommend installing GFCI protection for safety and proper compliance by a qualified, licensed electrical contractor.

Kitchen: GFCI not operational in kitchen.

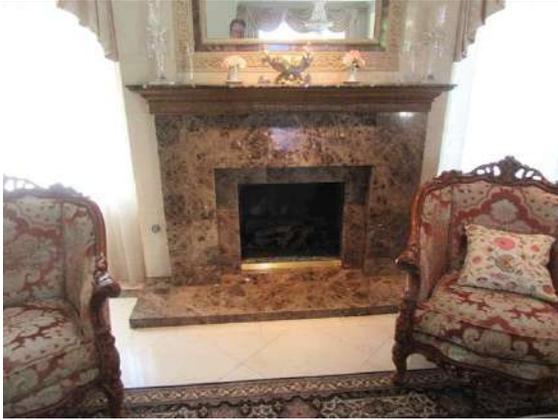
No fireplace doors or spark arrestor screen installed. Recommend review by a fireplace expert.

Fireplace/Stove: No fireplace doors or spark arrestor screen installed.

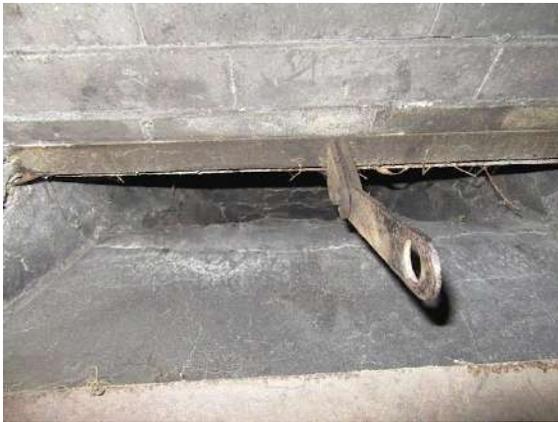
Vent appeared to be missing damper stopper clamp which when installed does not permit damper to be closed all the way. Completely closing the vent damper or forgetting the damper is all the way closed, while operating/starting the wood-burning fireplace will cause smoke/carbon monoxide to enter the living space. Recommend a damper stopper be installed.

Fireplace/Stove: Vent appeared to be missing damper stopper clamp

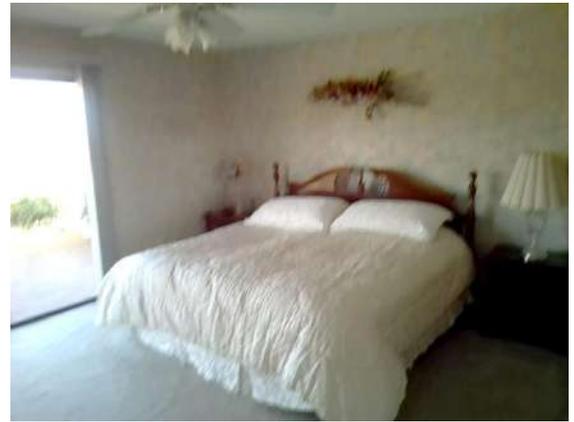
East Master Bedroom:

Water damage observed next to closet door near floor. Ceiling looks as if it has been recently repainted, with paint making its way onto the wallpaper in several locations. Though this is cosmetic in nature and typically not part of a home inspection, it warrants pointing out as evidence of potential or past water leaks based on what was observed around perimeter of the house flatwork and the roof disrepair.
